# **FRANKLIN TRAIL**

## **Trail Assessment, Analysis And Plan of Work Phases I and III**

*Report Prepared By:*  
Ray Ford, Project Manager  
Santa Barbara County Trails Council  
December 1, 2018

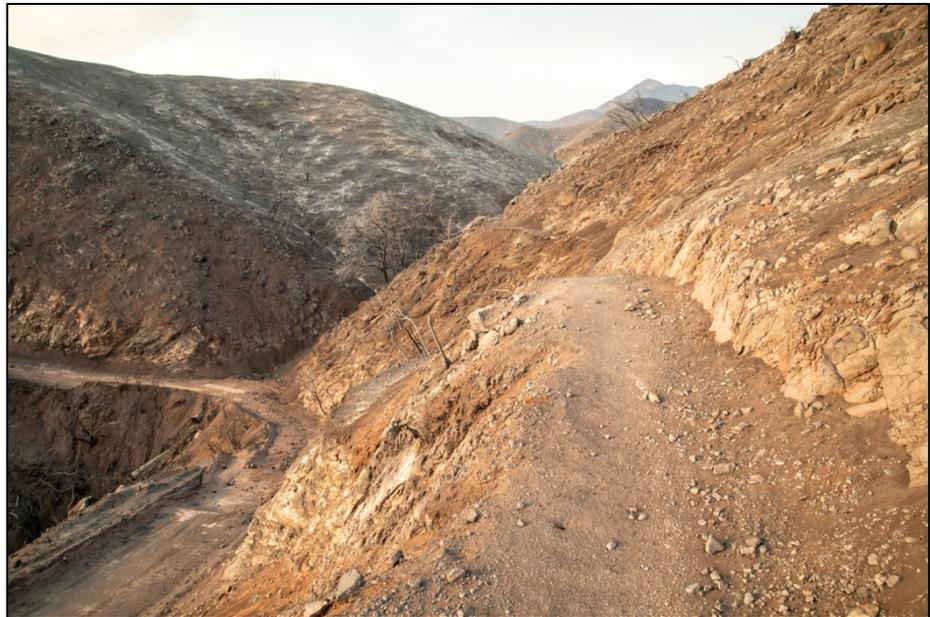
*Pict 1. Traverse directly above the trailhead road has been completely stripped of vegetation, leaving a 30-50 foot drop with no protection should you go off the trail.*

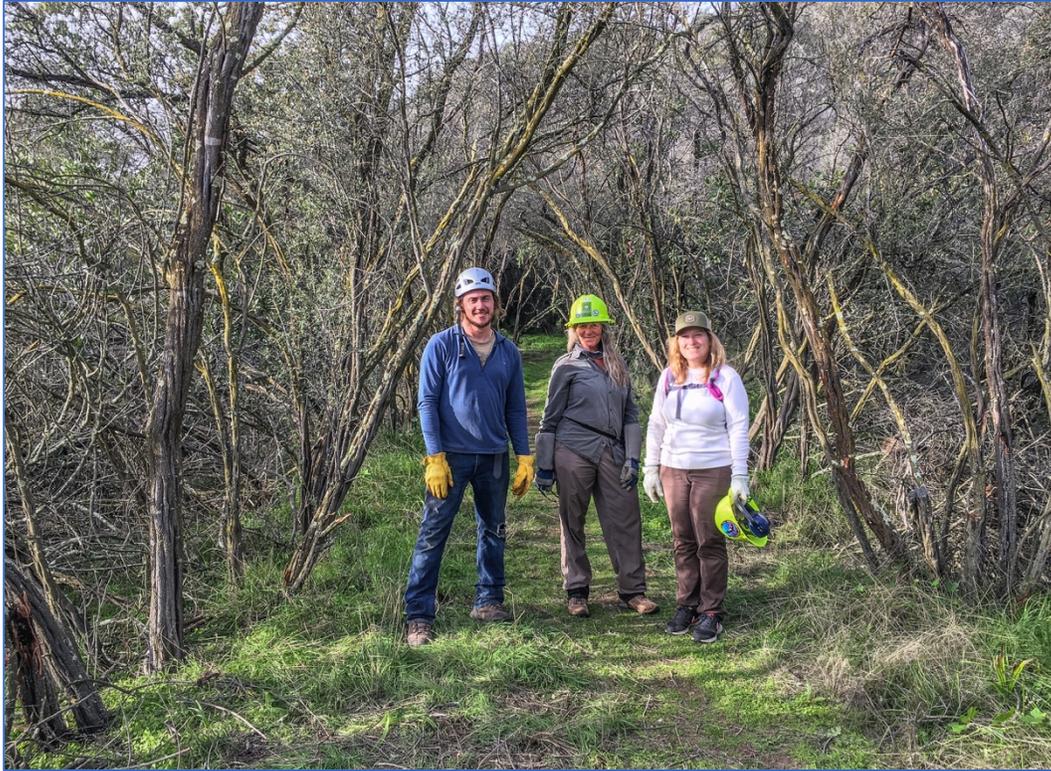
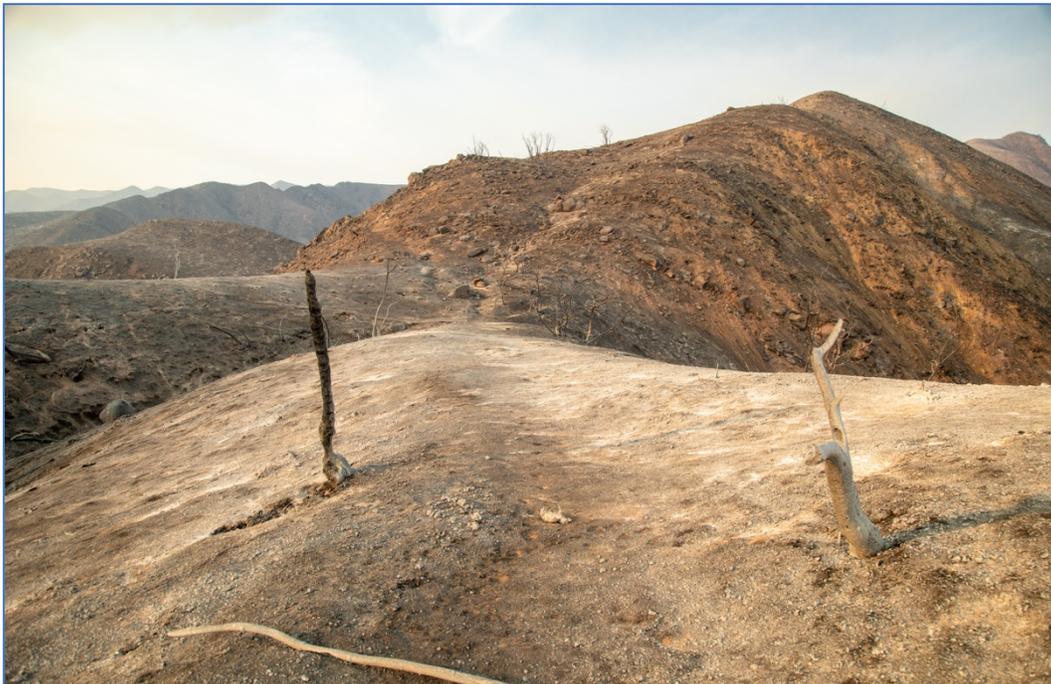
*Picts 2-3. The upper image along a nice long section with a canopy of chaparral to walk through. Below only scattered sticks remain from the thick brush shown above. The entire 2.9 miles of trail and surrounding brush have been burned to mineral soil in similar fashion.*

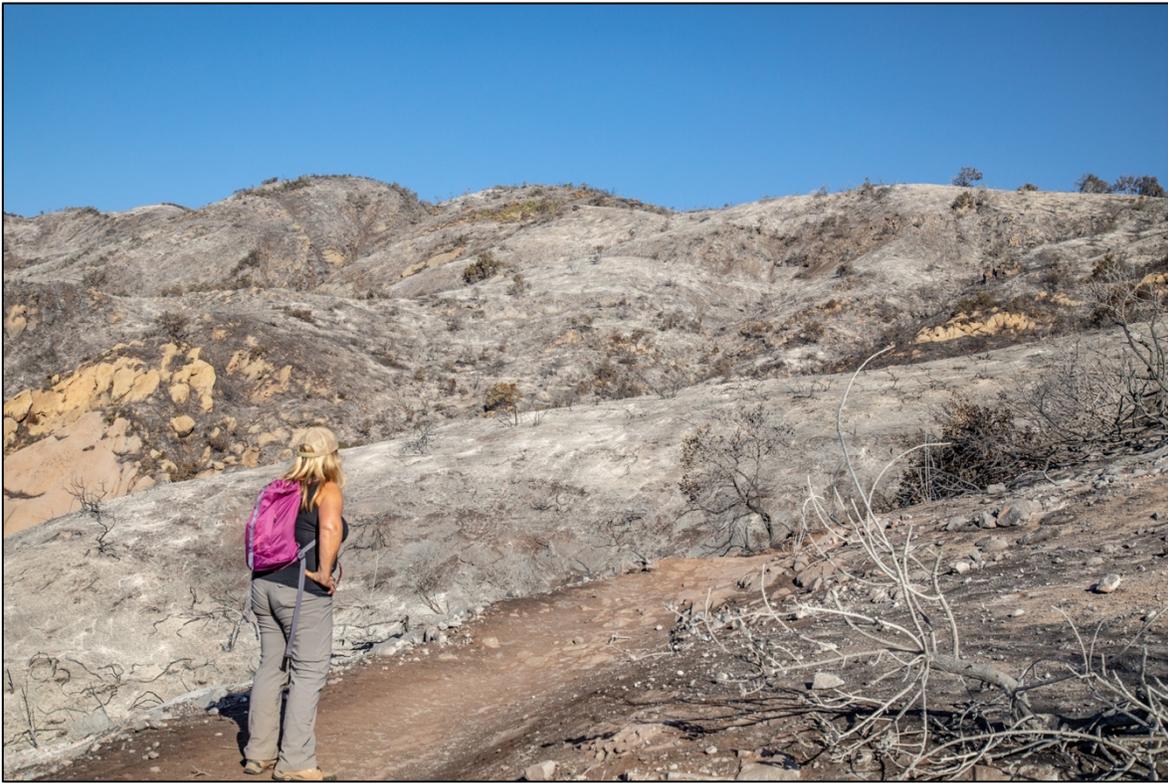
*Pict 4. Kim Fly surveys the damage to the Lower Franklin Trail a few days after the Thomas Fire passed over it. Almost all of the vegetation on the lower part of the trail was burned to mineral soil.*

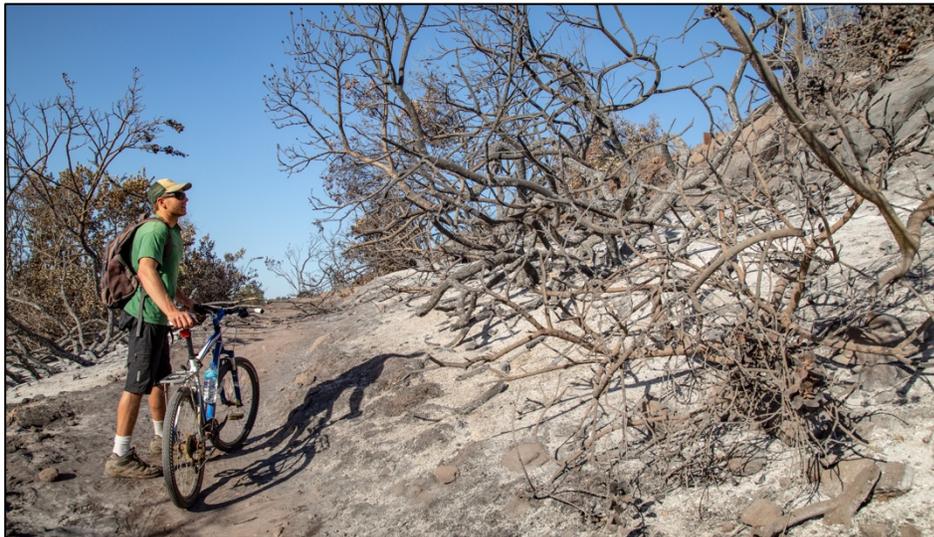
*Pict 6. Mountain biker at the beginning of the single track looking at the trail damage a few days after the Thomas Fire burned this part of the trail.*

*Because the lower trail was not damaged as significantly as the upper trail, the lower trail should be able to be restored for multiple use in early Winter 2019.*

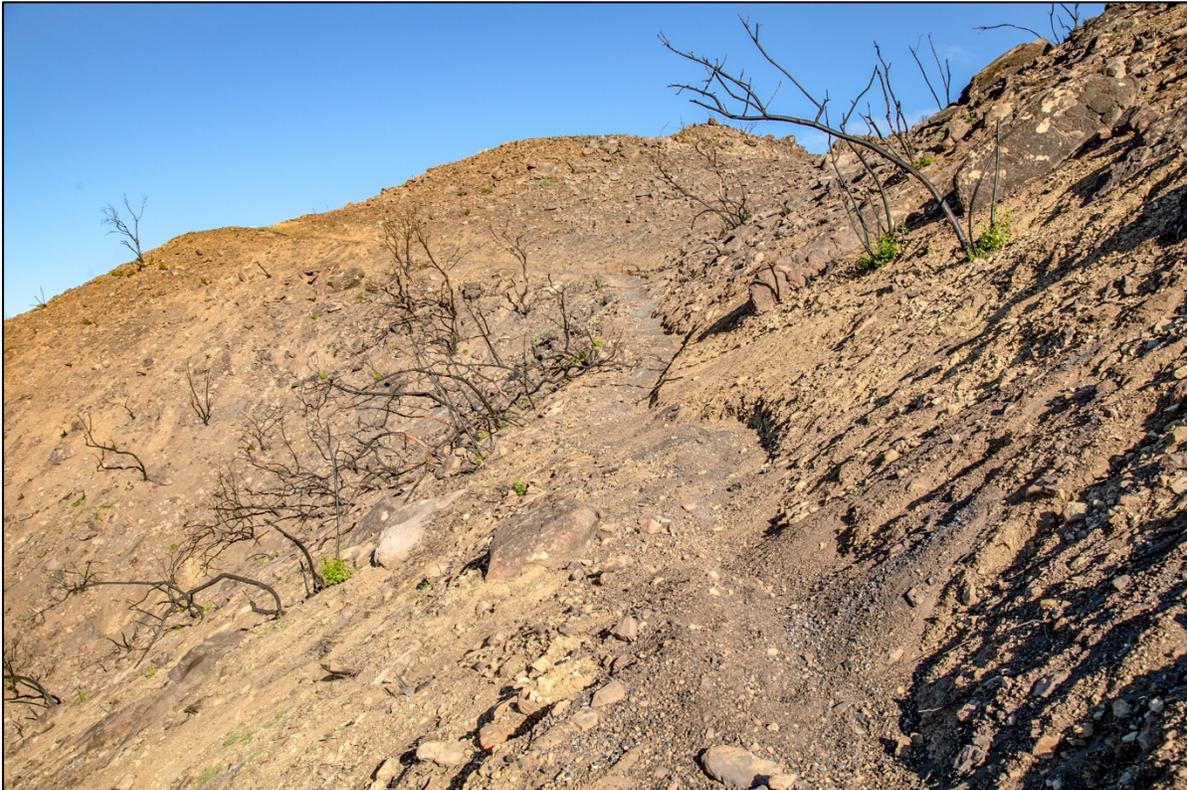
*Pict 7. A section of the upper trail on February 18, 2108, two months after the Thomas Fire burned this area. There are hundreds of cubic yards of slump material that will need to be removed. Here the trail is extremely steep (grade from 24-32%) and from several inches to a foot of the outside part of the trail has been washed away, with nothing to hold it in place.*

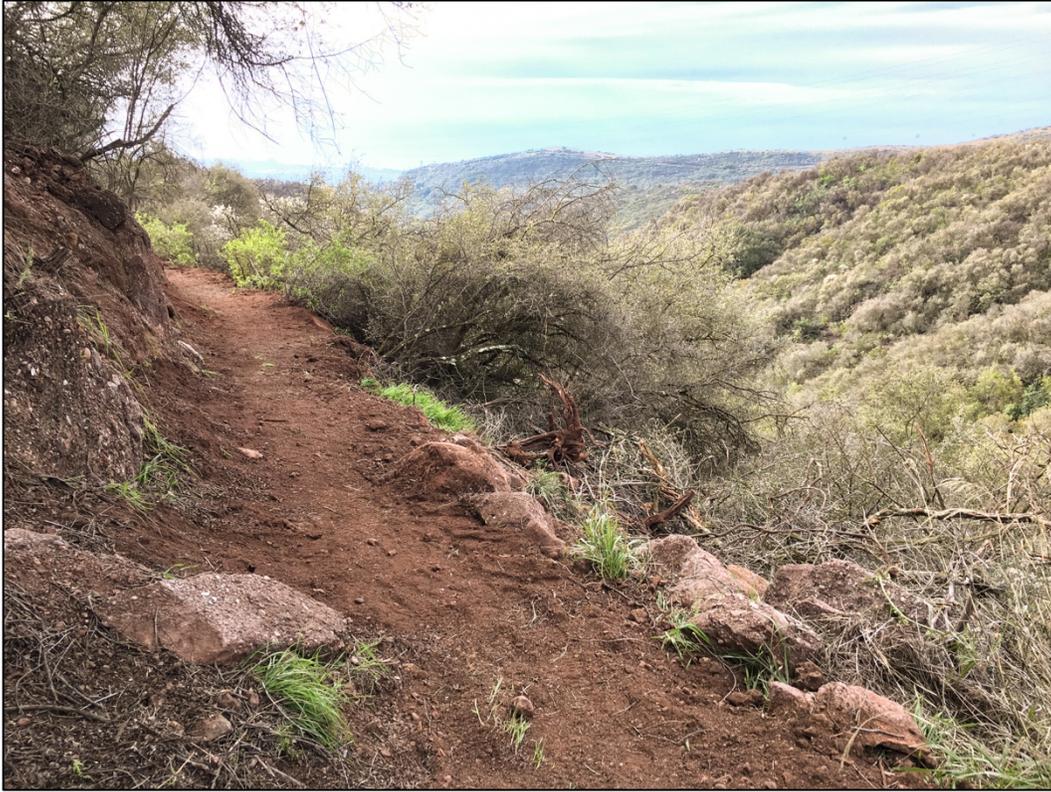
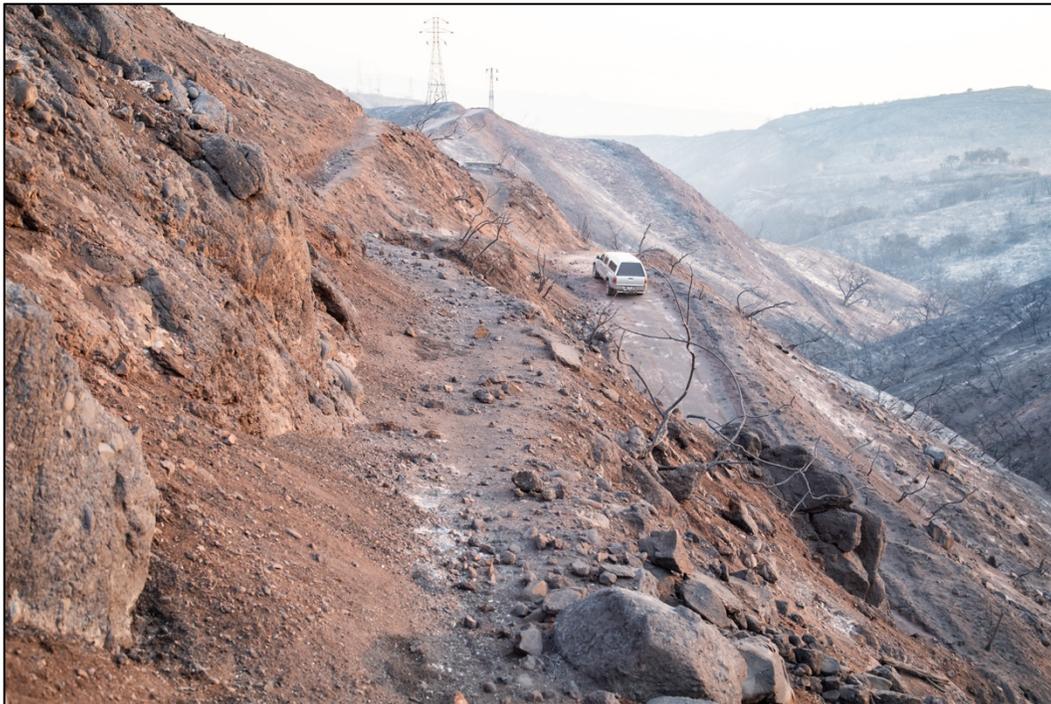
*Picts 9-10. Above, the completed restoration work in 2016 and below the same spot on Dec. 15, 2017, two days after the area burned. Much of the upper trail is in similar condition.*

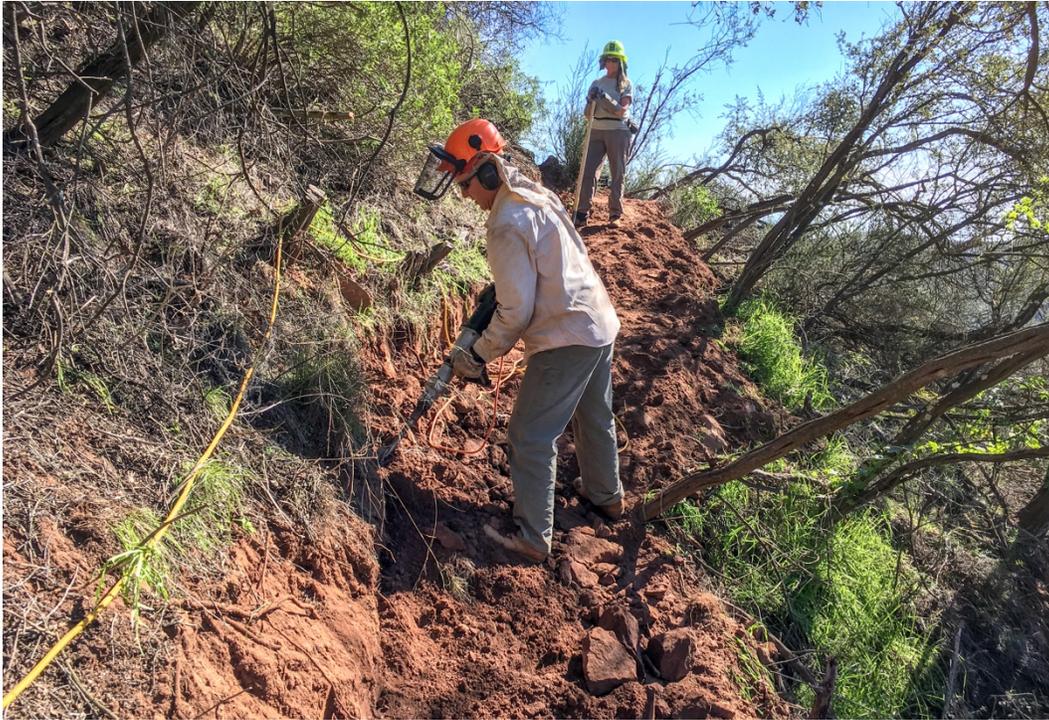
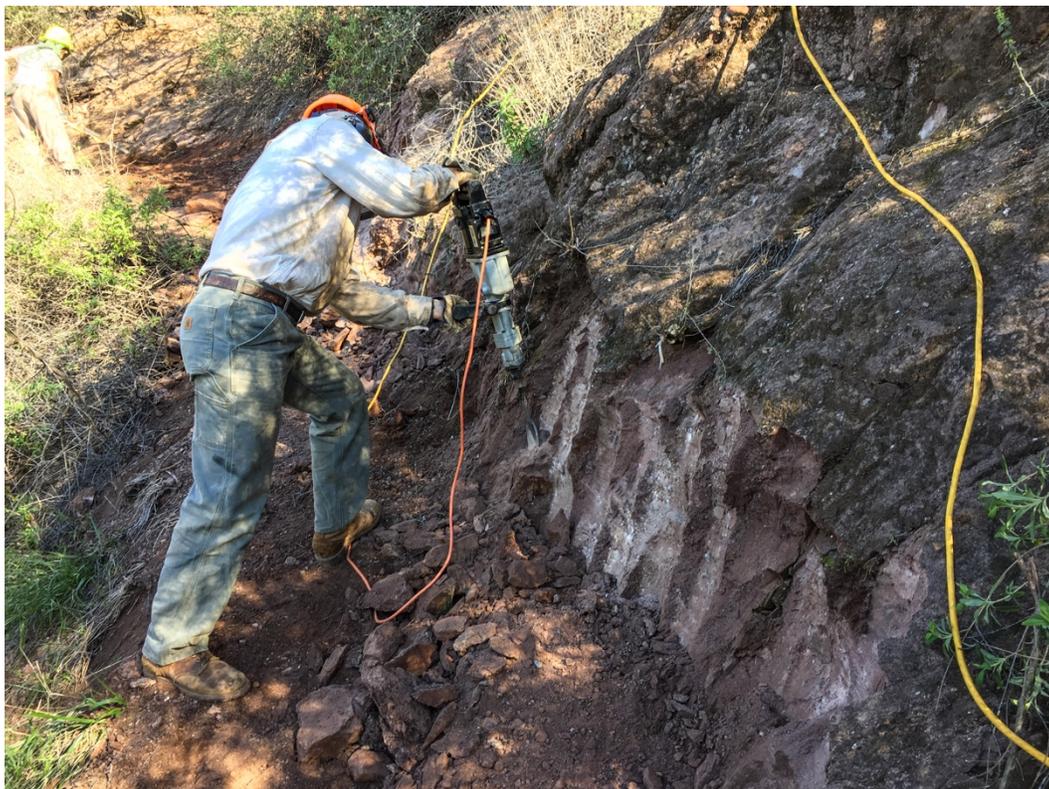
*Picts 11-12. Above original restoration work needed to widen the trail for multiuse. Below, widening the trail is much more difficult when rock is encountered. In many locations the trail edge has been lost and the tread is now very narrow. Armoring the trail edge to protect it will be critical as well as cutting into the hillside to add width.*

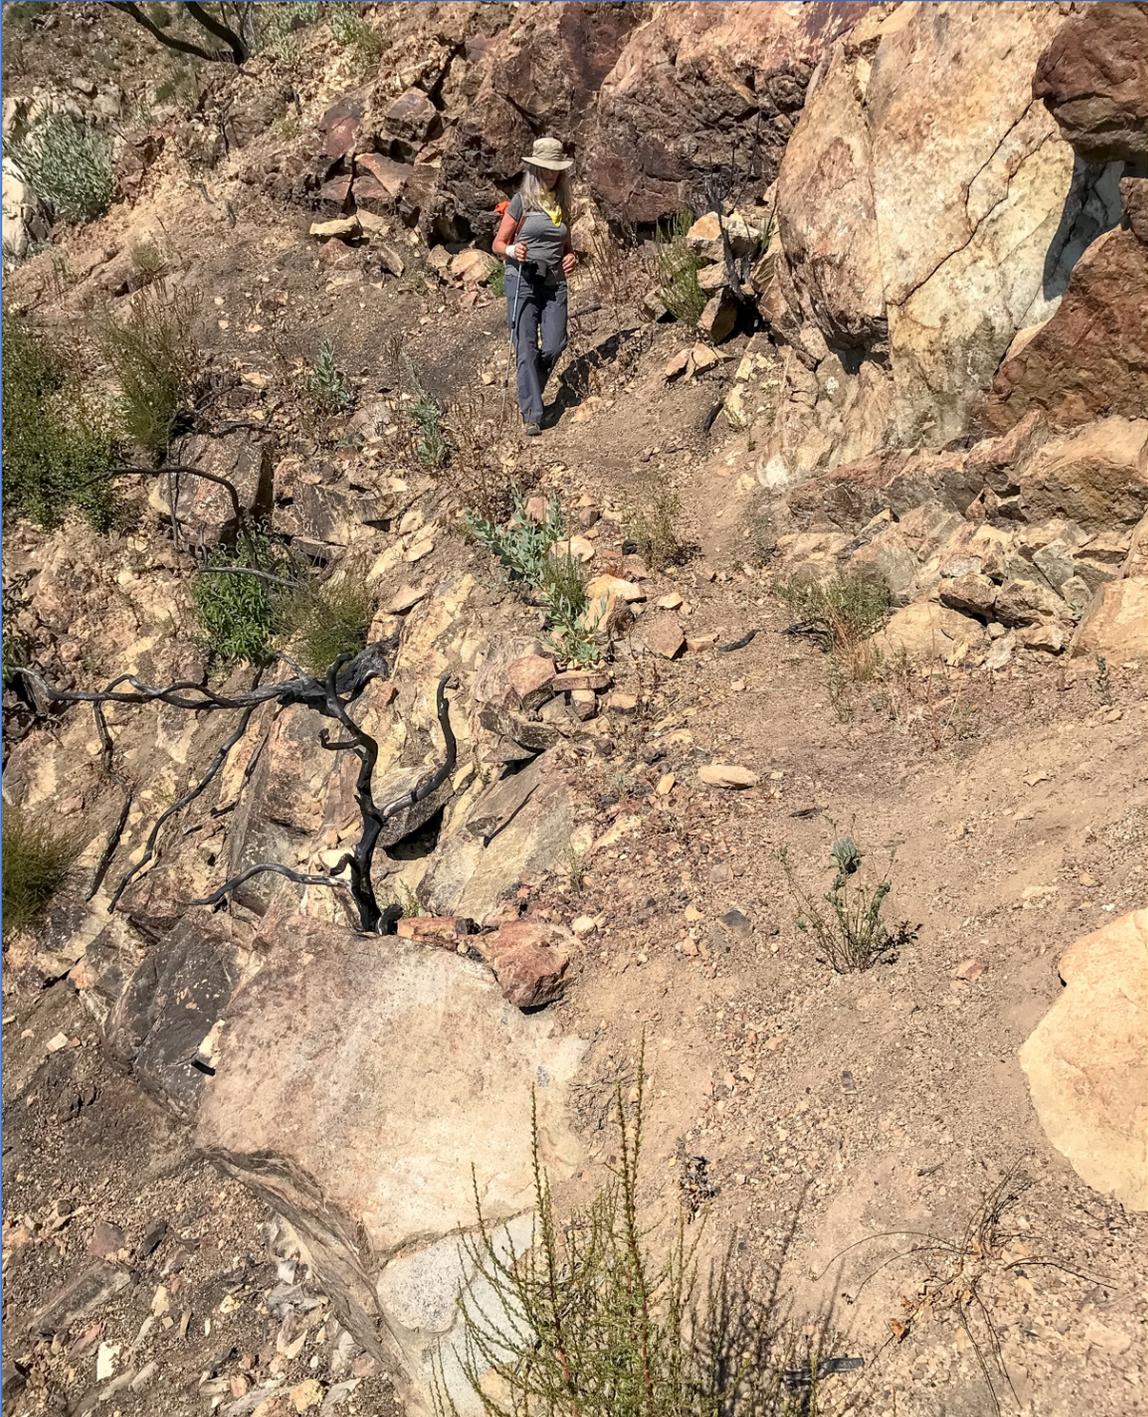
*Pict 21. Typical of the damage over much of the upper part of the Phase 3 trail.*

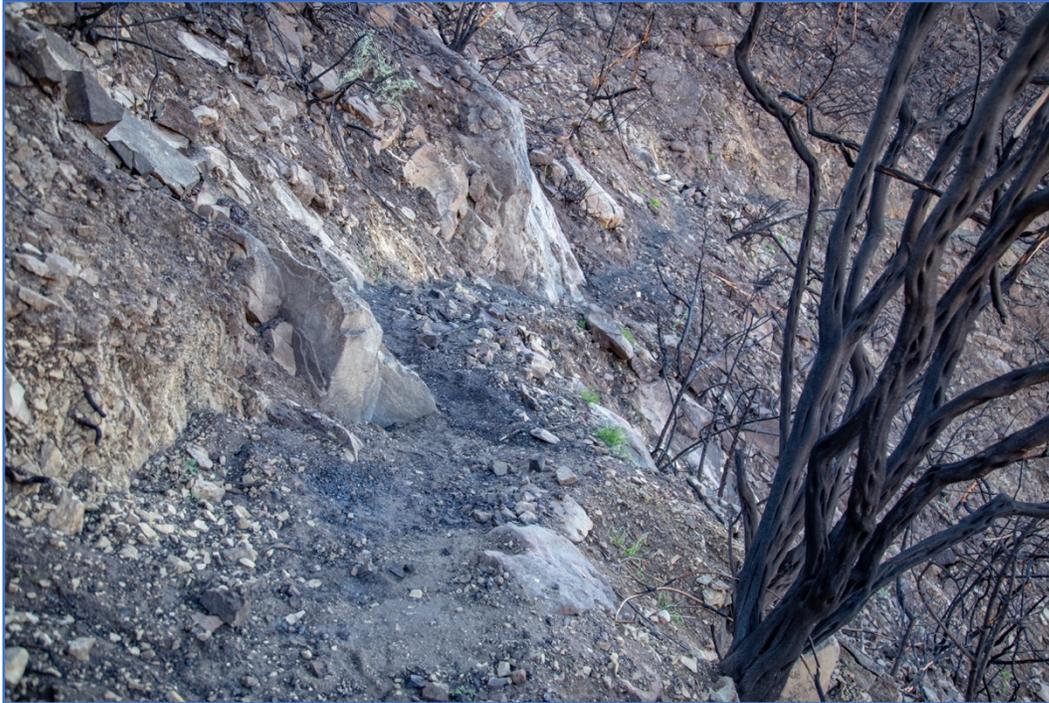
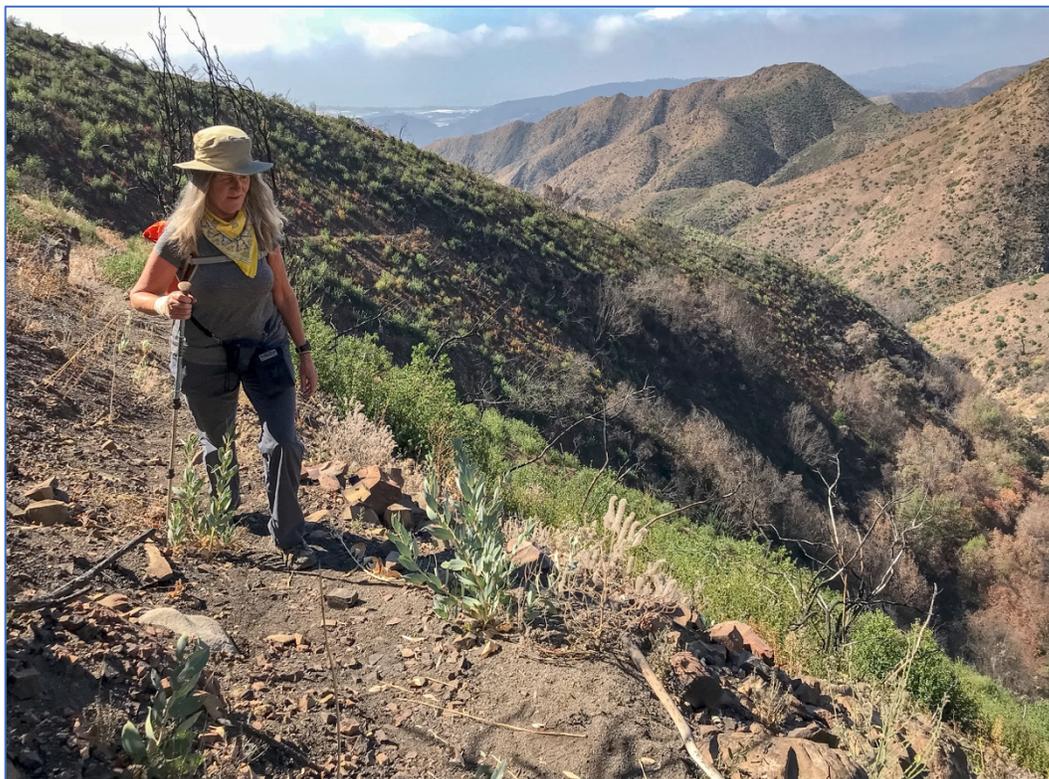
*Picts 22-23. This and the following images show the amount of damage caused by the Thomas Fire and subsequent debris flow in December 2017 and January 2018. Though the vegetation is returning, it may require several more years to stabilize the hillsides.*

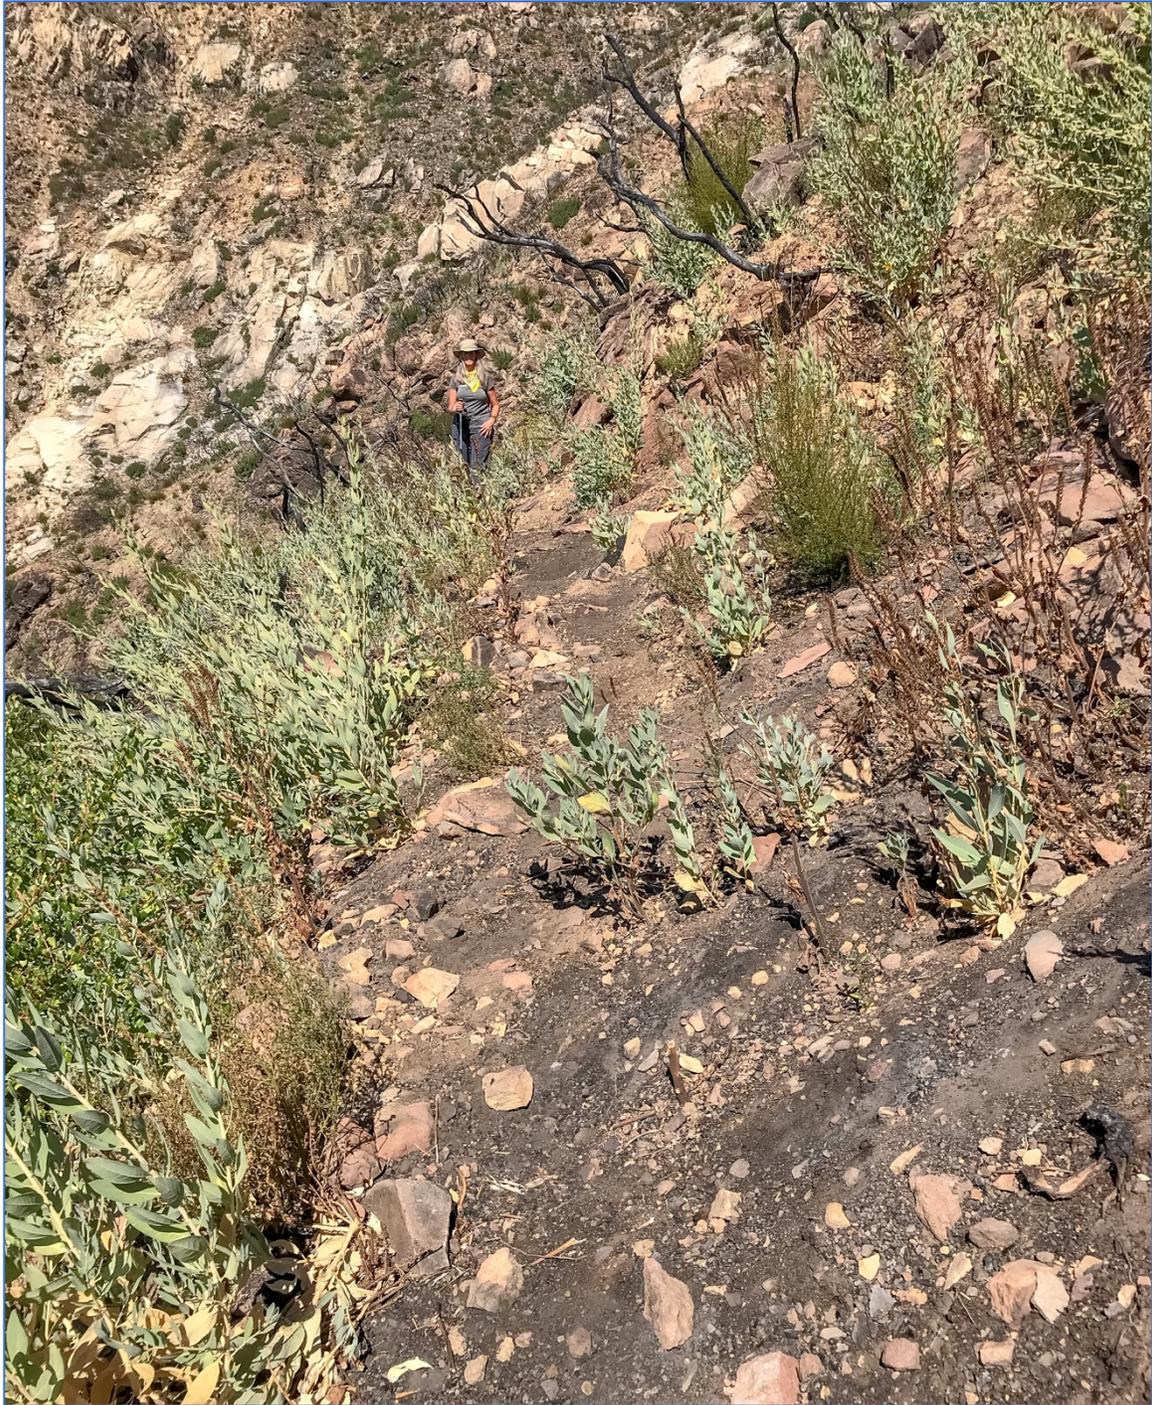
*Pict 24. While the majority of the trail averages 18" or less, much of it is actually much narrower and combined with slumping and rock litter, is on the verge of being completely erased. Plant growth this winter along with additional erosion will certainly make this section impassable in the next few months without extensive restoration efforts.*

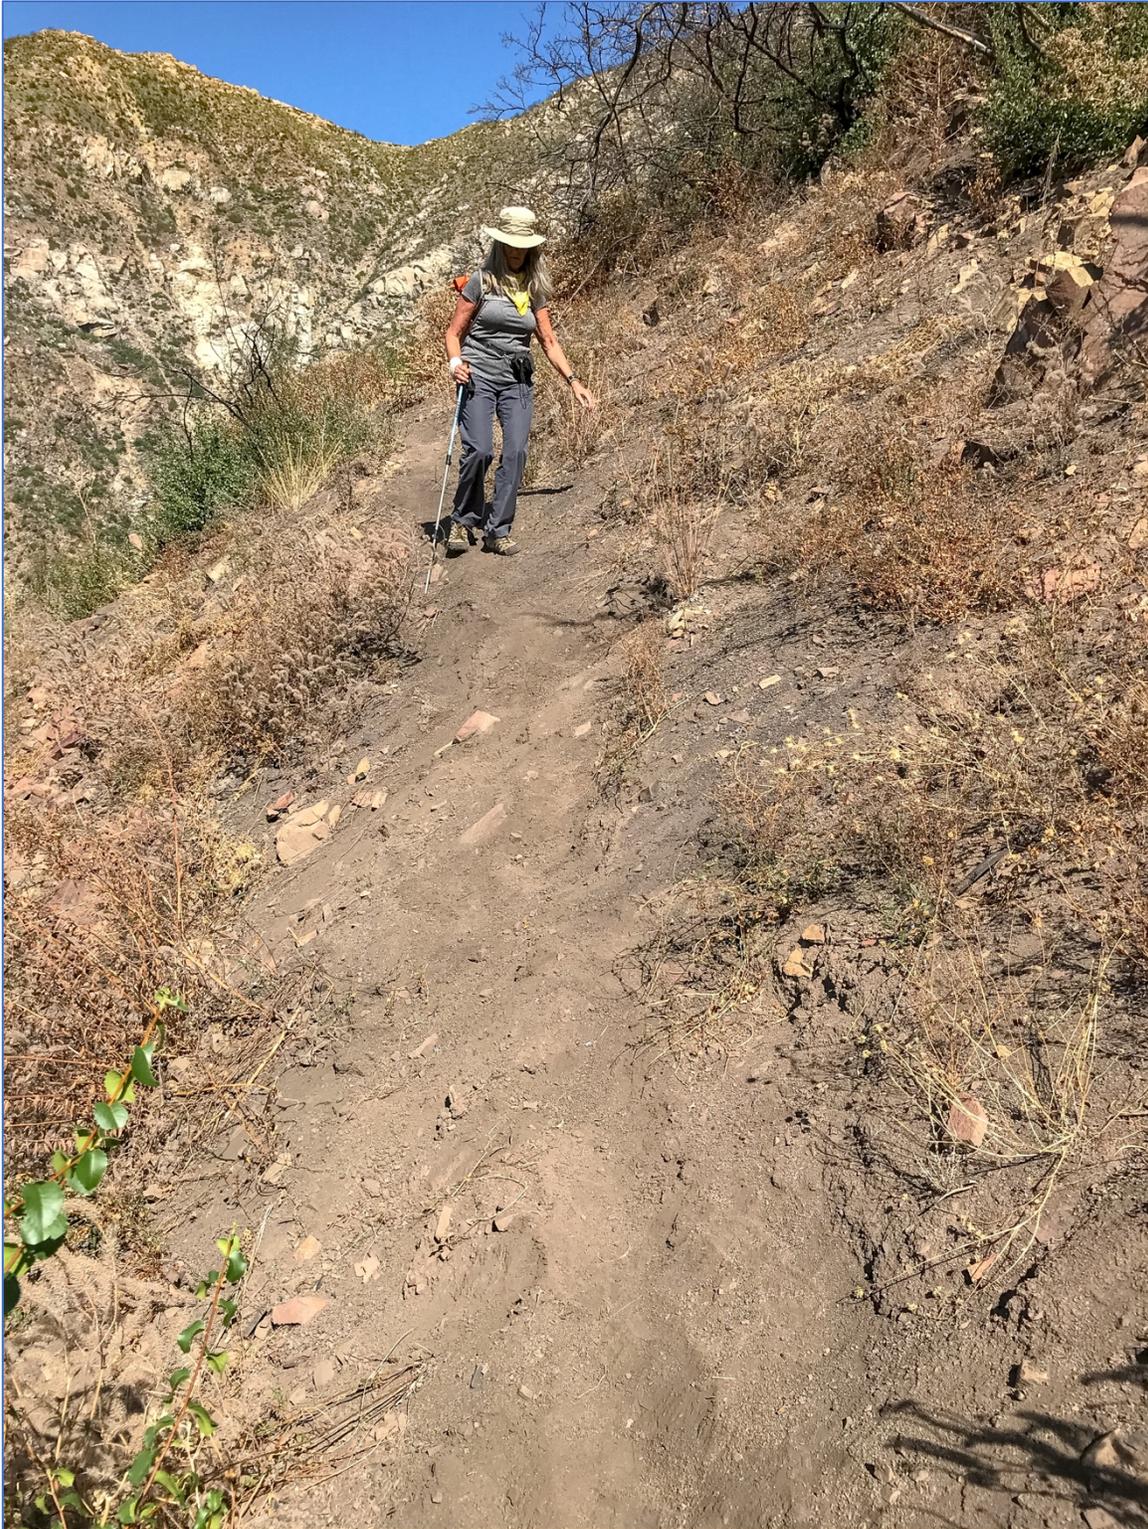
*Pict 25. Many sections of the trail have similar grades (approximately 20%) and widths. Note how difficult it is to navigate when almost no tread remains to walk on. This and the images above show why the trail currently is unsafe for equestrian or mountain bike use and dangerous for foot travel.*

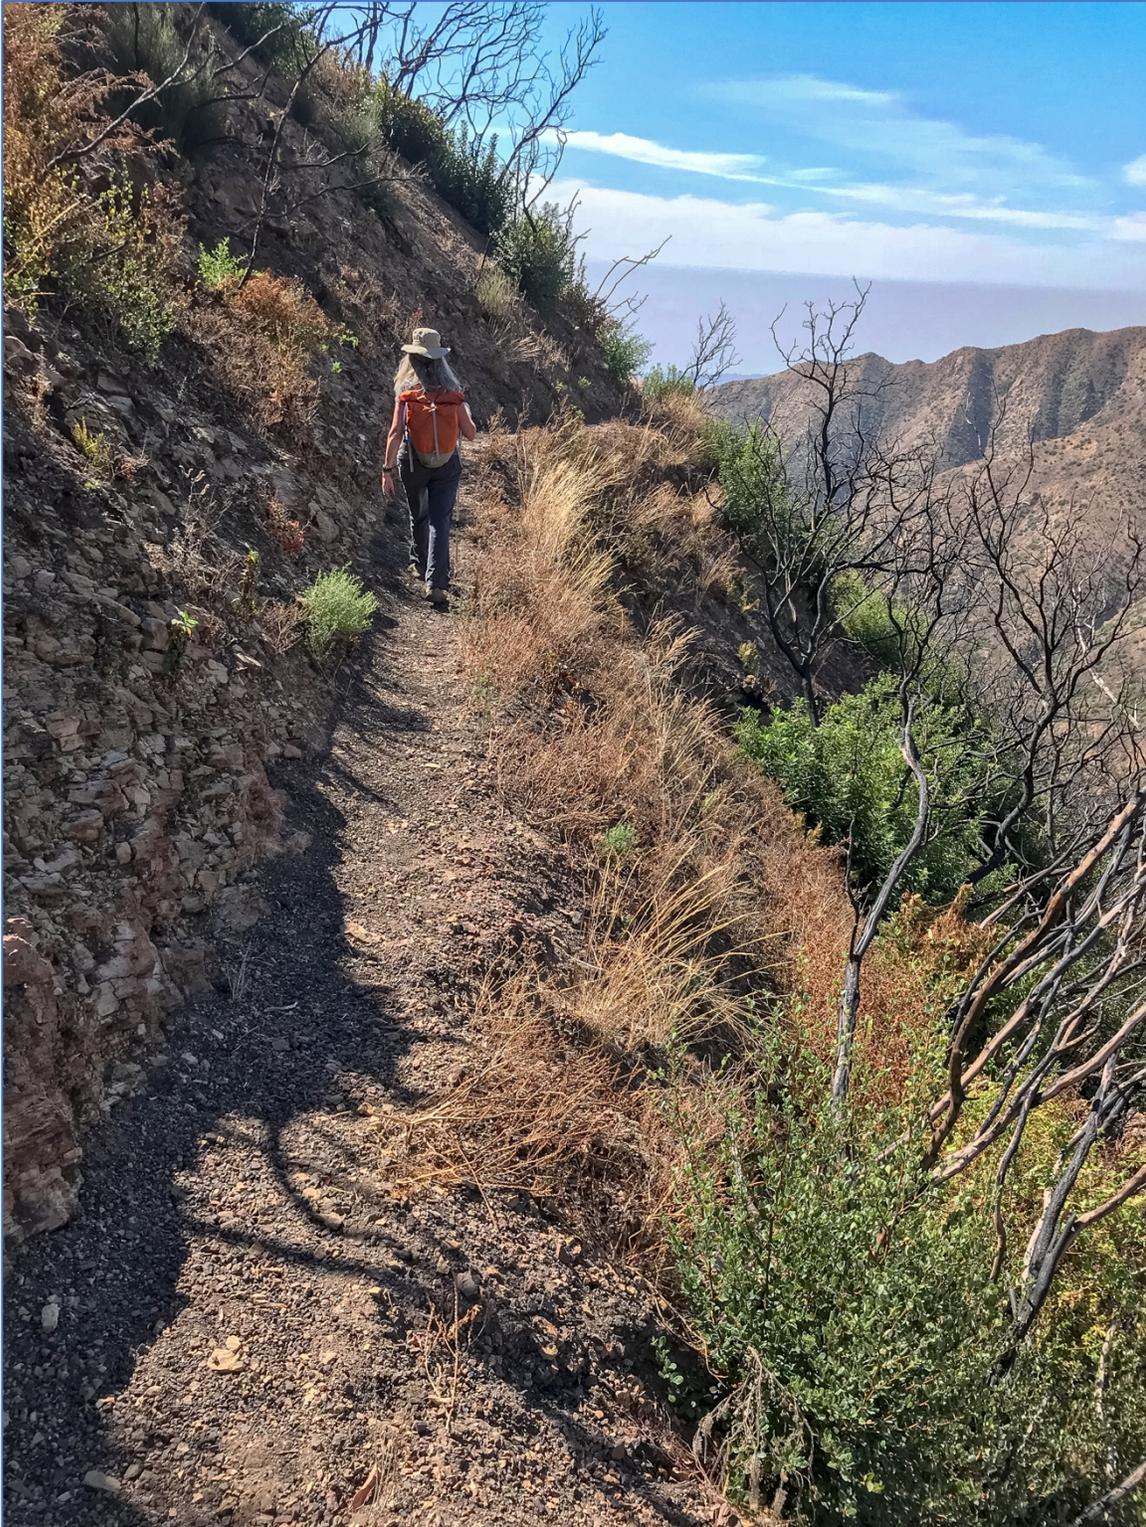
*Pict 26. This section of the trail follows a long traverse that is almost level but the hill slope is extremely steep. The trail here averages about 14" in width and the downslope is approximately 110% (slightly over a 45-degree angle). A fall off this part of the trail could result in a serious injury .*

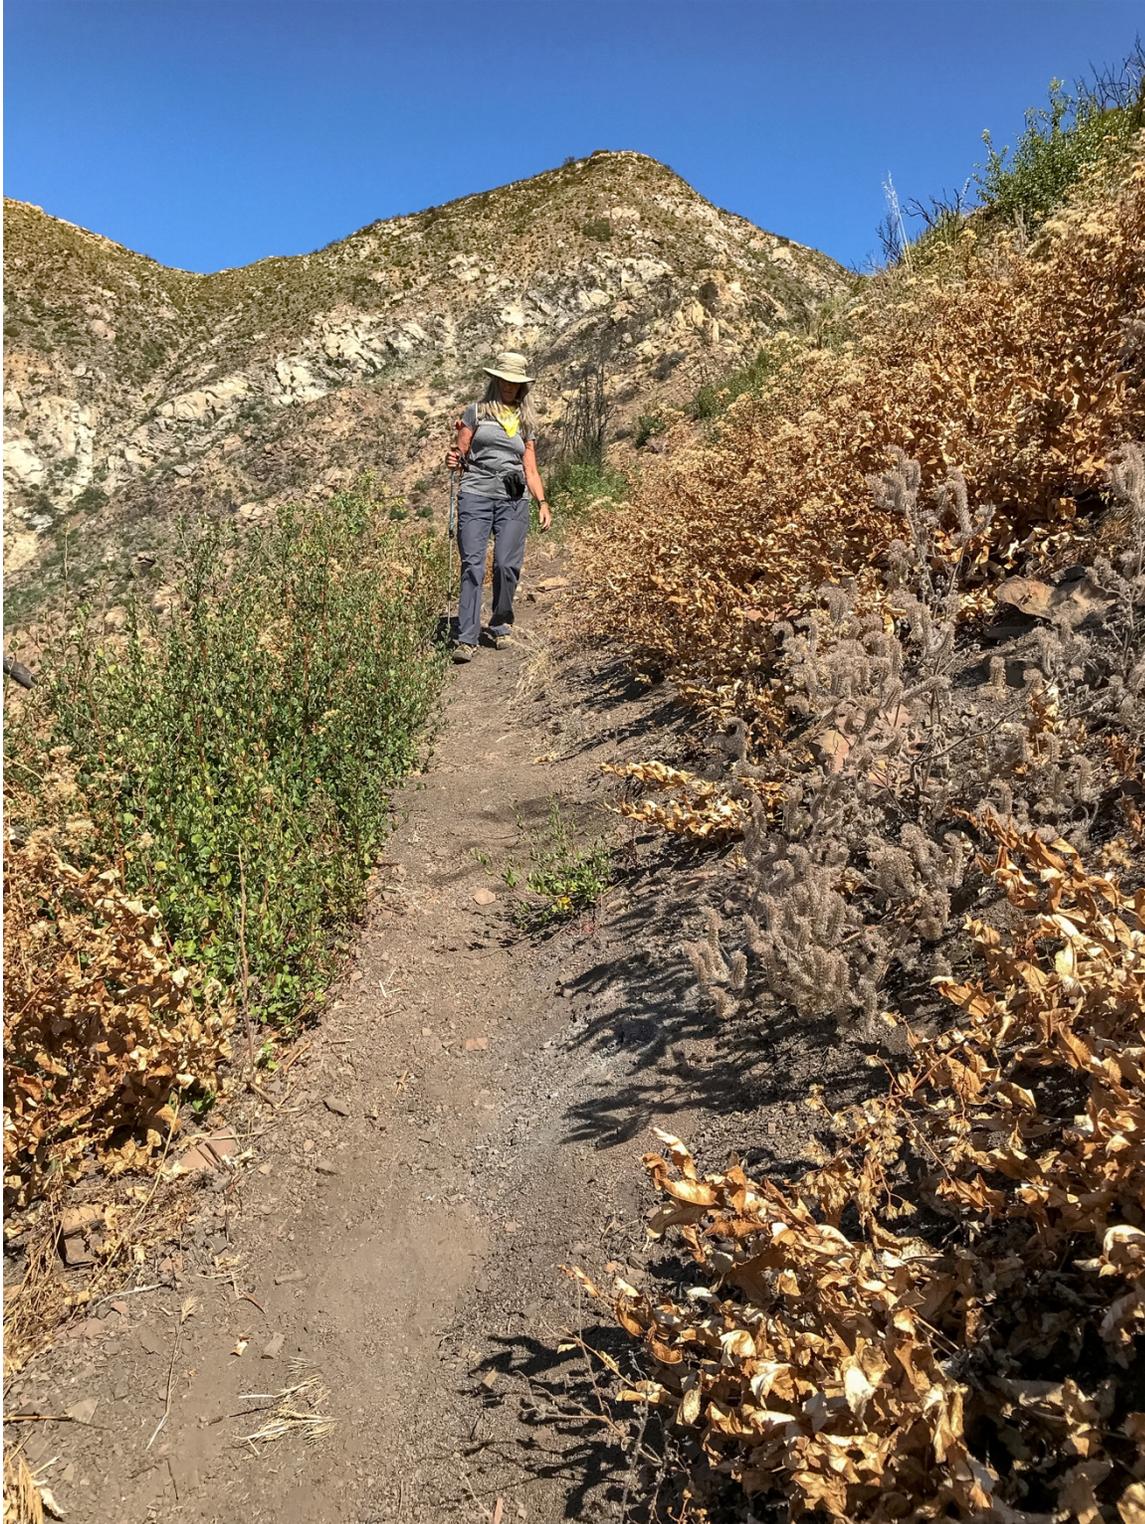
*Pict 27. Note the steepness of this part of the trail and its narrow width. Much of the upper mile of the trail is in similar condition to this and the images shown above. Tread work and addition of erosion control features are needed to keep this and other parts of the upper trail from disappearing.*
