TRAIL ASSESSMENT & ANALYSIS FOR PHASE III OF THE FRANKLIN TRAIL, SANTA BARBARA COUNTY, CALIFORNIA

Ray Ford, Project Manager
Santa Barbara County Trails Council

December 7, 2015

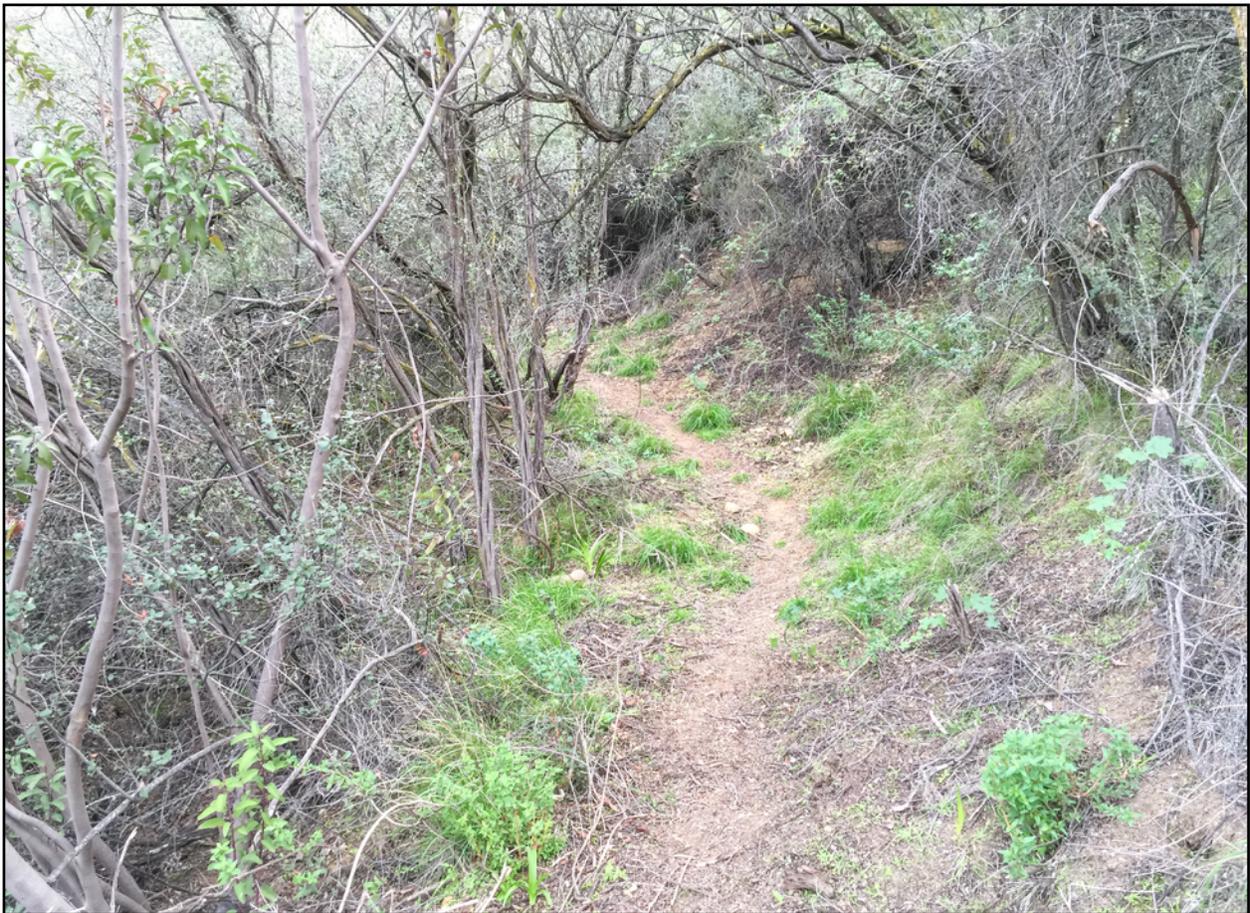
1. Almost 40% of the trail consists of firm tread that is a minimum of 4 feet wide or with minimal clearing of slump material along the inside part of the trail, would restore the trail to its original 4-foot width. It appears there has been little damage to the tread. Minimal work will be needed to improve these sections to Class 3 Pack and Saddle standards, including brushing, clearance of stubs and other obstructions, backsloping and the addition of erosion and sedimentation control features.

Figure 5. Tread typical along a majority of Phase III.

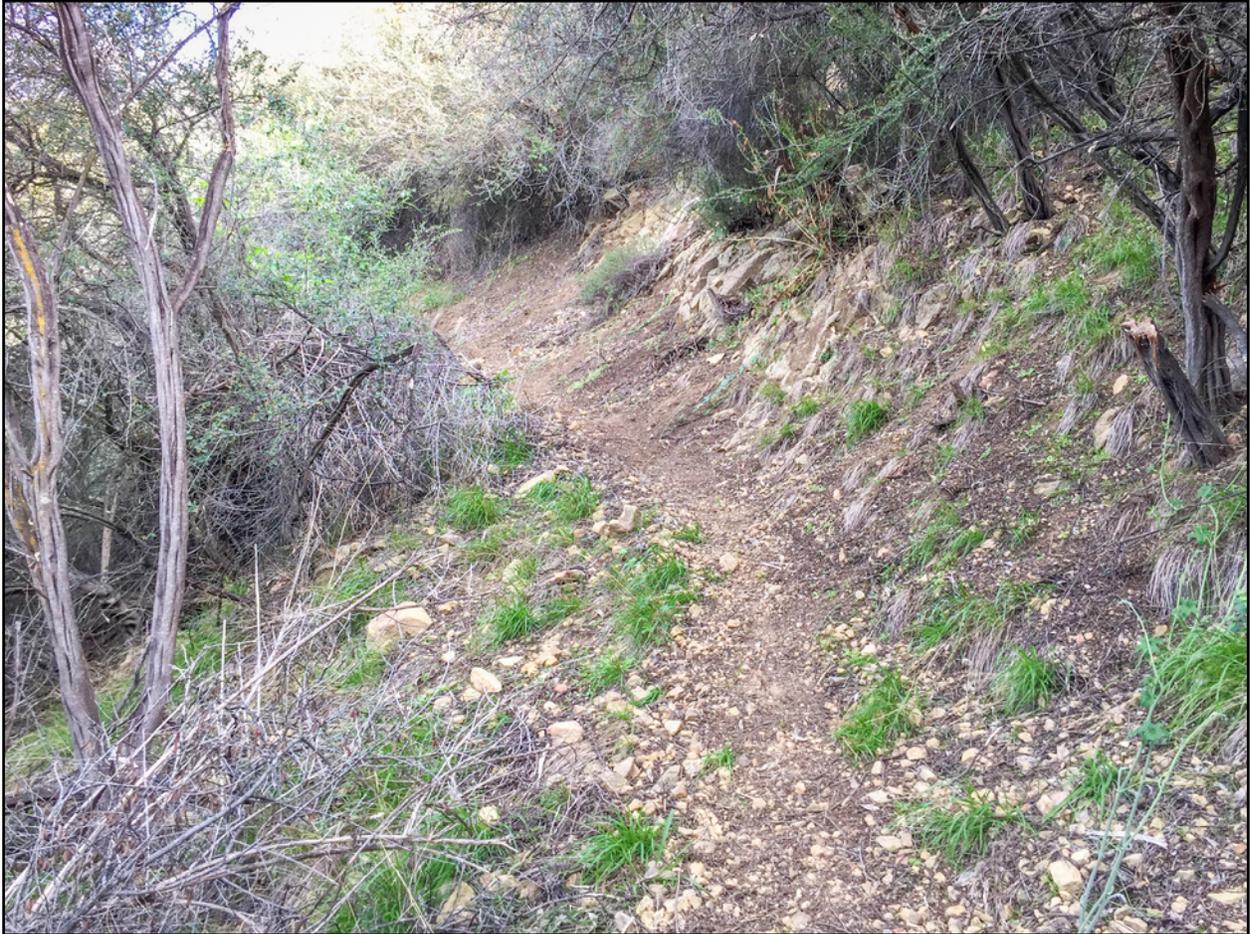
2. Along approximately 50% of the trail hillside slumping has narrowed the tread width to between 18-to-24 inches wide. In combination with the restoration described above, the slump material will have to be removed and additional backsloping done to widen the trail to a width of four feet. Additional features such as use of short sections of crib wall and armoring the outside edge of the trail may be needed to stabilize the tread and prevent erosion.

Figure 6. Narrow Tread Requires Widening

Other parts of the trail similar to the section above are narrower, either due to more extensive slumping. In areas like this removing more of the backslope material to widen the trail to a four-foot width will be required. Rock material from the backslope and finely cut dead brush can be used as armoring on the outside edge of the trail to minimize damage to the tread and reduce sedimentation.

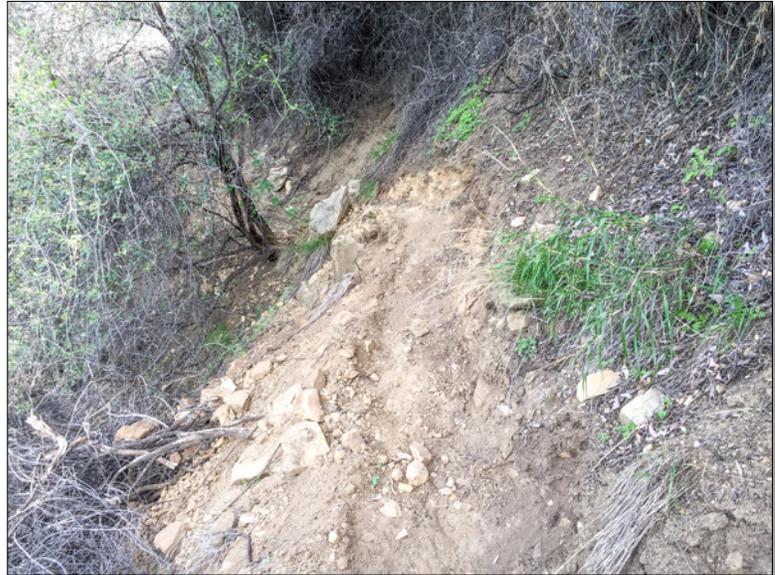
Upper right. A short 16' section of the tread has washed away. As a part of the p-line work to open the historic trail for environmental review, a narrow 10" wide tread was cut to allow safe passage. Areas like this are continual sources for erosion, unchecked sedimentation and eventually the creation of steep gullies. Use of nearby rock material is proposed for construction of crib walls to reinforce the outside edge of the trail and armor it against future damage.

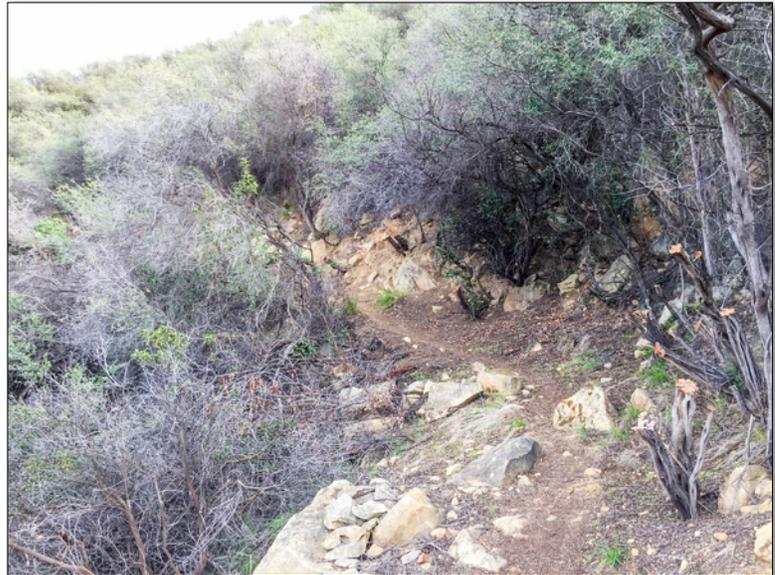
Figure 8. Narrow Rocky Section

Middle Right. The trail passes through a rocky section. More extensive work to remove some of the rock will be required to widen the trail but areas like this are also excellent sources of rock for crib wall construction, step overs and trail armoring.

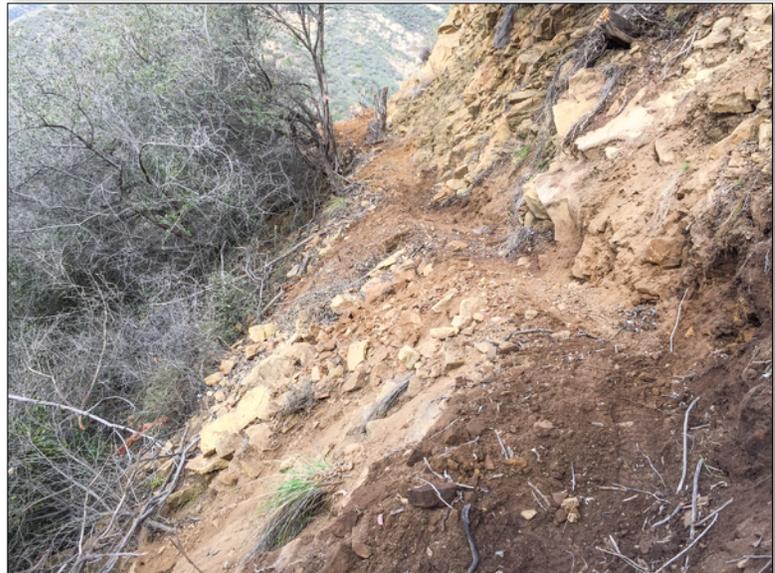
Figure 9. Major Restoration

Lower Right. This image shows one of two spots along the Phase III sections of the Franklin Trail that will require more extensive restoration. The other is around the corner and out of sight. Slumping of the extremely steep backslope has washed out this 80-foot section of trail and made it very dangerous for all trail users. These parts of the trail are the two main spots where more extensive Level 3 restoration will be required to make them safe for shared use.

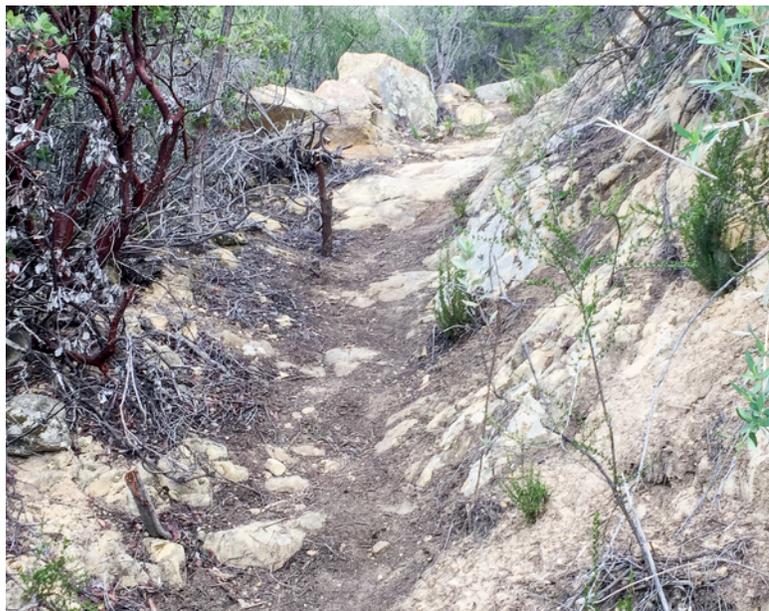
Figure 27. Exposed Bedrock Along Segment 3 Trail

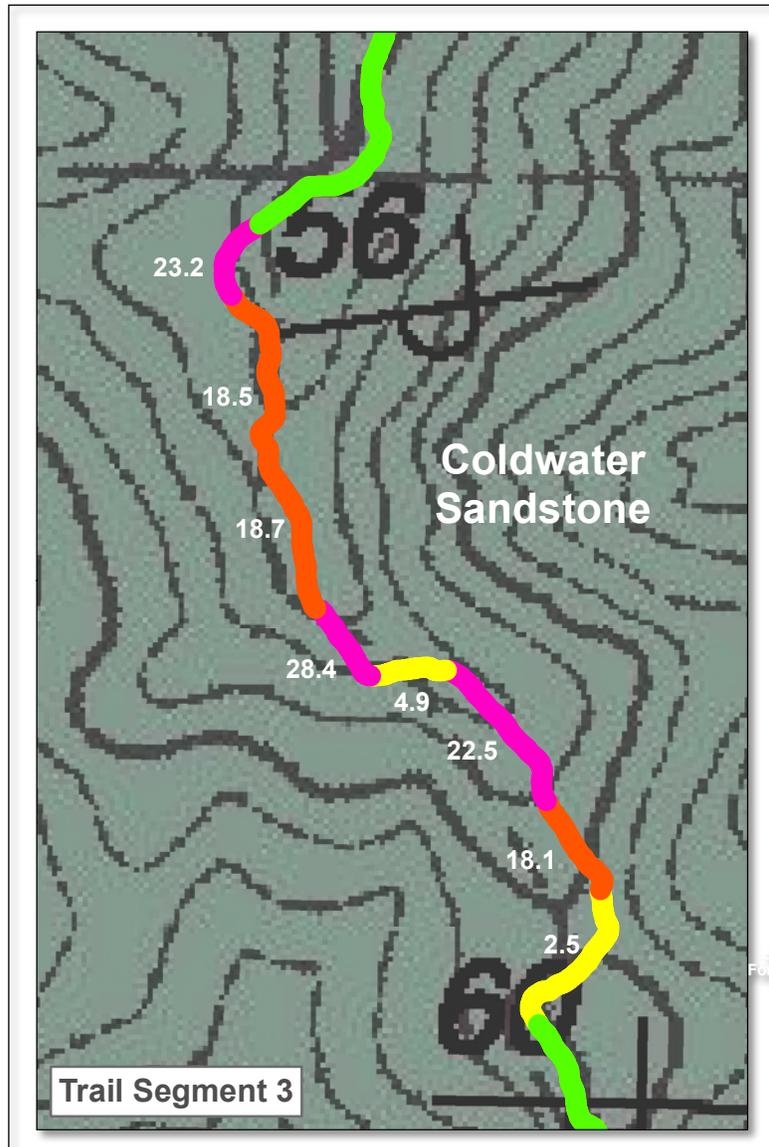
Image on the right shows how steep the grade is along this segment. Use of out-sloping, edge armoring and knicks will be used to mitigate the grade.

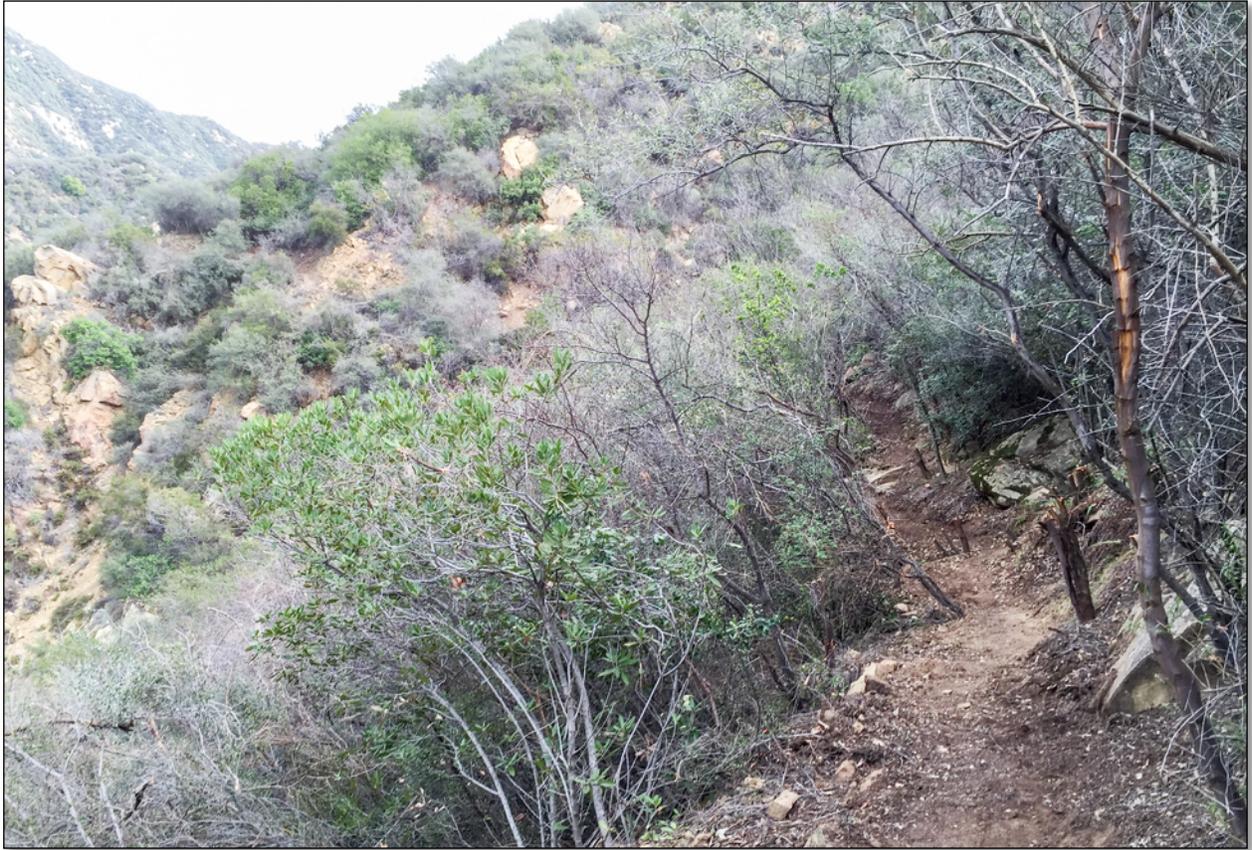
Figure 31. Segment 4 Trail Section Leading To Washout

- Cutting into the hillside to widen the tread to five feet so there is ample room for users to pass.
- Use of rock collected from widening the trail to construct the crib wall.
- Crib wall construction based on illustration shown on right with crib wall angled into the hillside at a 20-30% angle.⁷

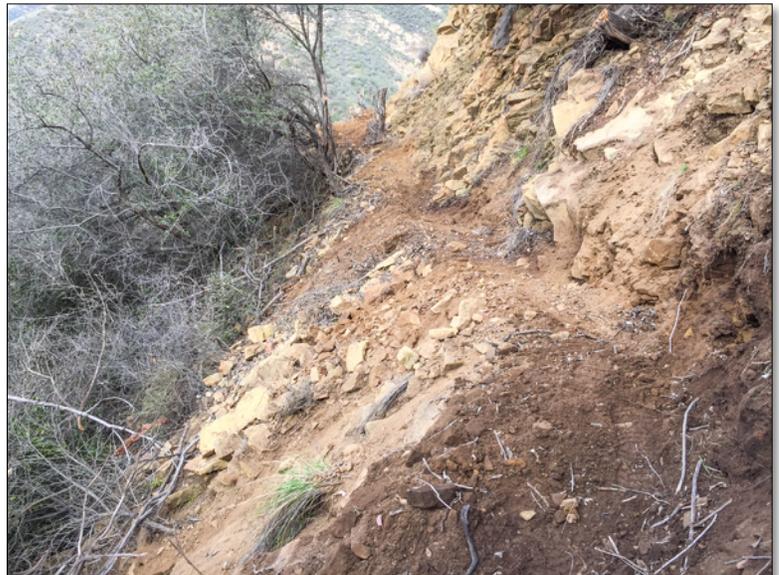
Photo to the right shows how unstable this section of trail is. Note the fractured rock in the hillside above the trail that could be used to armor the slopes below and in construction of the crib wall. The project proposes to widen this section to five feet and add crib wall using approved USFS standards for their construction.

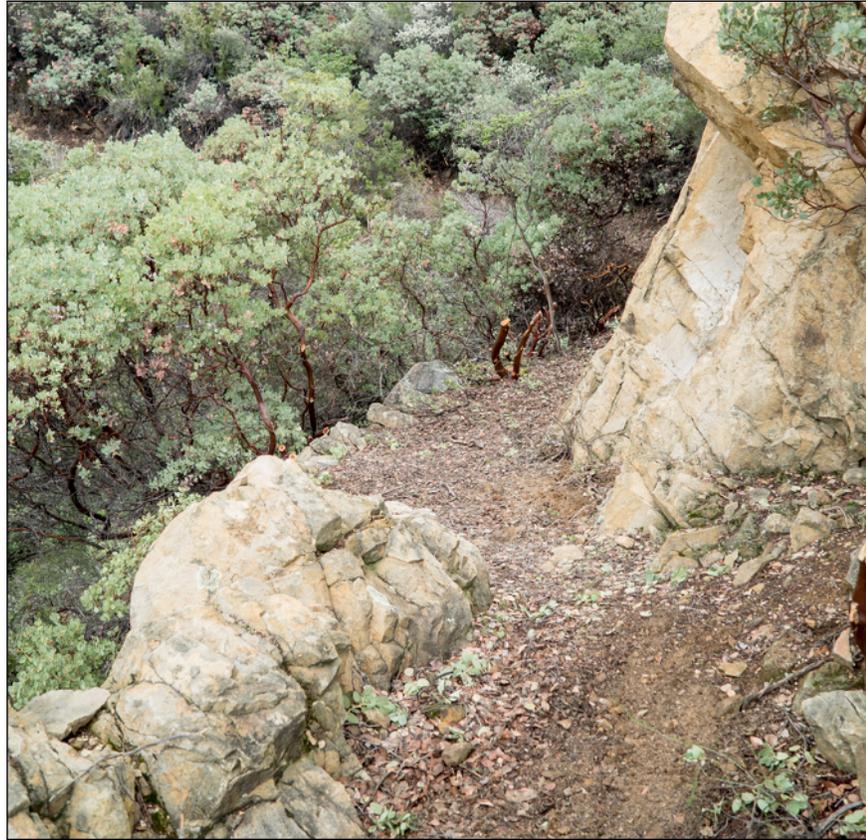
Summary. Cutting the trail through the Matilija Sandstone as it contoured through it must have been an interesting proposition. This is the only section where it appears that dynamite was required to blast out a route and must have taken quite a bit of time. While difficult for these early pioneers, once cut through, most of this section rests on exposed bedrock and has changed little over the past century. Minimal work —mainly additional brushing and chipping out the sandstone in places to increase the width for shared multi-use — will be needed to restore the trail. Use of rolling drain dips and armoring will mitigate for grade and prevent sedimentation.

Figure 40. Segment 7 Route Through Bedrock
