# Parma Park Sustainable Trail System Plan, Phase I

## TRAIL EVALUATION, ASSESSMENT AND DESIGN REPORT

Prepared by Ray Ford

Santa Barbara County Trails Council

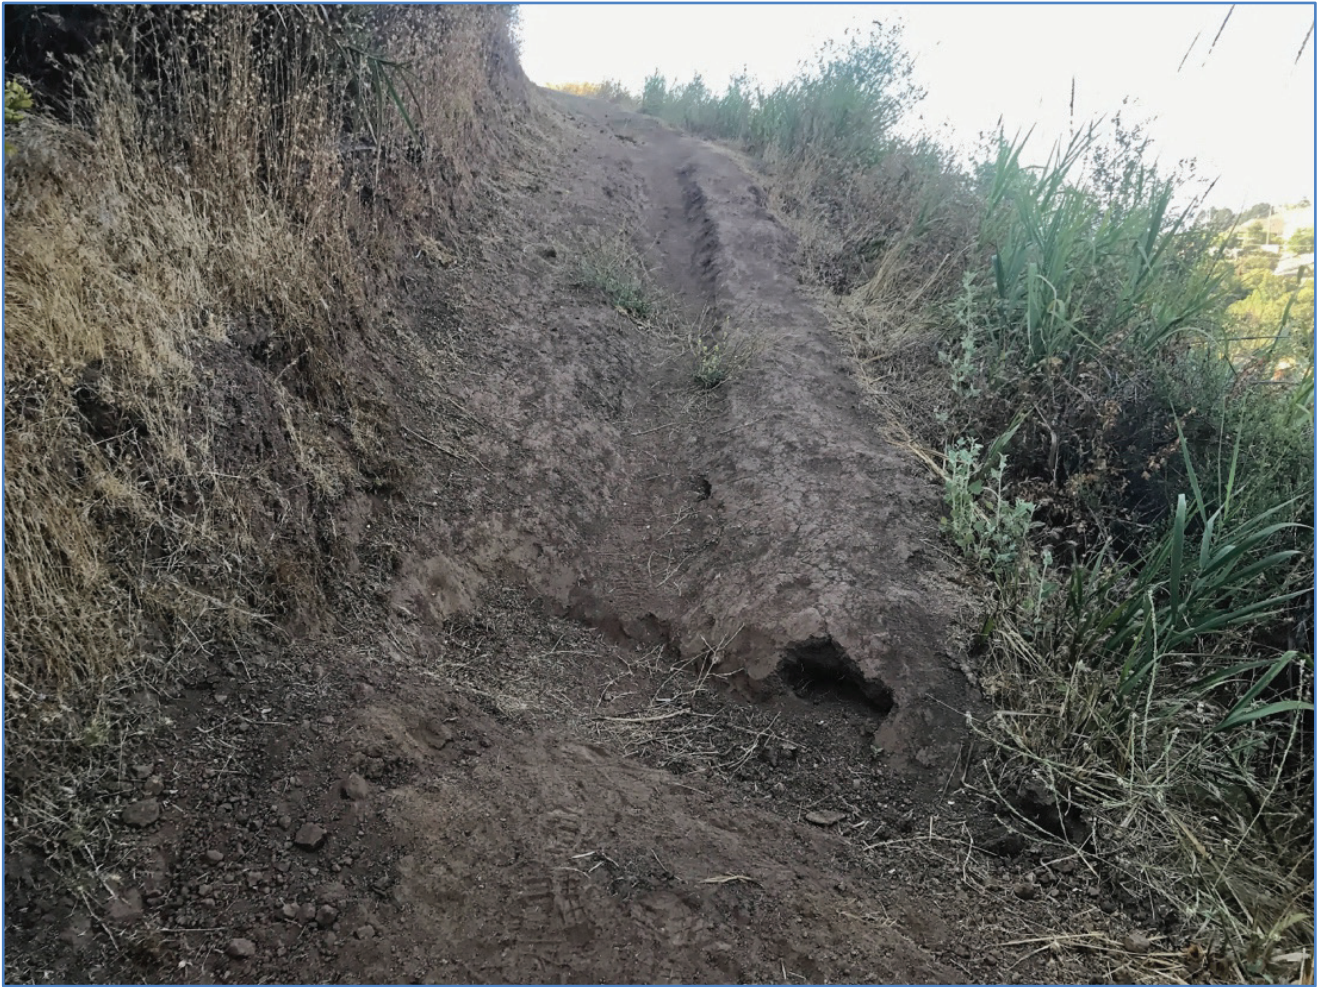
**Figure 1. Impacts of steep trail grade.**

*Top. A short steep section along Stanwood Trail Segment C4. With frequent equestrian use the excessive grade has caused the trail to become entrenched, causing tread damage and making it difficult for the waterbar near the bottom of the grade to function.*

*There are a number of issues shown in this photograph. The slope above the tread is extremely steep and needs to be cut back to create a wider corridor and keep vegetation above the trail from hanging over it. The waterbar at the bottom is poorly constructed and is at the bottom of a steep grade, making it almost impossible for the water to flow off the trail.*

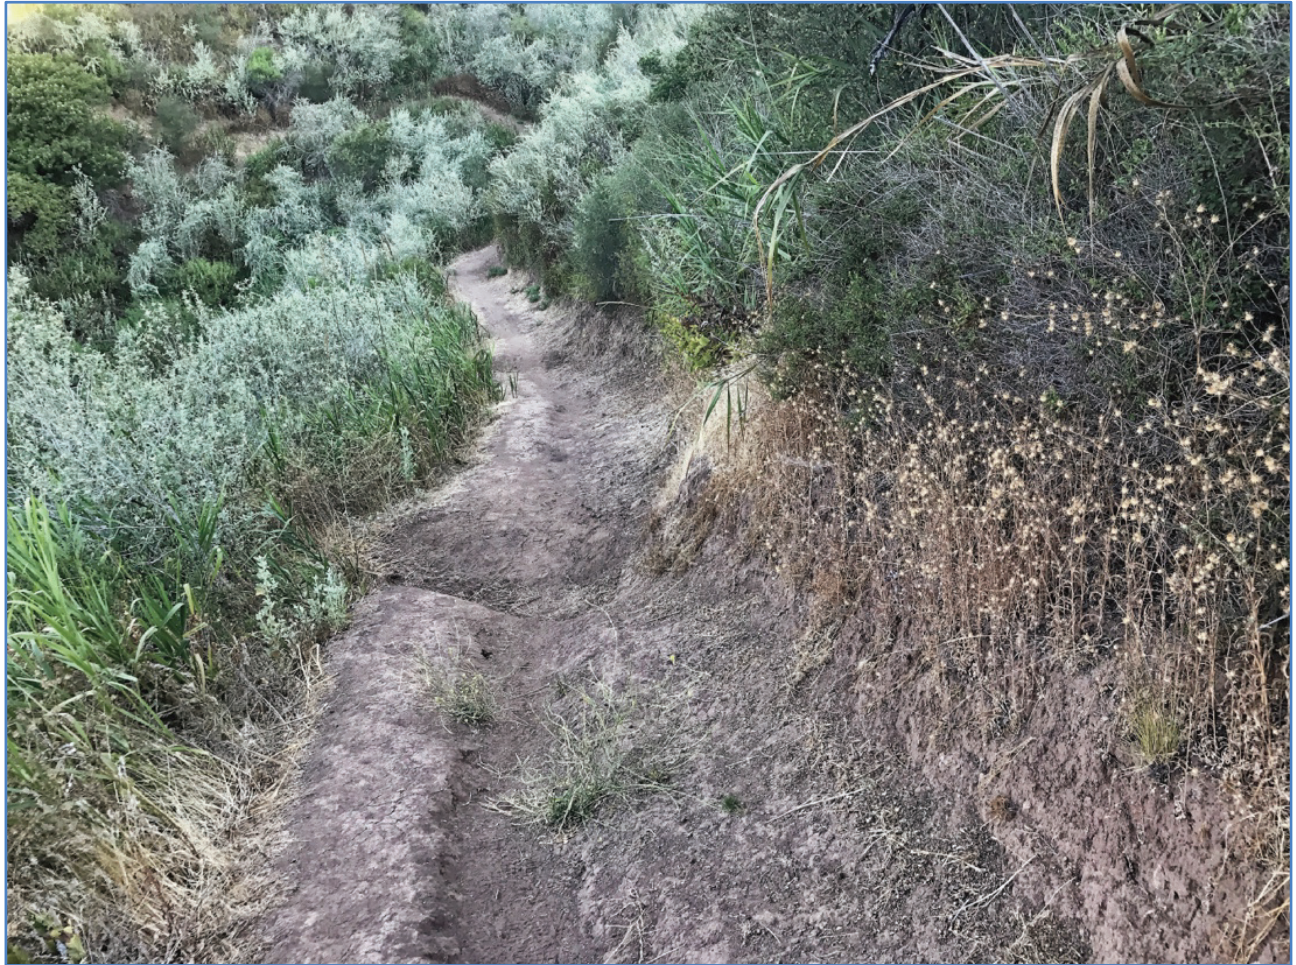
**Figure 2. Combination of steep trail grade and entrenchment**

*Looking down the same trail shown on the previous page shows the impact of grade, entrenchment and poor use of erosion control features such as the waterbar pictured here. The trail grade is 22%. Though the outsloping is adequate the entrenchment (10" wide and 2-3" deep) prevents water from sheeting off the trail.*

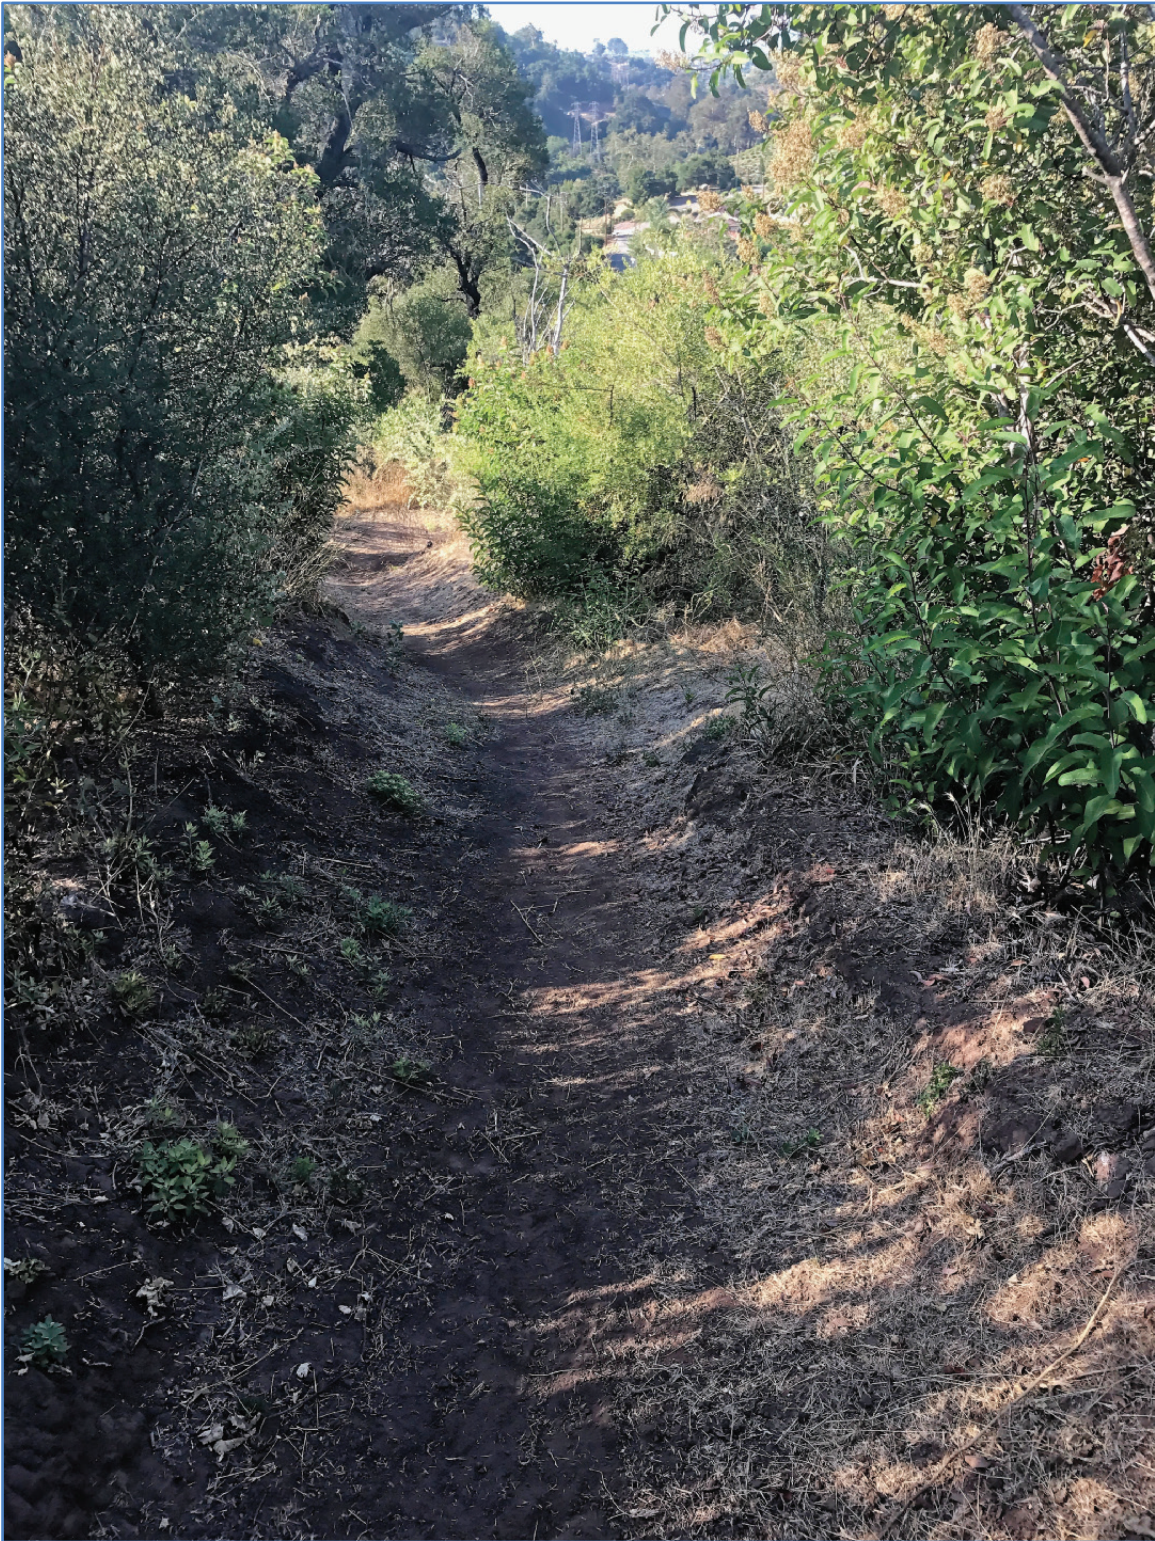
**Figure 3. Entrenched section of Stanwood Trail System**

*Section along Stanwood S5 heads straight downhill (along the fall line) at a grade in excess of 20%. Trail is deeply entrenched, further channeling water straight down it. Berms on both sides make it difficult to realign the trail.*

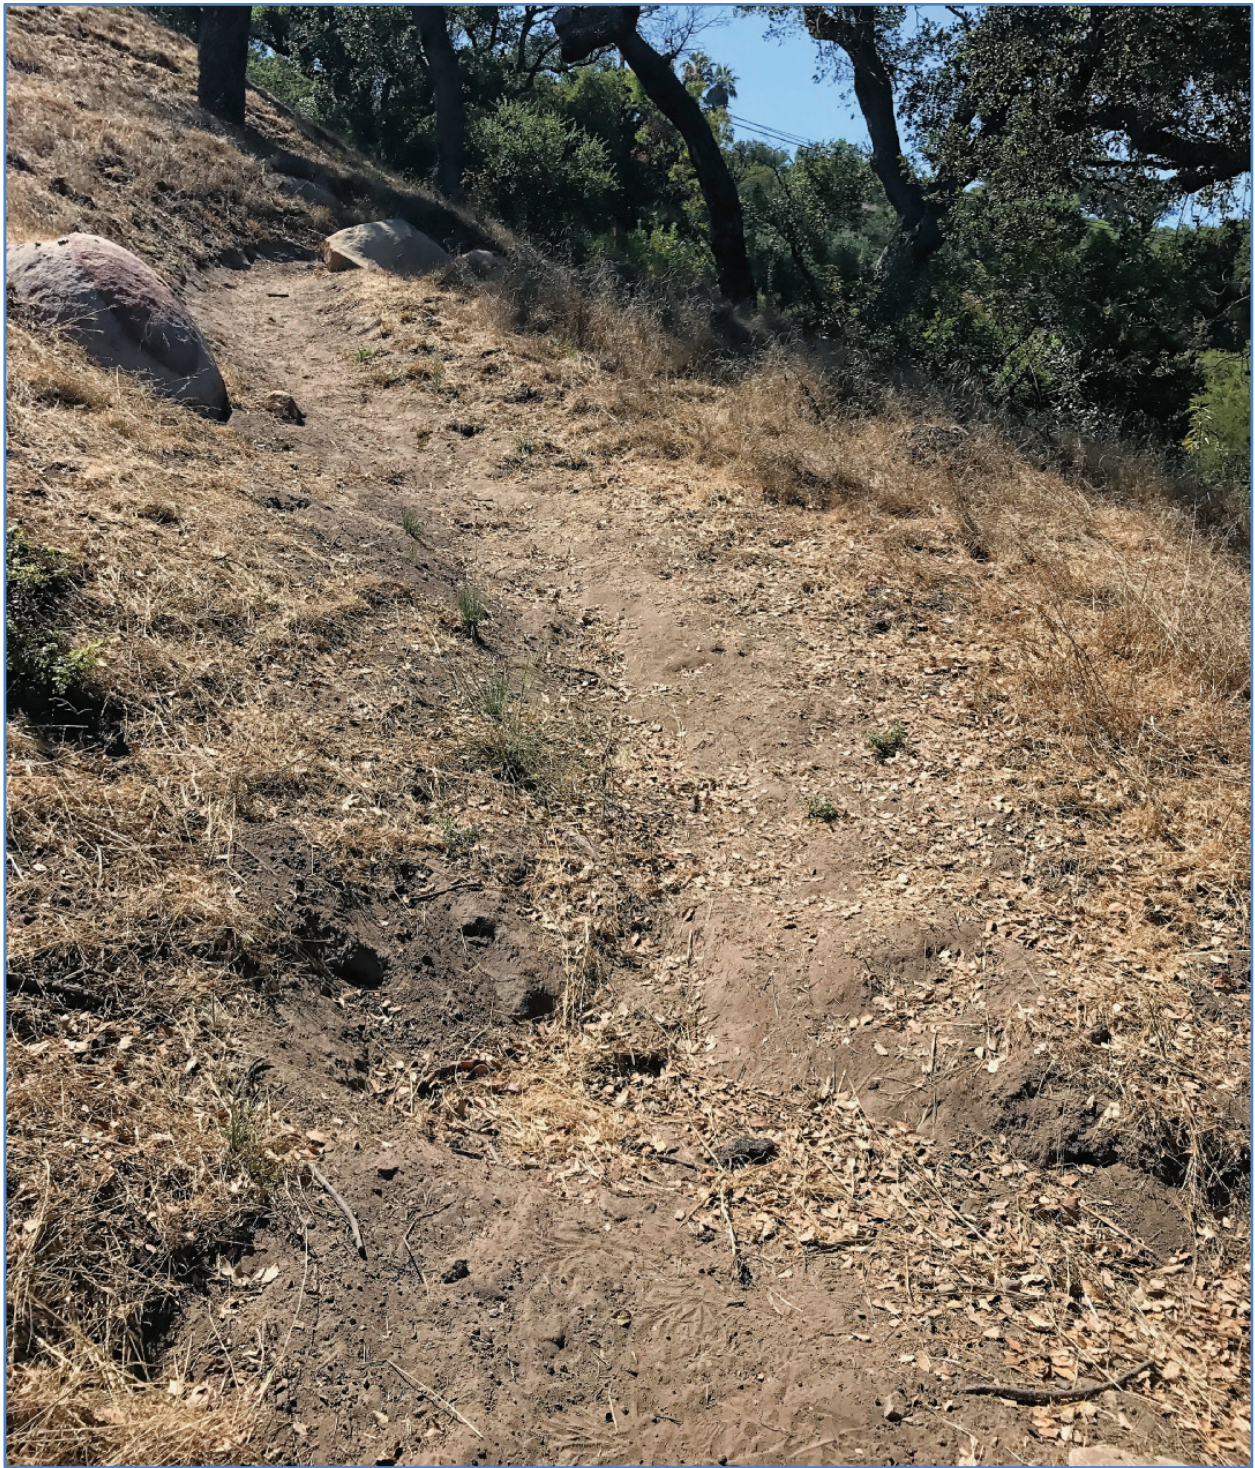
**Figure 5. Improper placement of waterbars**

*Note placement of waterbar at very bottom of a steep part of P1 where the trail makes the final climb (32%) to Mountain Drive. There is no outslope above it to get water moving off the trail before it reaches the waterbar, it is extremely shallow and there is no berm on the lower side to force water off the trail.*

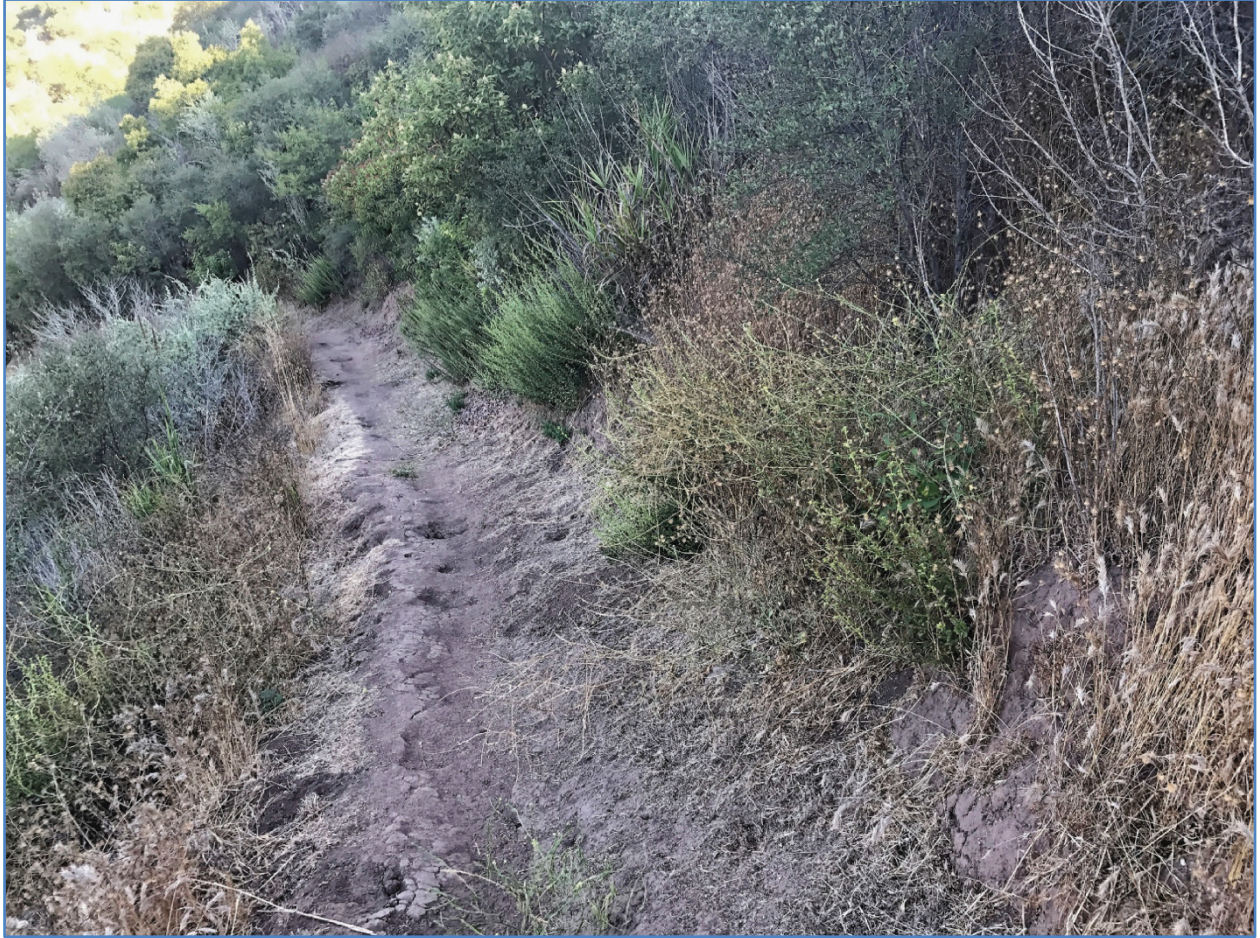
**Figure 6. Hillside slumping narrows trail**

*This section of the S4 segment along the Stanwood System is less than 15" wide. Partly this is due to hillside slumping as material from above migrated down onto the trail. The trail is also steep and crowded by brush. Had the trail been cut a bit wider and the backslope cut back properly (note how steep it is) there would have been less slumping and the brush would not be crowding the trail. This section does not allow users to pass one another, especially equestrians.*

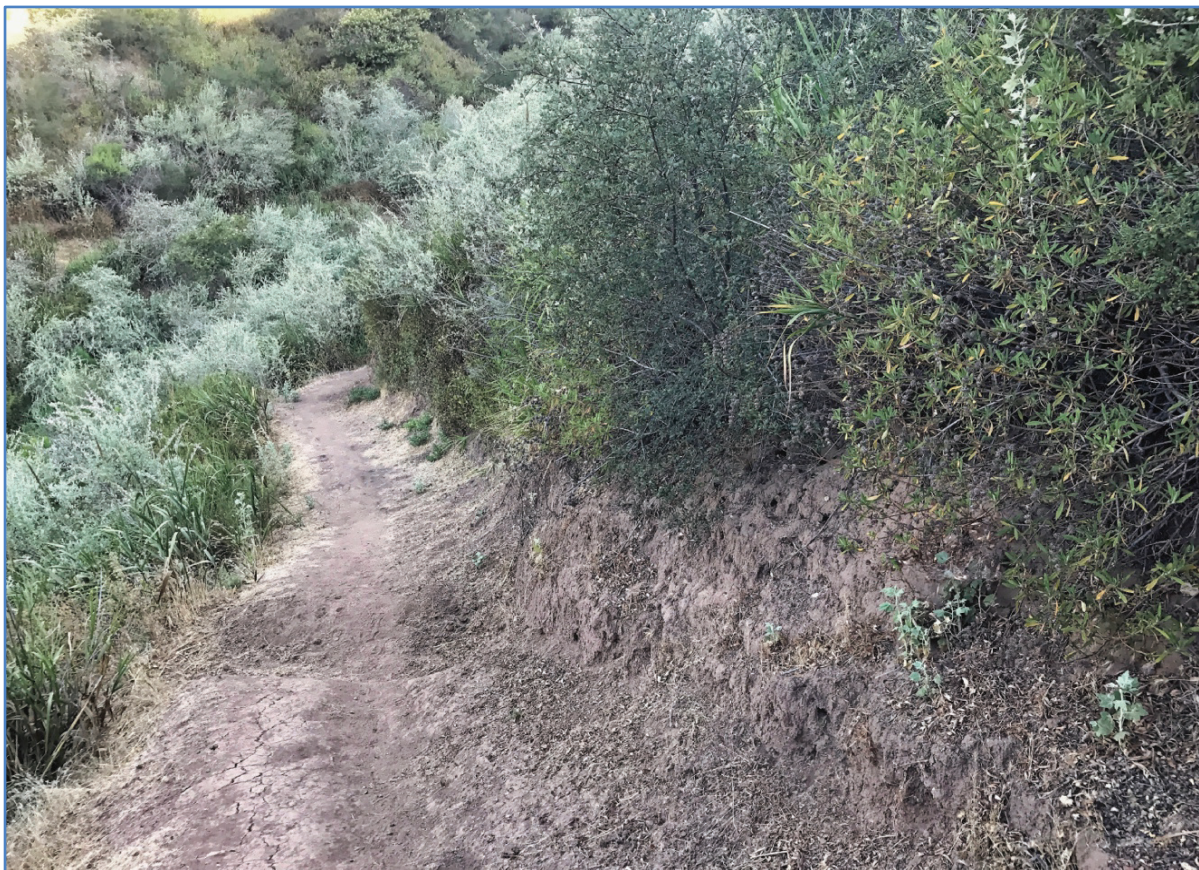
**Figure 7. Trail rated in poor condition**

*There are a number of reasons why this section of trail would be rated as being in poor condition (width, entrenchment, brush, backsloping). But the majority of the Parma Park trails (close to 2/3 of them) like this can be transitioned to meet both TMO and SMO standards. However, the remaining 1/3 will require much more extensive efforts — and in a number of cases, re-alignment or re-routing — to do so.*

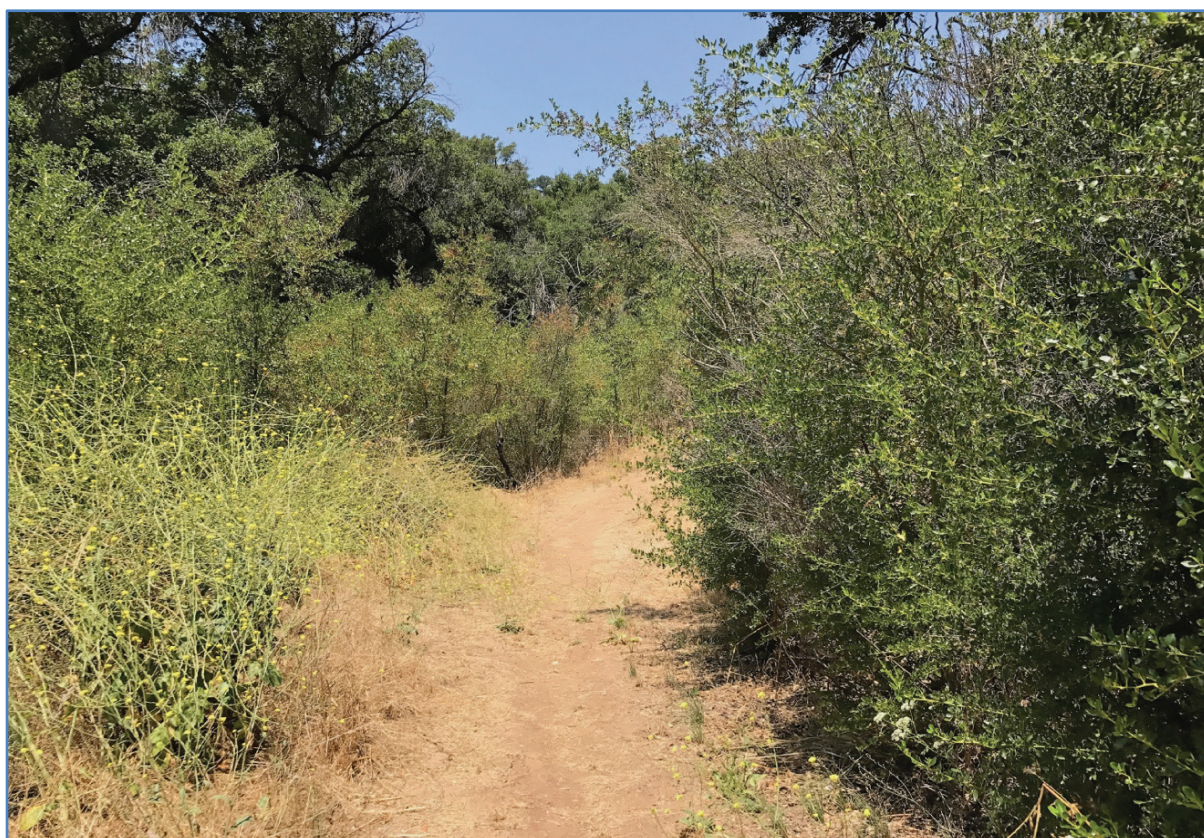
**Figure 8. Overgrown section of the Mountain Drive Easement**

*While much of the tread is in good condition, the trail could use additional erosion control features added and brushing to restore the corridor width.*
