## **BARON RANCH TRAIL & RANCH ROAD SURVEY**

### **Impacts Alisal Fire & Debris Flows**

Ray Ford • February 1, 2022

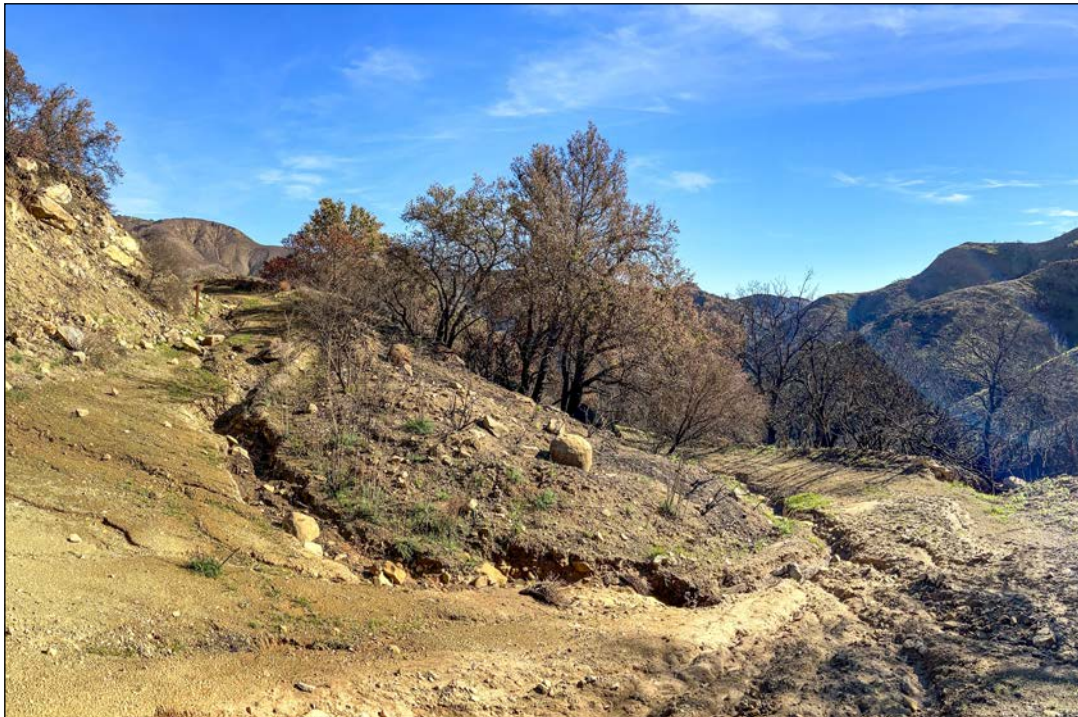
Presently the crossing is completely impassable. As a result there is no access to the upper west side of the loop for repairs to the road or the ridge trail. T

This report recommends that County Parks conduct a site visit as soon as possible to determine if permitting will be required to reopen the crossing.

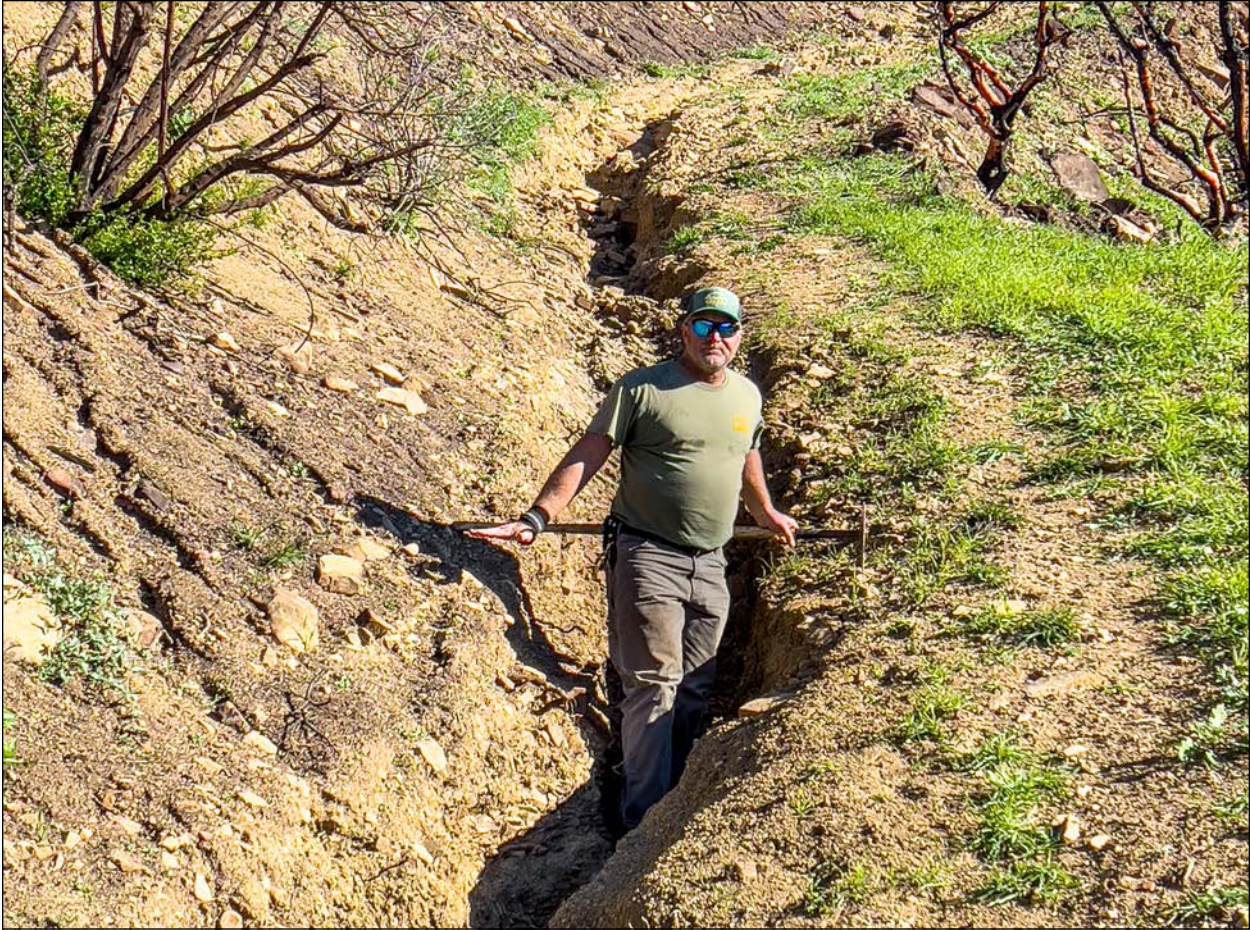
1. Water flows unchecked down for hundreds of yards along the roadways before exiting the roadways.
2. Due to the steep gradient of the roads — often exceeding 20% and in some cases 30-35% — deep gullies are formed, on average from 1-4 feet in depth.
3. Where the water does exit the roadways the larger volumes of water cause much more damage both at those locations, including bank failure and watershed damage.

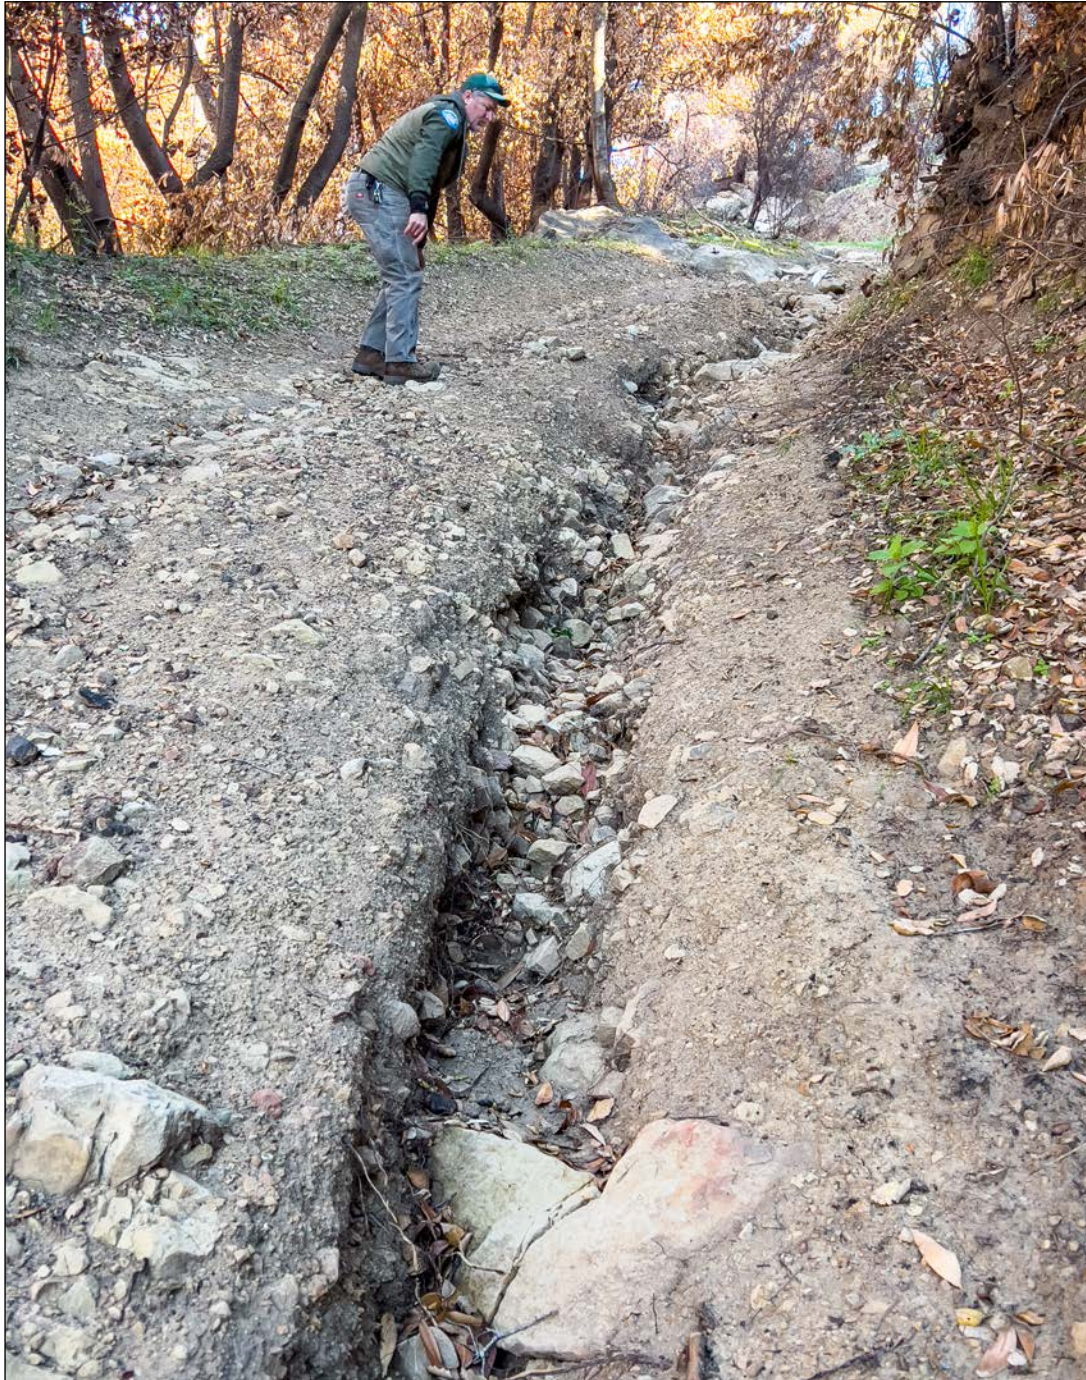
*Gullied section the Restoration Management Plan proposed language would not allow cutting into the outside berm to create a more sustainable trail.*

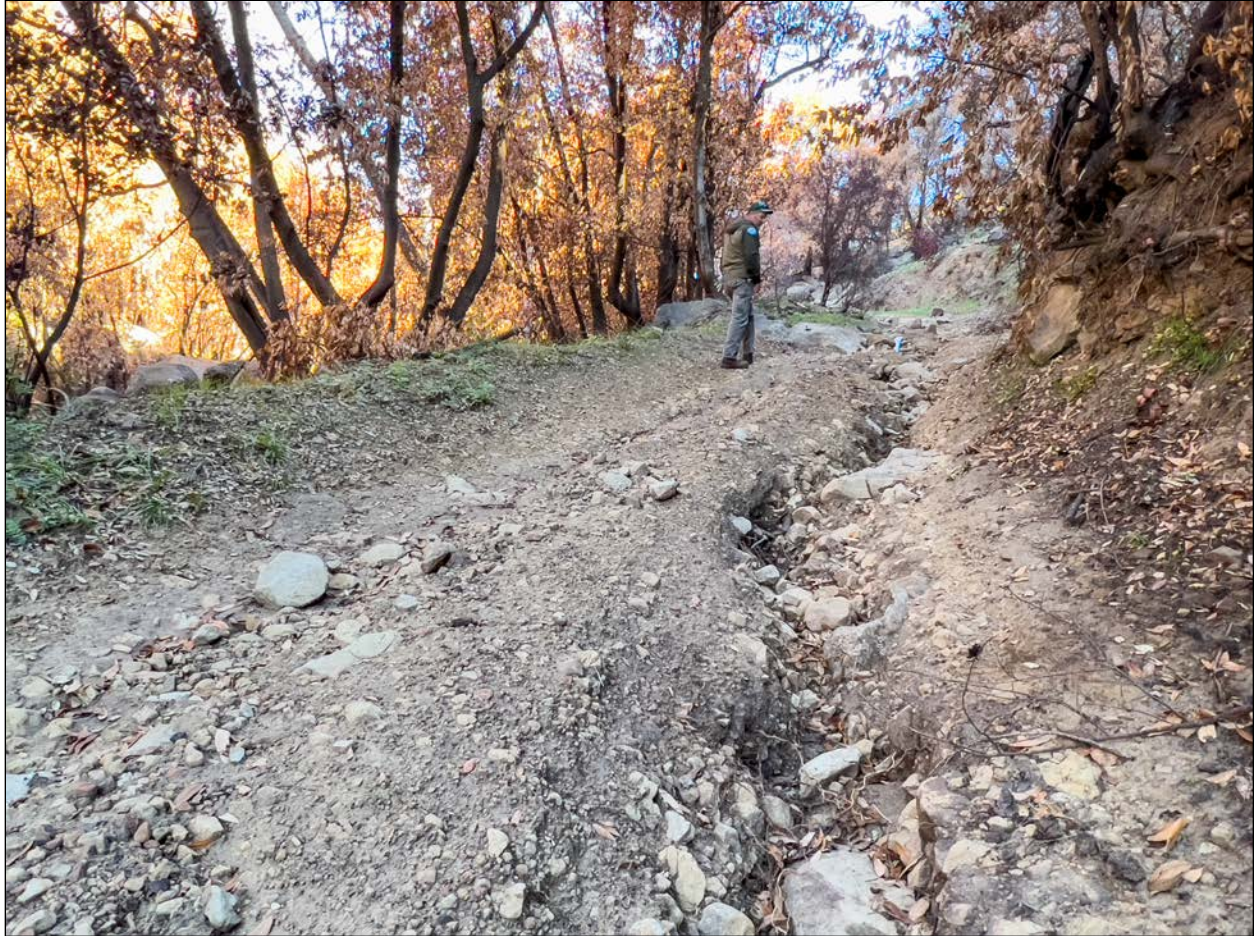
*A closer view of the area provides a better view of the potential for use of the techniques proposed above to deal with the gullying such as removal of the outside berm to provide a 6-7' wide UTV-style road surface, stabilizing the gullied channels and addition of regularly spaced dips to shed water off the roadway.*
