BIOLOGICAL STUDY BARON RANCH TRAIL REALIGNMENT SANTA BARBARA COUNTY

Prepared for:

Santa Barbara County Trails Council
PO Box 22352
Santa Barbara, California 93121

November 2023

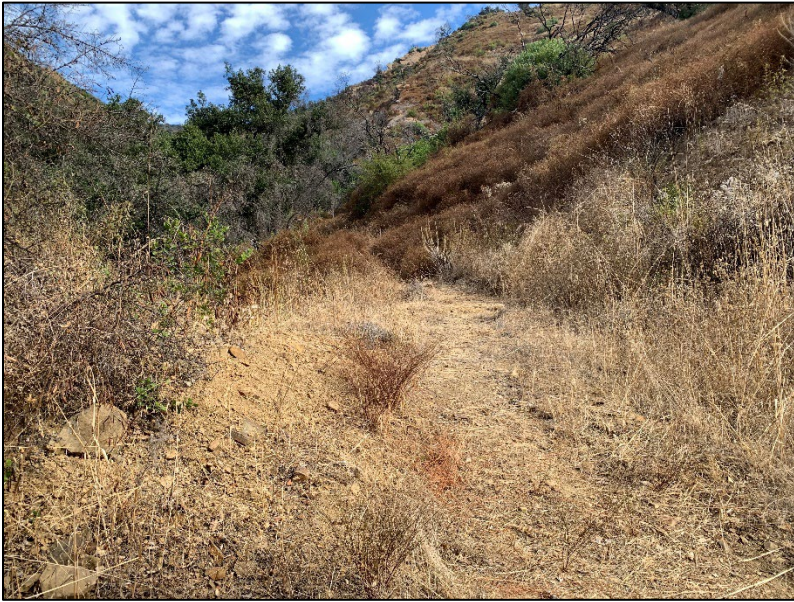
a. Lower end of the proposed trail alignment, facing north (~MP 0.02)

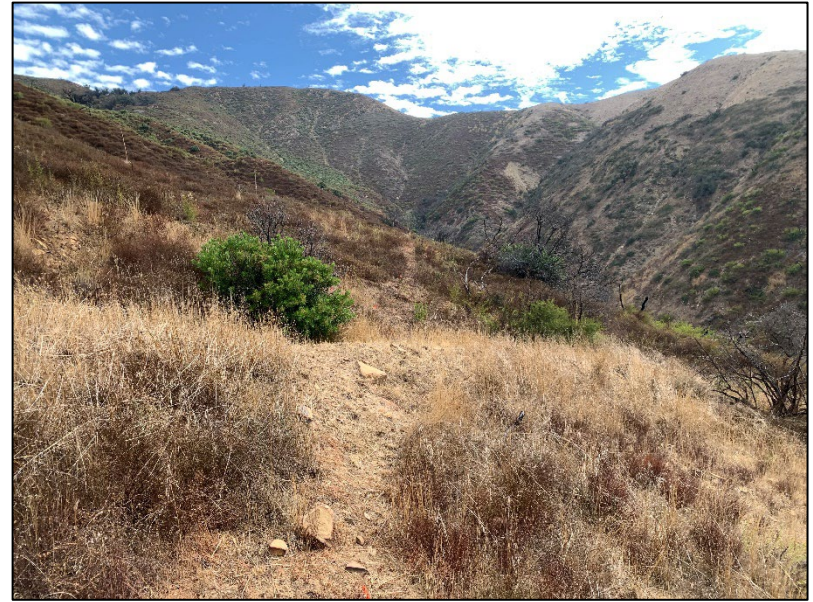
b. Lower end of the proposed trail alignment, facing east (~MP 0.22)

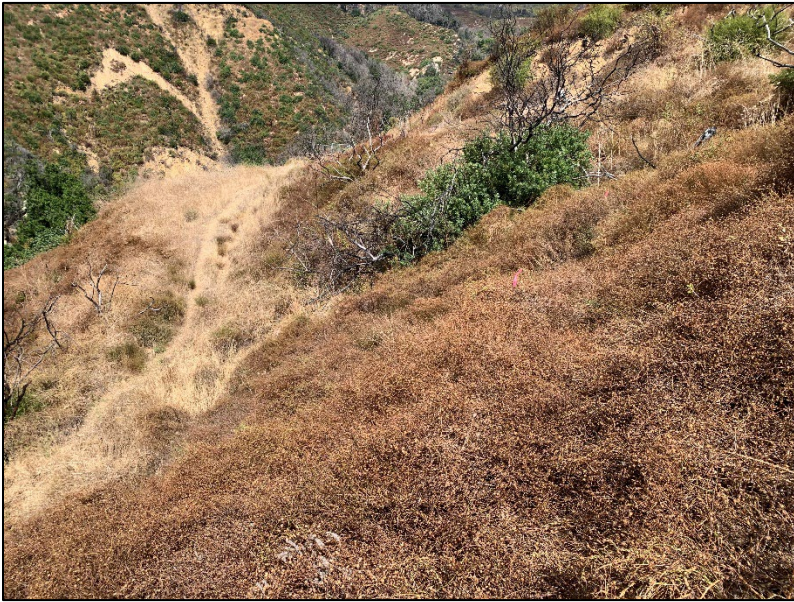
c. Middle of the proposed trail alignment, facing northwest (~MP 0.46)

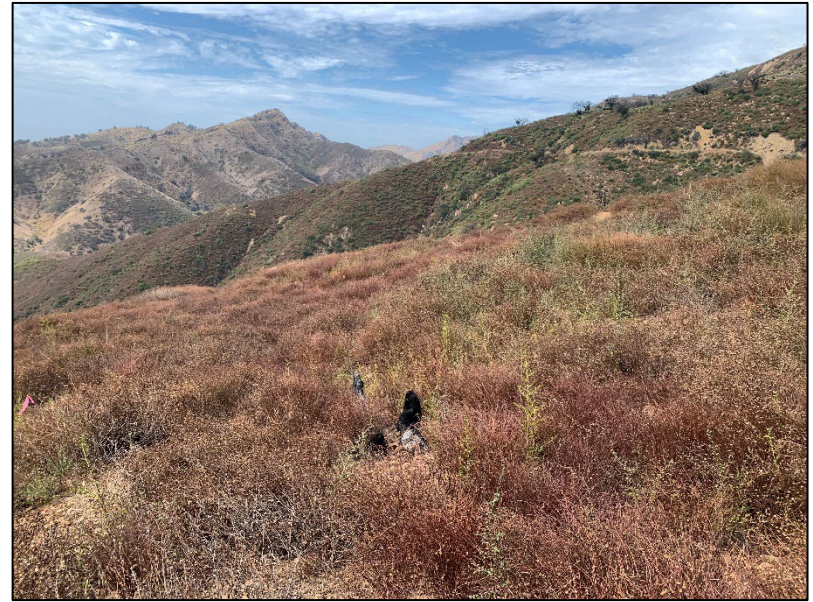
d. Upper end of proposed trail alignment, facing west (~MP 0.67)
