# **FRANKLIN TRAIL**

## **Trail Assessment, Analysis And Plan of Work Phases I and III**

*Report Prepared By:*  
Ray Ford, Project Manager  
Santa Barbara County Trails Council  
December 1, 2018

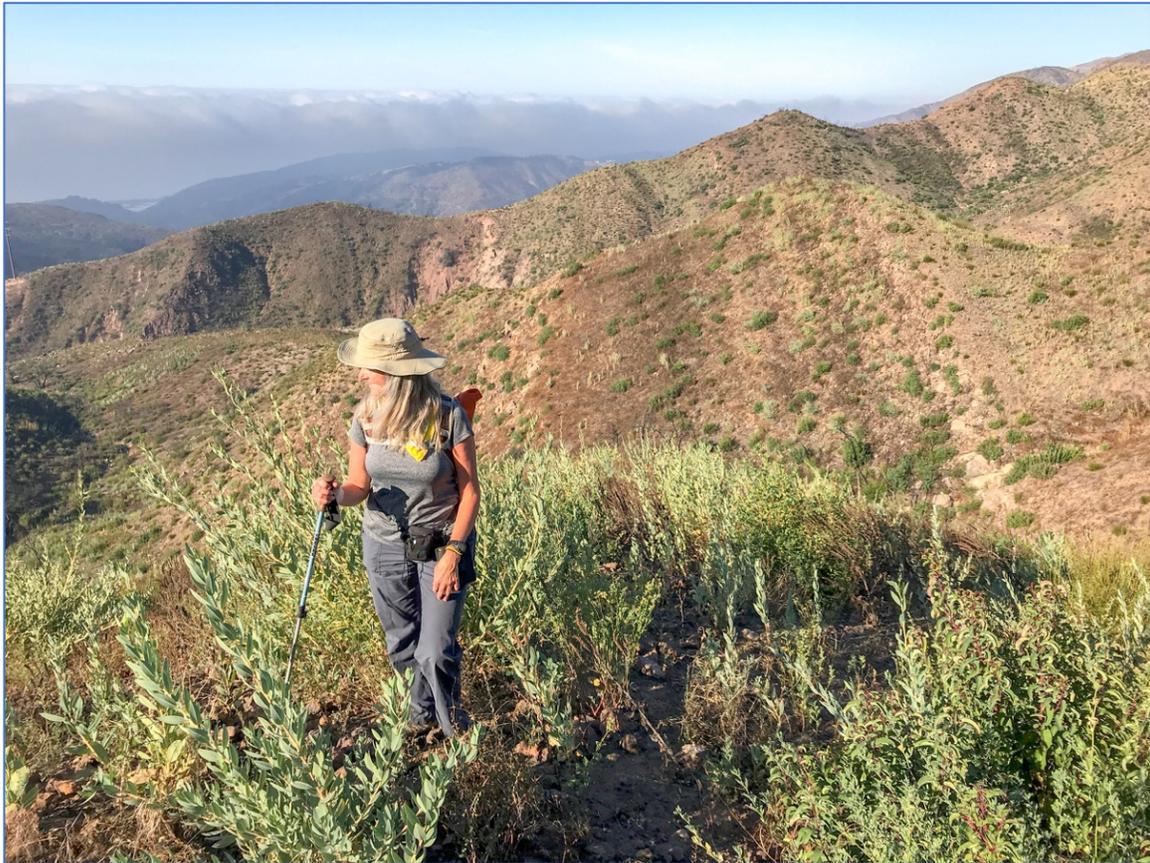
*Pict 5. November 2018, just 11 months later, light brush is beginning to cover parts of the hillsides and start the stabilization process. Restoration now will help sustain this process.*

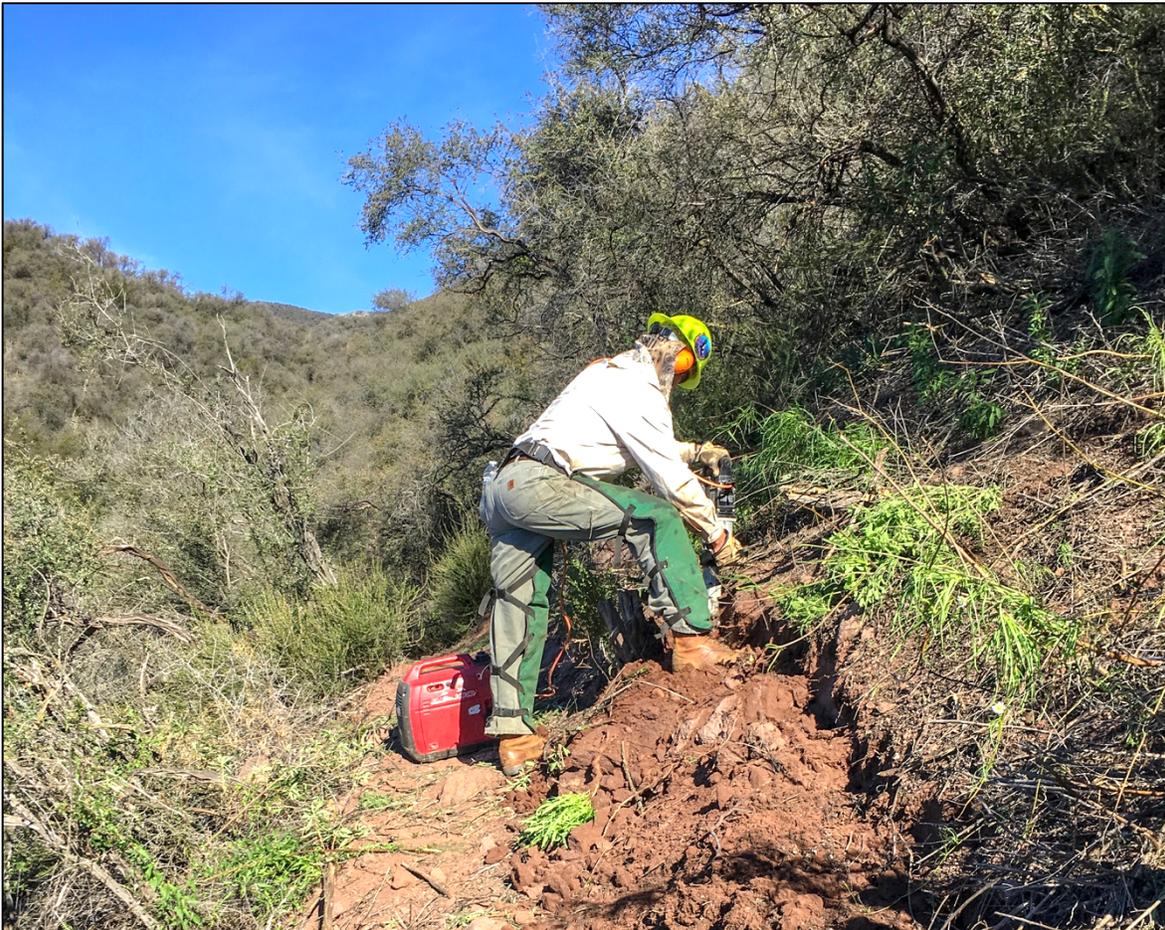
*Pict 8. Gordon Jenkins uses a portable jackhammer and generator to widen a part of the upper Franklin Trail in 2016 as a part of our initial restoration of the trail. Equipment like this will be used to remove slump material and chip into the hillside to widen the trail.*

- Removing all existing slump material to the extent possible.
- Clearing loose materials on the slopes above the trail.
- Chipping into the uphill edge of the trail to widen it as much as possible to widen the trail, especially where there are dangerous dropoffs.
- Adding crib walls and/or rock armoring to create additional tread width or protect the trail edging.
- Rebuild dips and other erosion control features and construct new ones where needed to protect against damage this winter and be effective in moving water off the trail for Years 1-3.

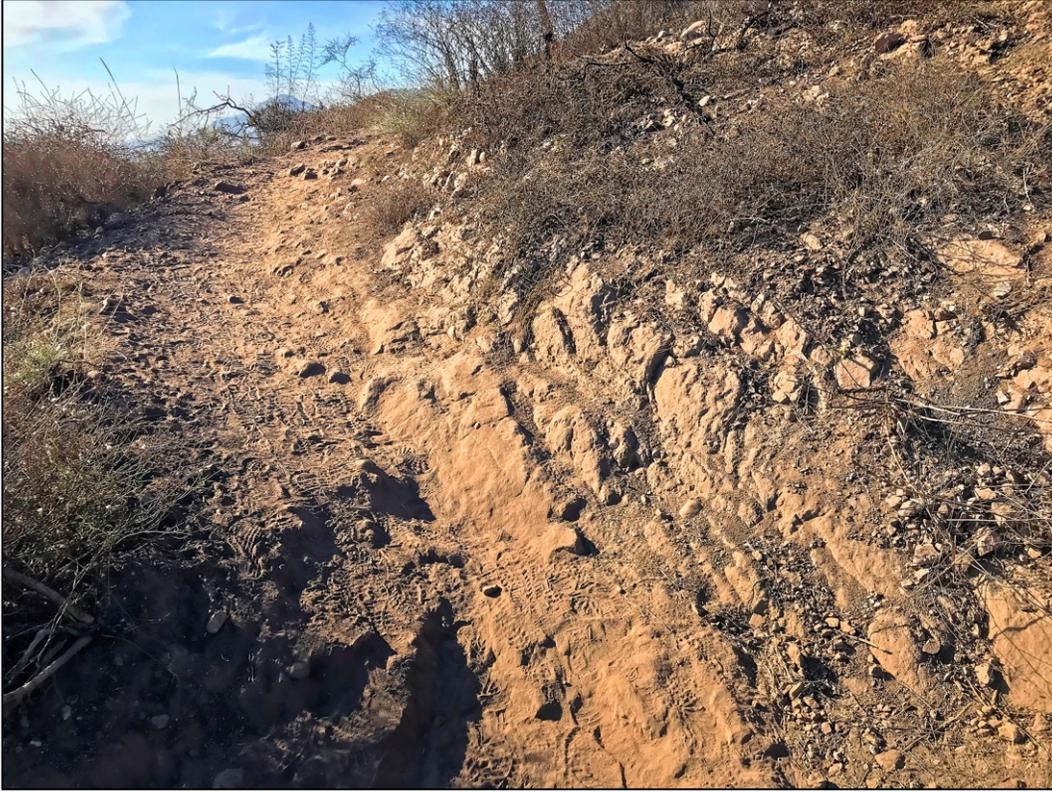
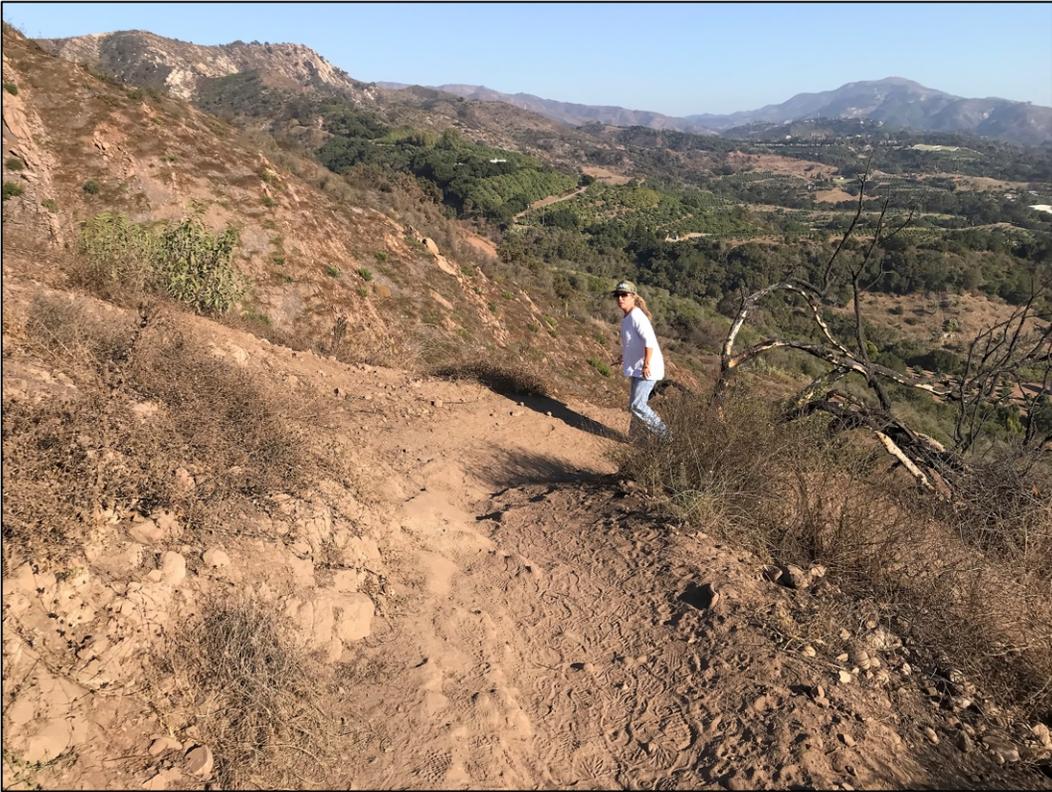
*Picts 17-18. Kim Fly surveys the damage to the Lower Franklin Trail a few days after the Thomas Fire passed over it. Almost all of the vegetation on the lower part of the trail was burned to mineral soil.*

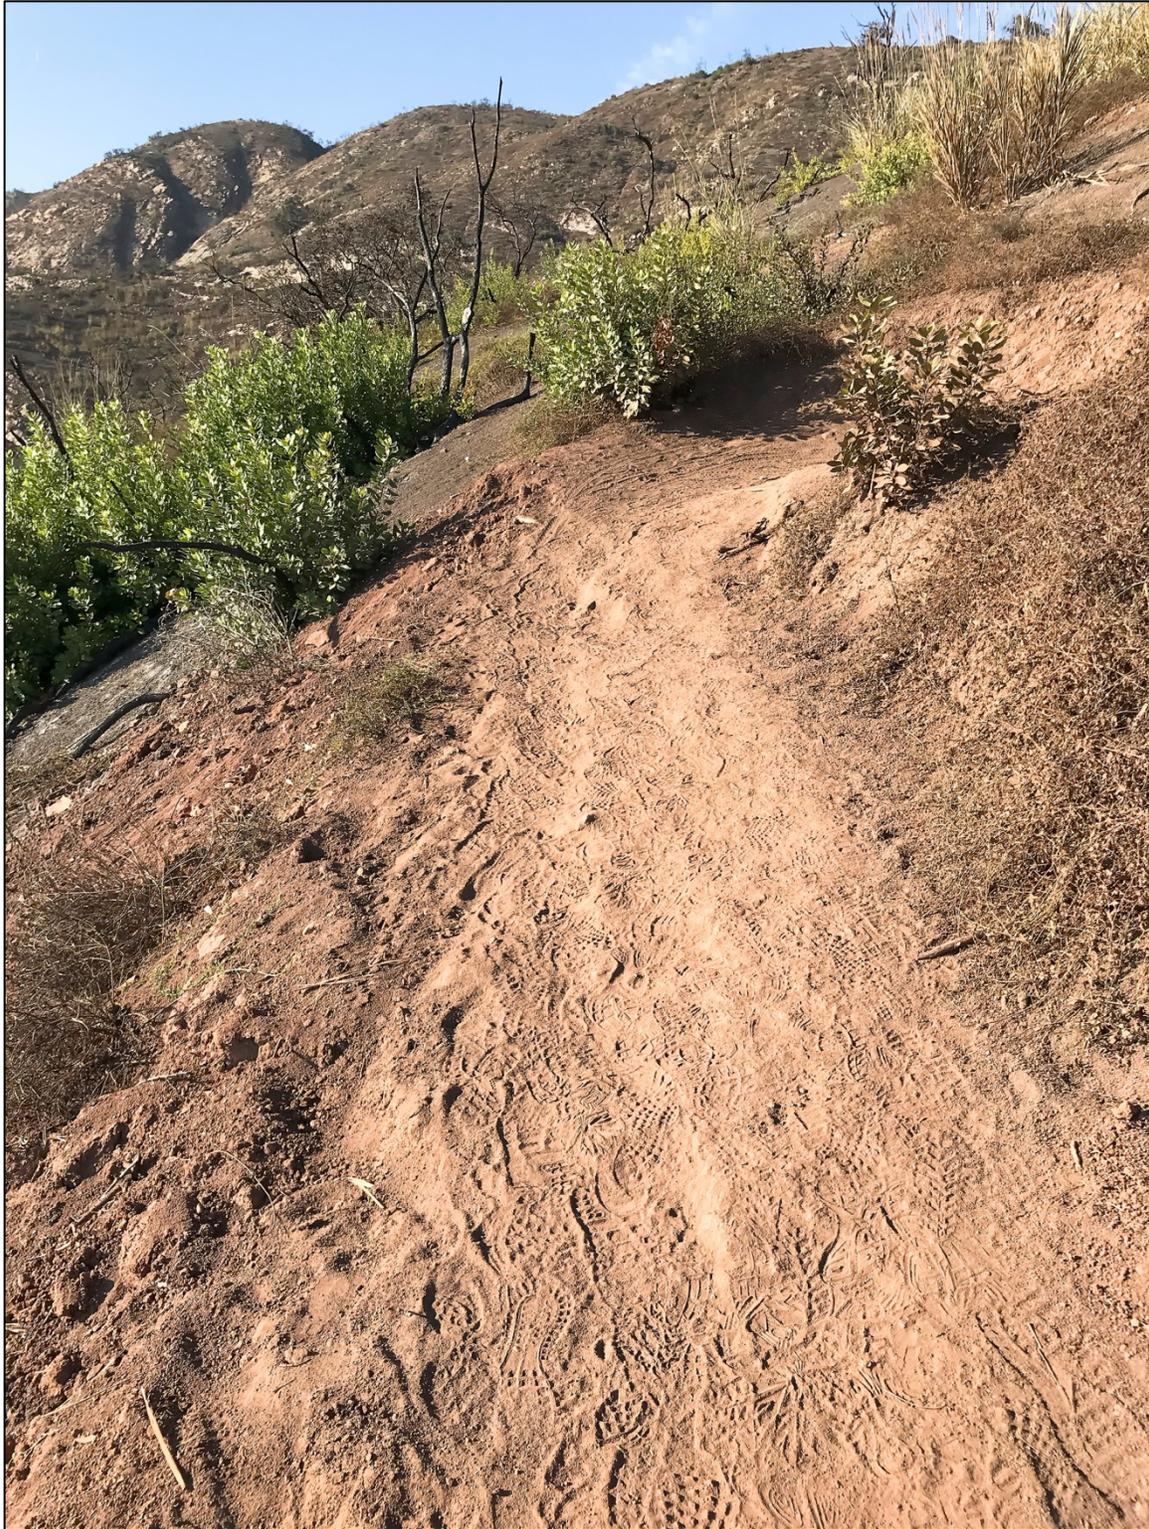
*Pict 19. Kim Fly surveys the damage to the Lower Franklin Trail a few days after the Thomas Fire passed over it. Almost all of the vegetation on the lower part of the trail was burned to mineral*

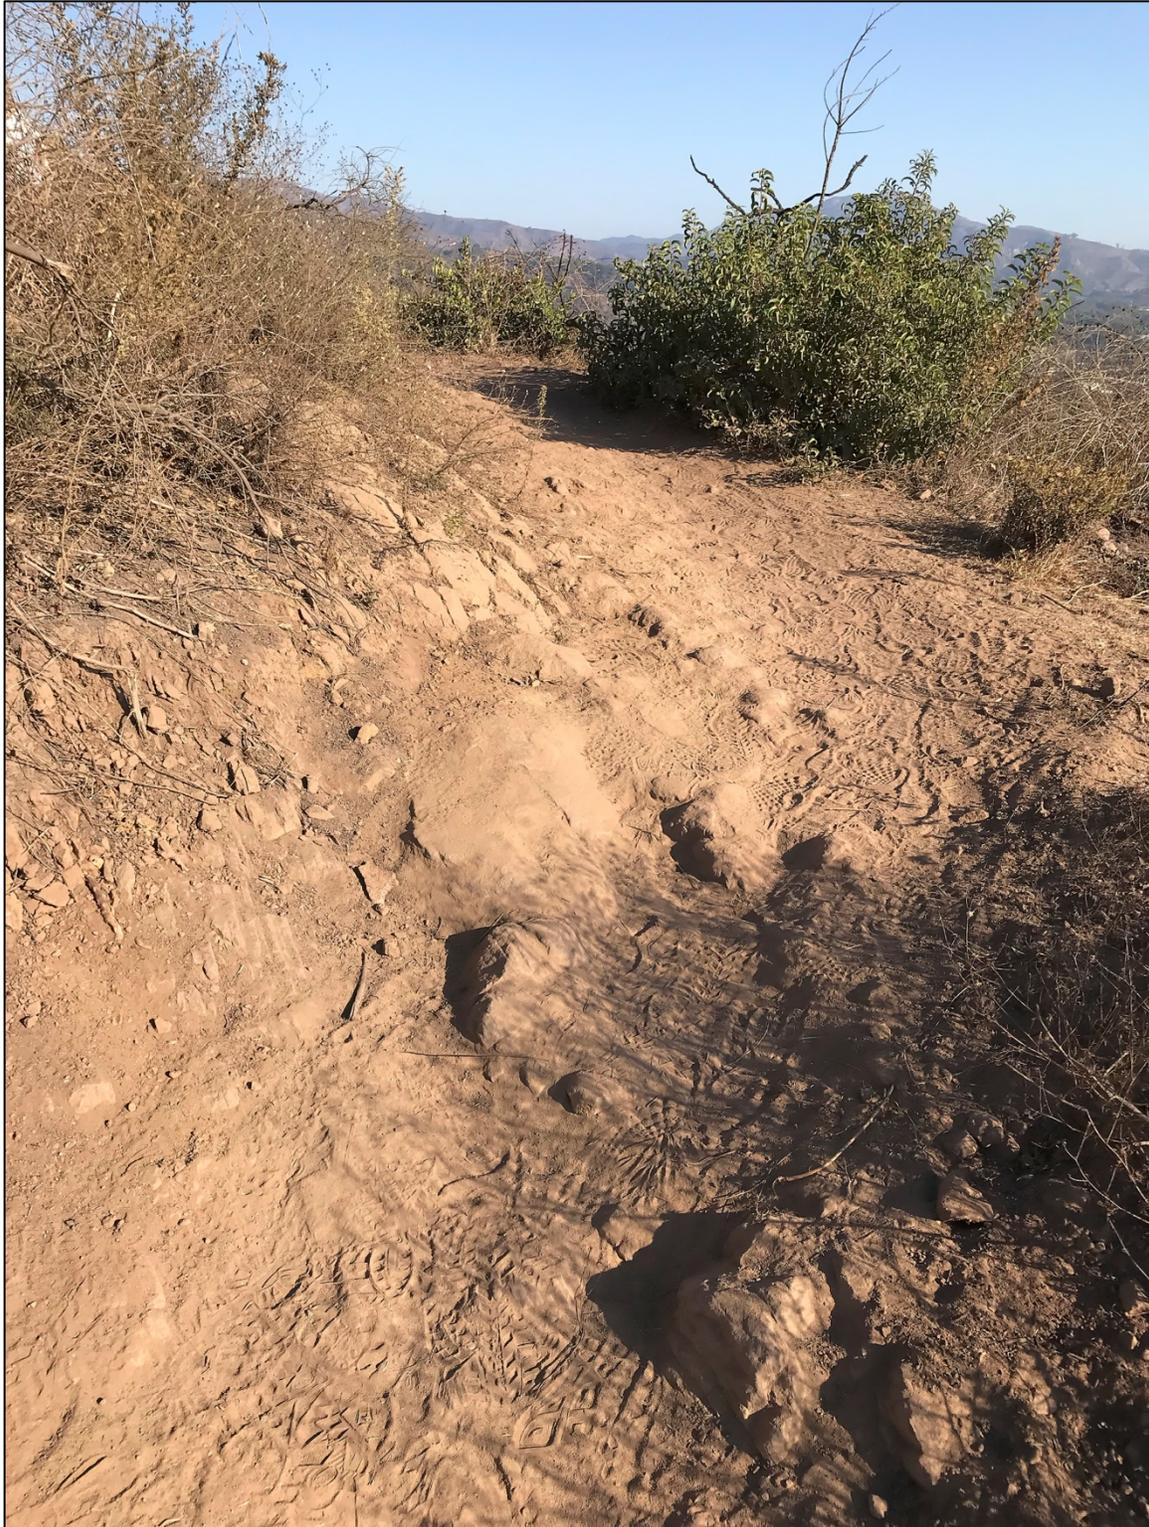
*Pict 20. Kim Fly surveys the damage to the Lower Franklin Trail a few days after the Thomas Fire passed over it. Almost all of the vegetation on the lower part of the trail was burned to mineral*

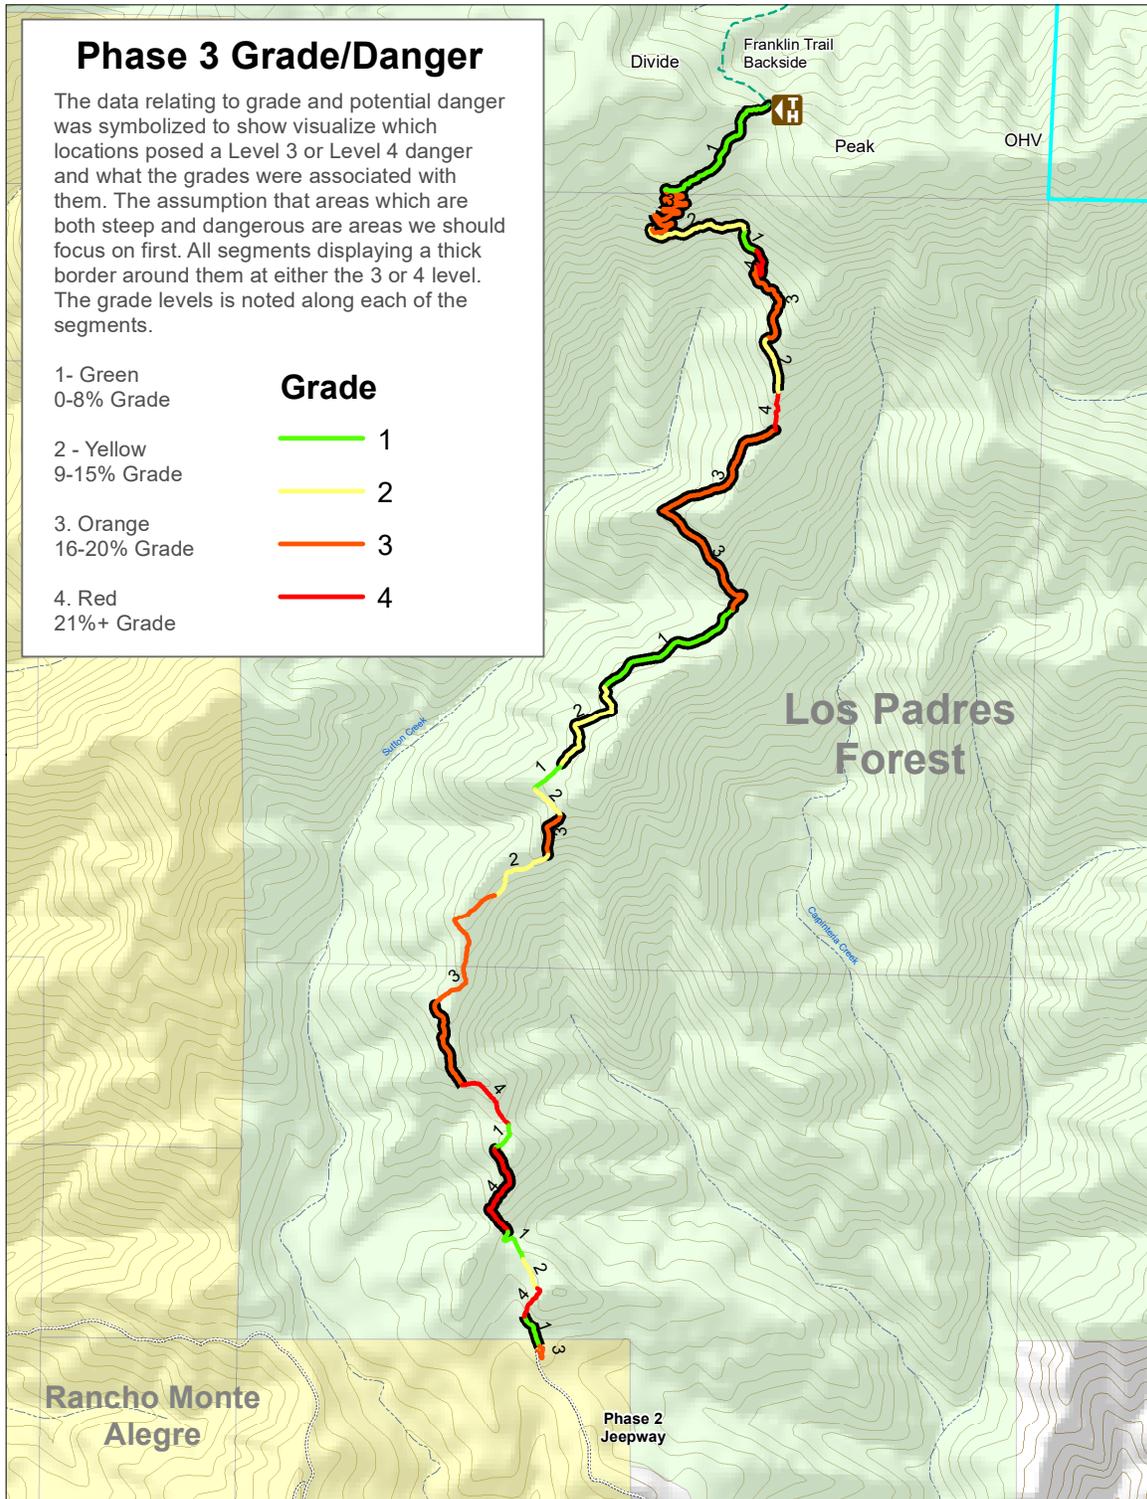
Trail Grade/Danger. The segments are symbolized in colors that represent trail grade. Those with thick black borders note trail segments that are both steep and cross through danger zones. The project will focus on restoration in those to reduce erosion and increase safety.
