TRAIL ASSESSMENT & ANALYSIS FOR PHASE III OF THE FRANKLIN TRAIL, SANTA BARBARA COUNTY, CALIFORNIA

Ray Ford, Project Manager
Santa Barbara County Trails Council

December 7, 2015

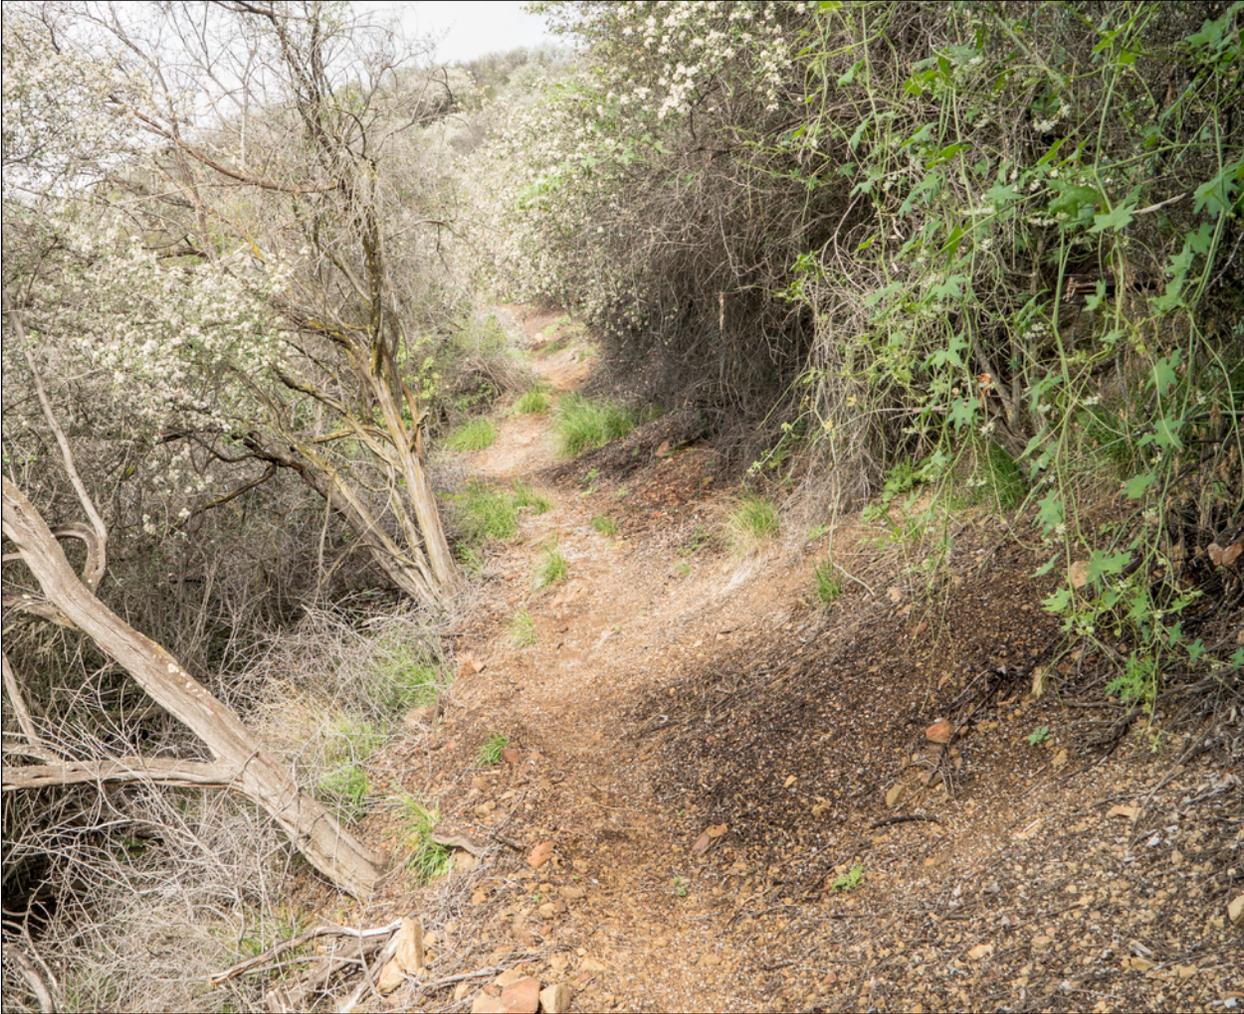
Figure 12. Use of Drain Dips and Reversals.

This 150-foot length of trail climbs at a grade of 19%. Note the slightly undulating character of the trail and slight dips along it. Even though climbing at a relatively steep grade, by using more pronounced outsloping (8-9% rather than the usual 5%) and adding several rolling drain dips, water can be sheeted off the trail.

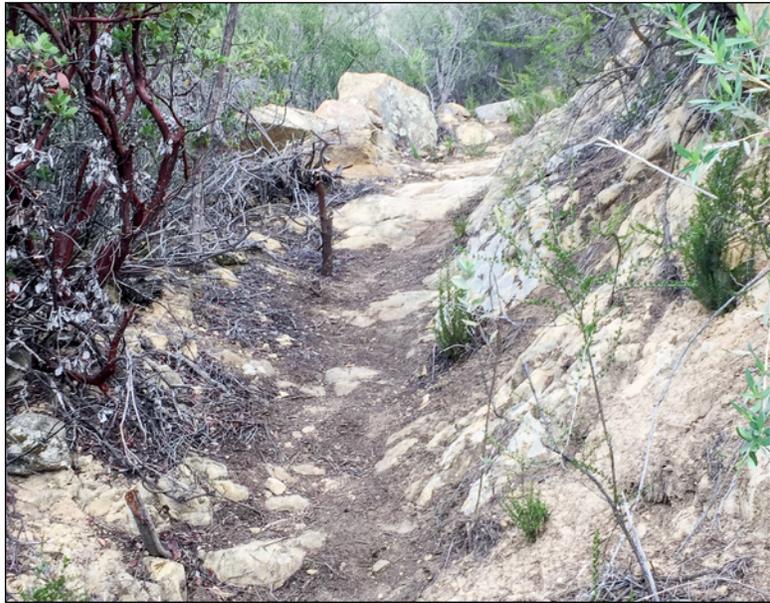
Figure 15. Coldwater Sandstone Basics

Example on the right provides an example of what the underlying structure of a large part of the Phase III trail is like where the sandstone is exposed. Sections like this were cut into the sandstone. The grade here is 15-20% and as the trail climbs up through the sandstone it does so in staircase fashion, with short rises followed by more level sections.

Also note the entrenchment. By removing the berm on the outer edge, cutting dips into the bedrock and cutting into the backslope to widen the trail, due to the resistance of the sandstone to erosion, this section will be sustainable with maintenance even though very steep.

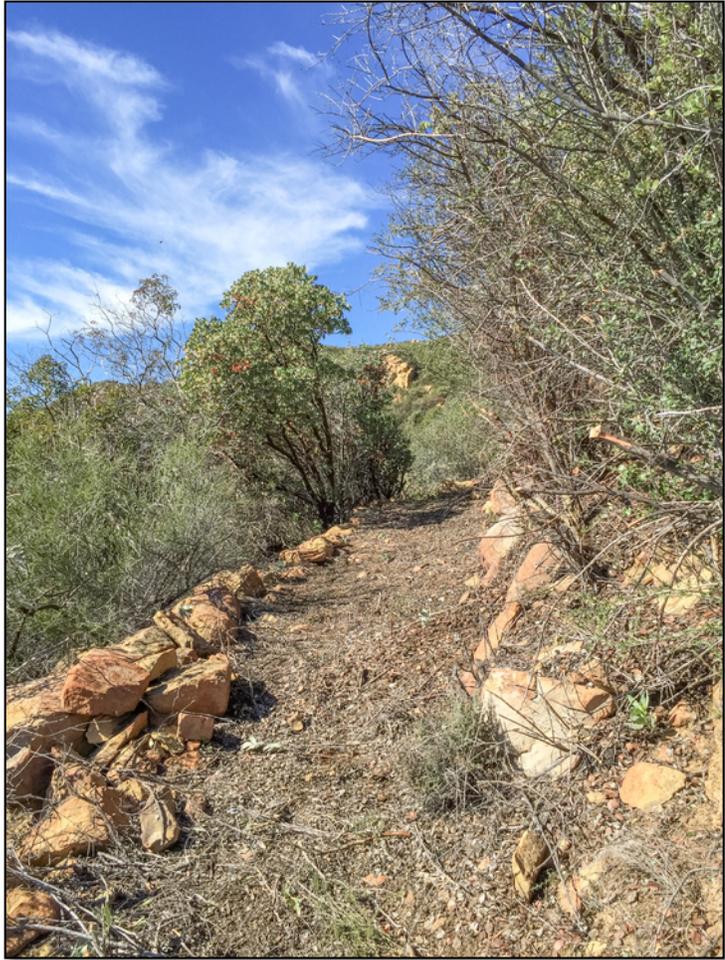
Figure 17. Rock Stacking - Upper Switchbacks

5. Rock “Stacking”. The phrase comes from the concept used by those who originally built the Franklin Trail, though they might not have used this term. In constructing the trail, it appears they realized that they could stabilize the outer edge of the trail simply by using the rock piled up when they were removing rock and soil to create the tread. The image on the right appears to have crib wall both above and below the trail, but actually the rock below the trail was stacked in place from rock removed while creating the tread. This work was done a century ago and still serves well.

With almost 70% of the trail underlain by Matilija and Coldwater Sandstone, there is a ready supply of rock available for similar uses along much of the trail. Quite a bit of the rock has also fractured into slabs similar to the ones in the photo and are perfect for stacking. Where there is a large supply of rock, loosely stacking it below the lower edge of the trail will lightly armor the slope, add protection, can be done reasonably quickly.

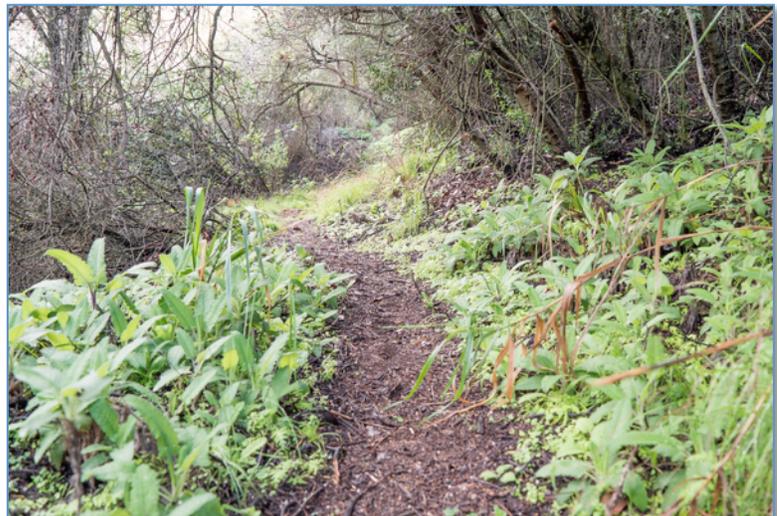
Figure 22. Section 1 Tread

Photo to the right shows the wide tread characteristic of Section 1. Grade averages 10-13%.

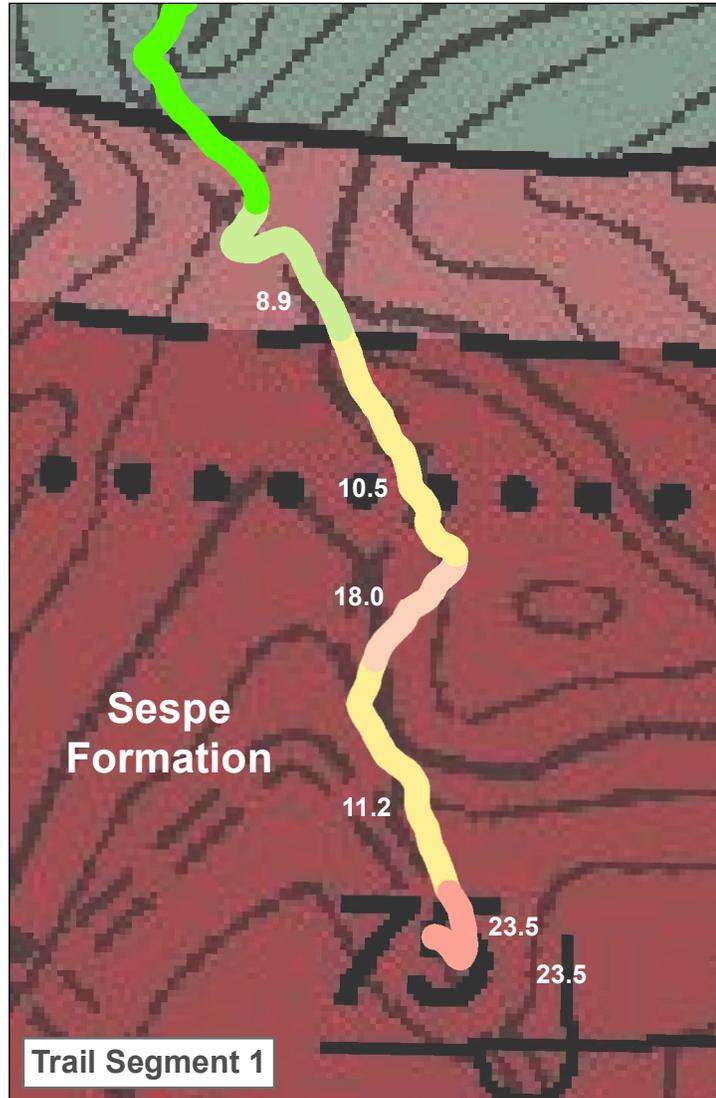
Image on the right shows grade broken down by segment. Highest grade is at the very beginning of the trail, primarily due to the steepness of the road cut, which will be reduced when the trail is constructed. Though one part of this segment reaches 18% in grade, it lasts only 150 feet and shows no signs of damage. Use of outsloping, edge armoring and knicks will be used to mitigate the grade.

Summary. The majority of this section of trail is in reasonably good condition, showing little impact from the lack of maintenance over the past four decades. The average tread is 4 feet wide and will mainly require brushing to meet Class 3 Pack and Saddle standards, clearance of slump material to restore the trail to its full width. Use of basic erosion control techniques such as outsloping the tread, addition of grade reversals and rolling drain dips to shed water off the trail and step overs to slow user speed can be combined to mitigate any impacts due to excessive grade.

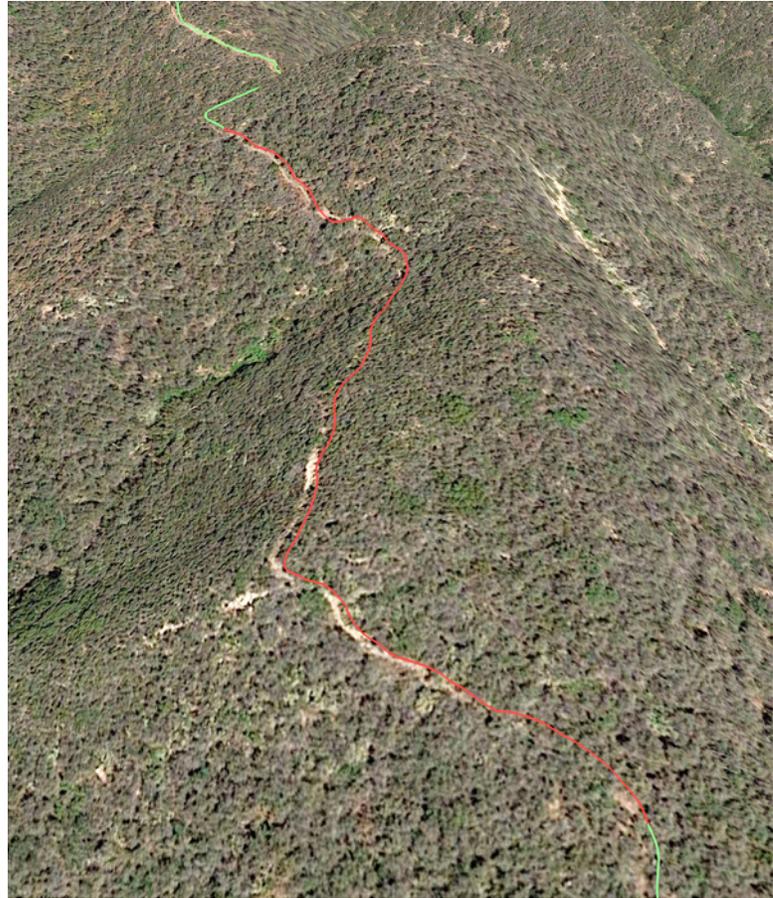
Figure 24. Aerial View Trail Segment 2

Evaluation: Though it doesn't appear to be too steep in the photo of the right, this segment has the most extreme grade on the entire trail, with one short section reaching a grade of 34%. Other parts of this segment range from 19-27% grade. The sideslope is also steep, ranging from 30-50%, making it difficult to add one or more switchbacks to lower the grade.

Mitigation: Most of Segment 2 is underlain by Coldwater Sandstone, which forms a rocky surface that is resistant to erosion. However, in several places because of the steep sideslopes, the trail has washed out and requires short crib walls to stabilize the hillside.

There is also an abundance of sandstone, consisting of fractured rock slabs, small boulders and larger rock 2-3 feet in diameter. This rock will be helpful in the crib wall construction, armoring the slopes below the trail and for adding step overs.

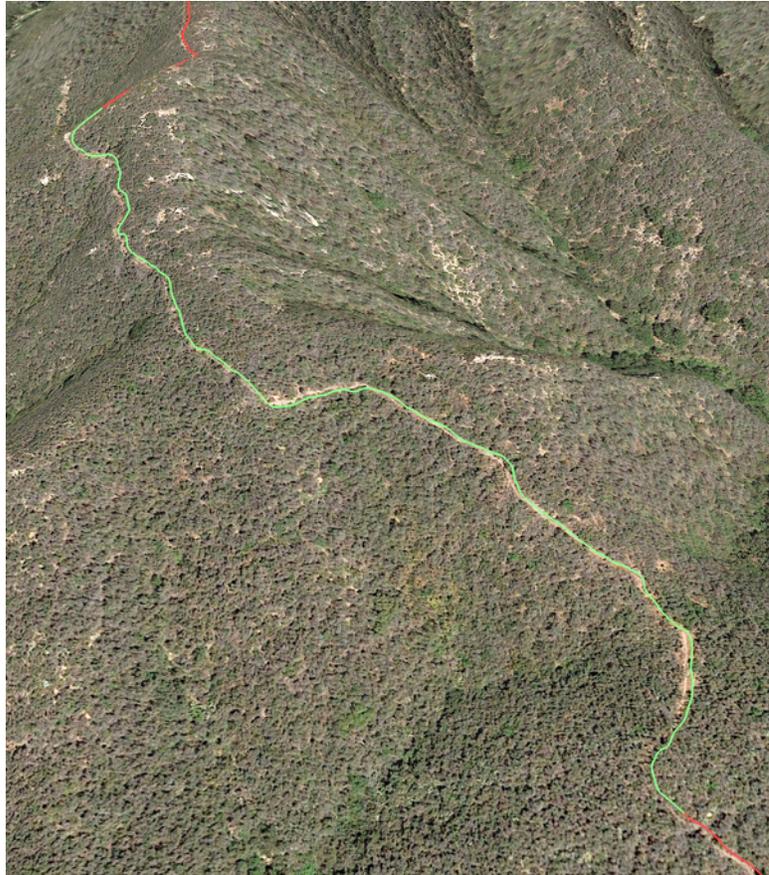
Figure 26. Aerial View Trail Segment 3

Though sections of the trail have grade in excess of 20%, because it rests on the sandstone bedrock there is little danger of it eroding. Rather than mitigating primarily for erosion, the main concern is the narrowness of the trail. Given the difficulty of cutting tread through the sandstone, those who originally constructed the trail appeared to be more concerned about opening the way through this section than making it as wide as it is in other places.

Mitigation: While outsliping and addition of rolling drain dips are proposed to control erosion, the primary goal will be widening the tread to a four-foot width.

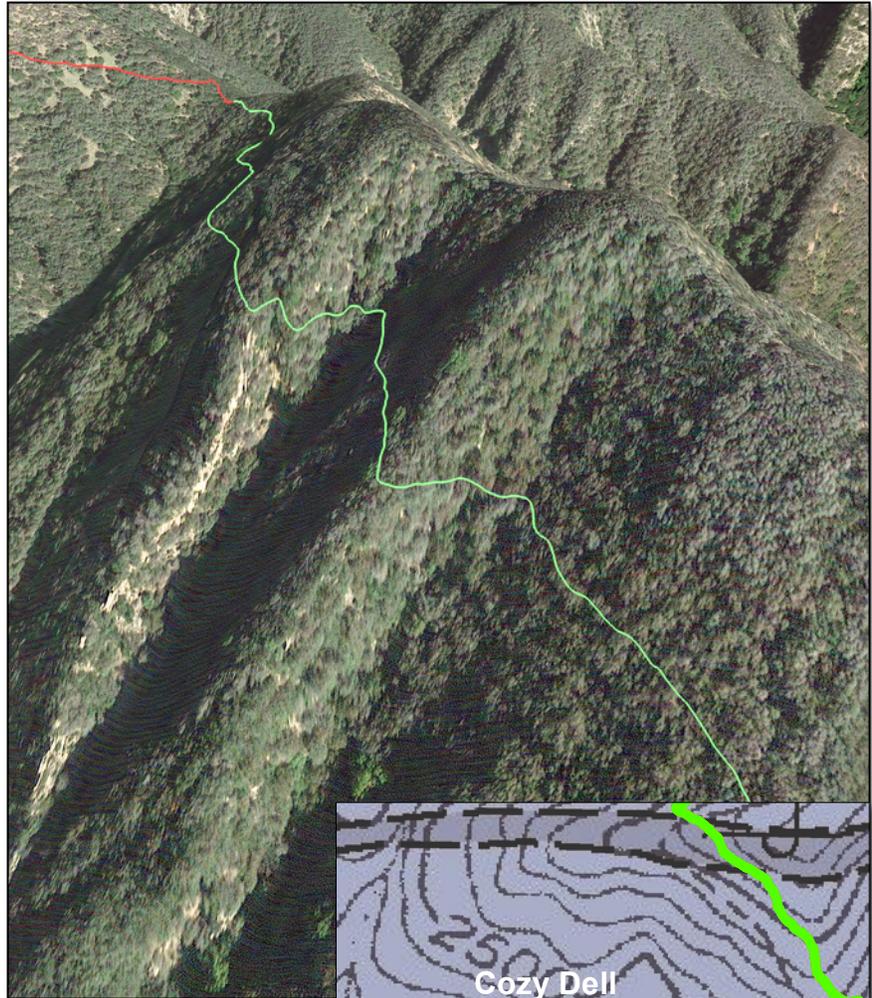
Figure 34. Segment 5 Aerial View

Evaluation: Segment 5 is actually one of the few sections of Phase III trail that meets USFS standards for grade except for a few short sections.

Mitigation: As you can see from the image on the right, this trail segment contours along a steep ridgeline. Despite the steepness of the sideslope, the rock along the trail is highly fractured and

Summary. Though a good portion of this segment contours along a very steep side hill, the fractured sandstone rock to be found along it will provide excellent opportunities to armor the trail and minimize erosion.

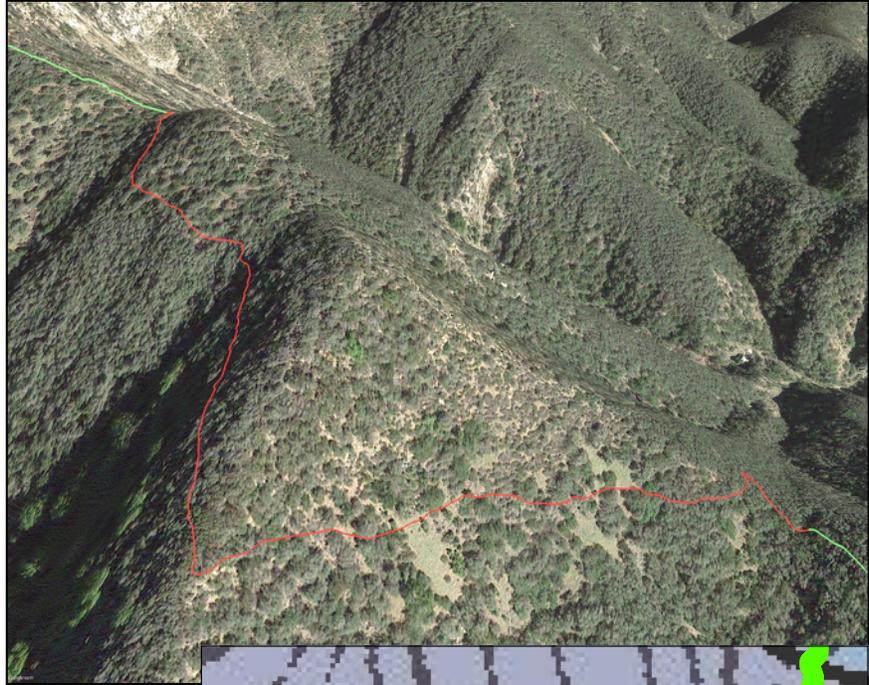
Figure 36. Segment 6 Aerial View

Trail Segment 6 contours around the western corner of a prominent unnamed point mostly through the Cozy Dell Shale Formation though the point itself that rests on top of the Cozy Dell sediments is composed of Matilija Sandstone. The junction between the two formations is fairly visible, with the Cozy Dell weathering to form the more open grass-covered slopes.

Though this section of the trail isn't as steep as some of those below, it does average between 16-20%, which is far higher than desired based on Forest Service standards. Along the lower part of the section, where the trail goes through the Cozy Dell Shale, this can be mitigated through the use of rolling drain dips, grade reversals, outsloping and step overs. Above, where the trail begins to enter the more resistant Matilija Sandstone, in addition to these techniques, the fractured rock along the trail provides a good source for armoring the trail and adding step overs.

Summary. Though this section exceeds USFS standards for grade, using both available sources of rock and the techniques described in Section 5.1, this segment of trail is designed with the intent of providing a sustainable condition.

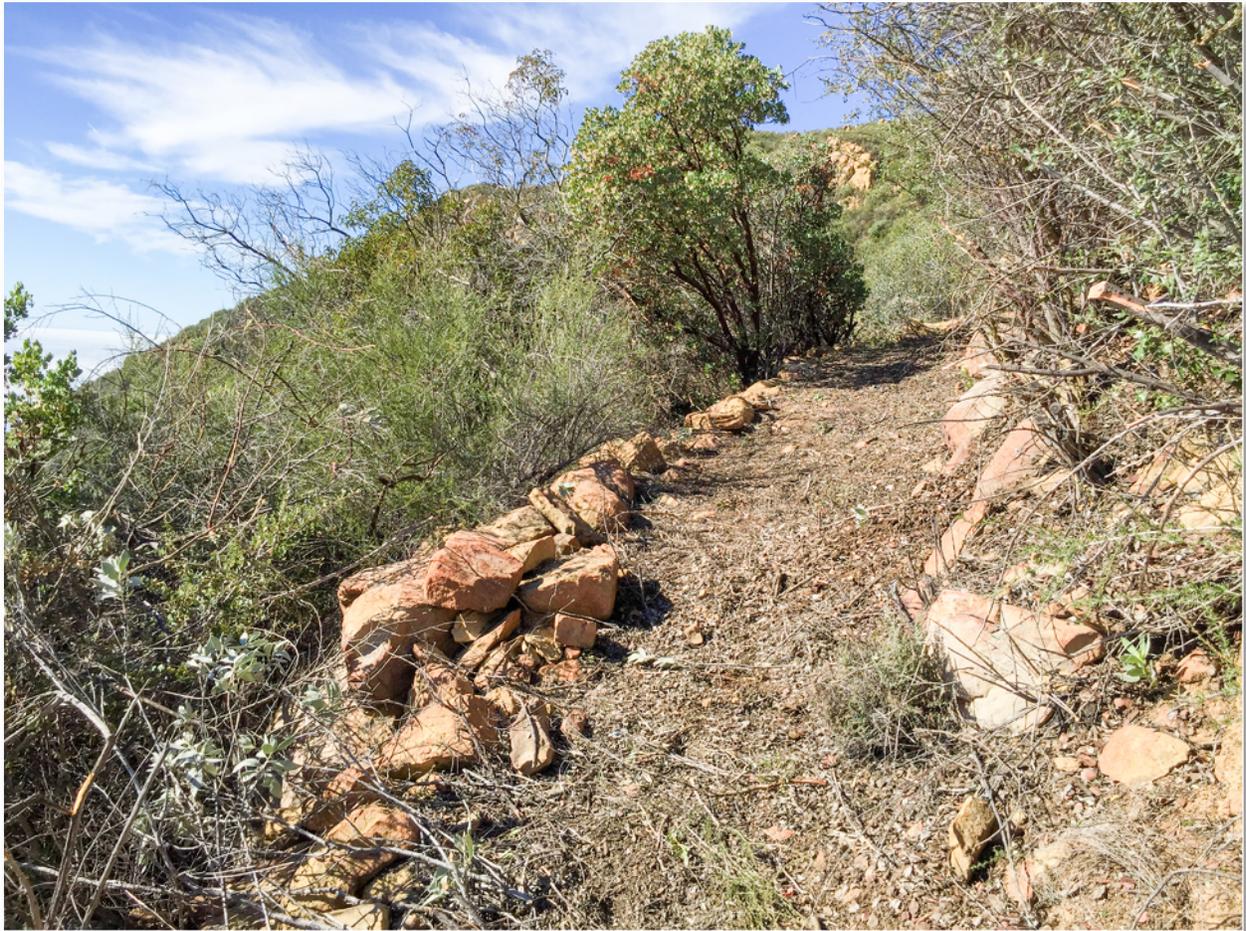
Figure 43. Segment 8 - Switchback

Switchbacks on the upper part of this section are in excellent condition. No maintenance has been done on this part of the trail for the past 45 years, other than to clear it recently for environmental reviews for this project.
