# Parma Park Sustainable Trail System Plan, Phase I

## TRAIL EVALUATION, ASSESSMENT AND DESIGN REPORT

Prepared by Ray Ford

Santa Barbara County Trails Council

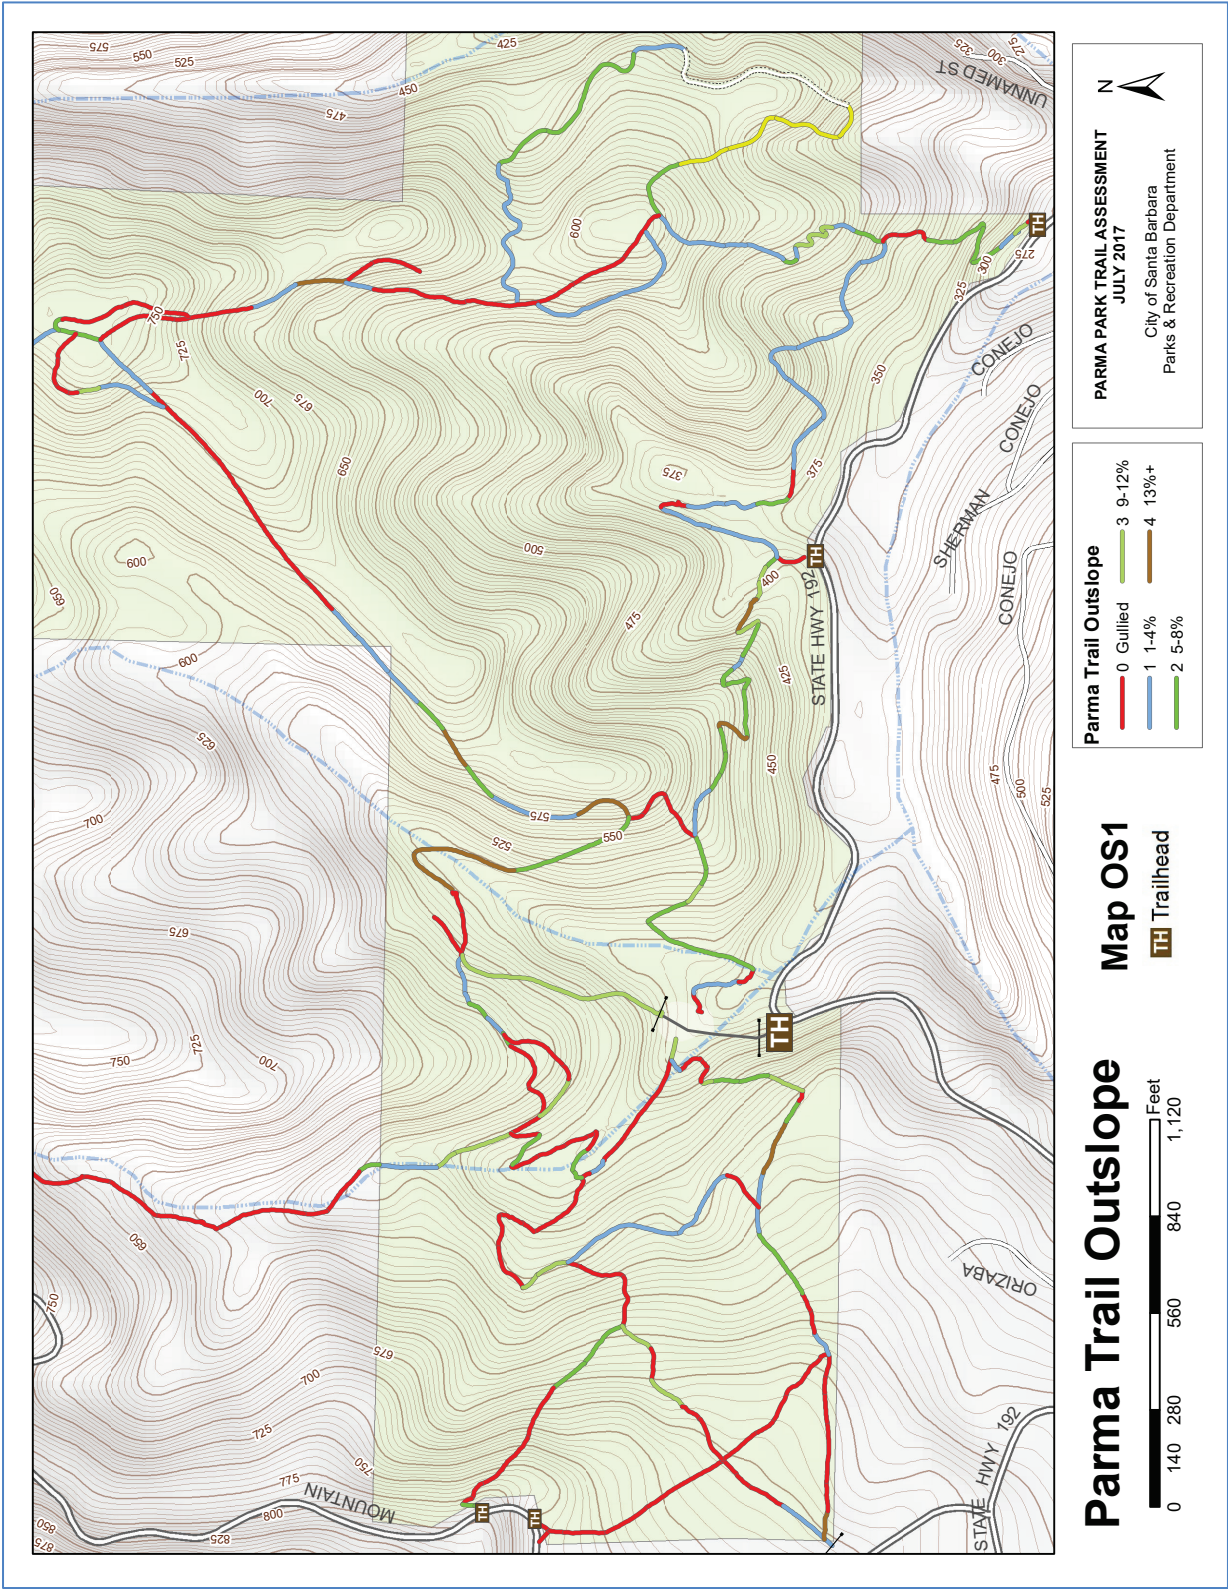
Map OS1. Parma Trail Outslope

Table 4. Percentage of Outslope				
Grade ID	Outslope % Range	No. of Segments	% of Total Segments	Notes
0	Gullied (no outslope)	118	51%	More than half the Parma trails have some level of entrenchment so that there is no outsloping. Water is flowing down trail and not sheeting off it.
1	1-4%	44	19%	These trails have a small amount of outsloping but not quite enough to do a good job of sheeting water off the trail.
2	5-8%	39	17%	These trails have the appropriate amount of outsloping and meet TMO and SMO standards.
3	9-12%	19	8%	A small amount of the trails has slightly more outsloping and are within TMO and SMO levels of being acceptable.
4	13+	11	5%	A very small amount of the trails has enough hillside slumping or other issues that have created an outslope that needs to be corrected.

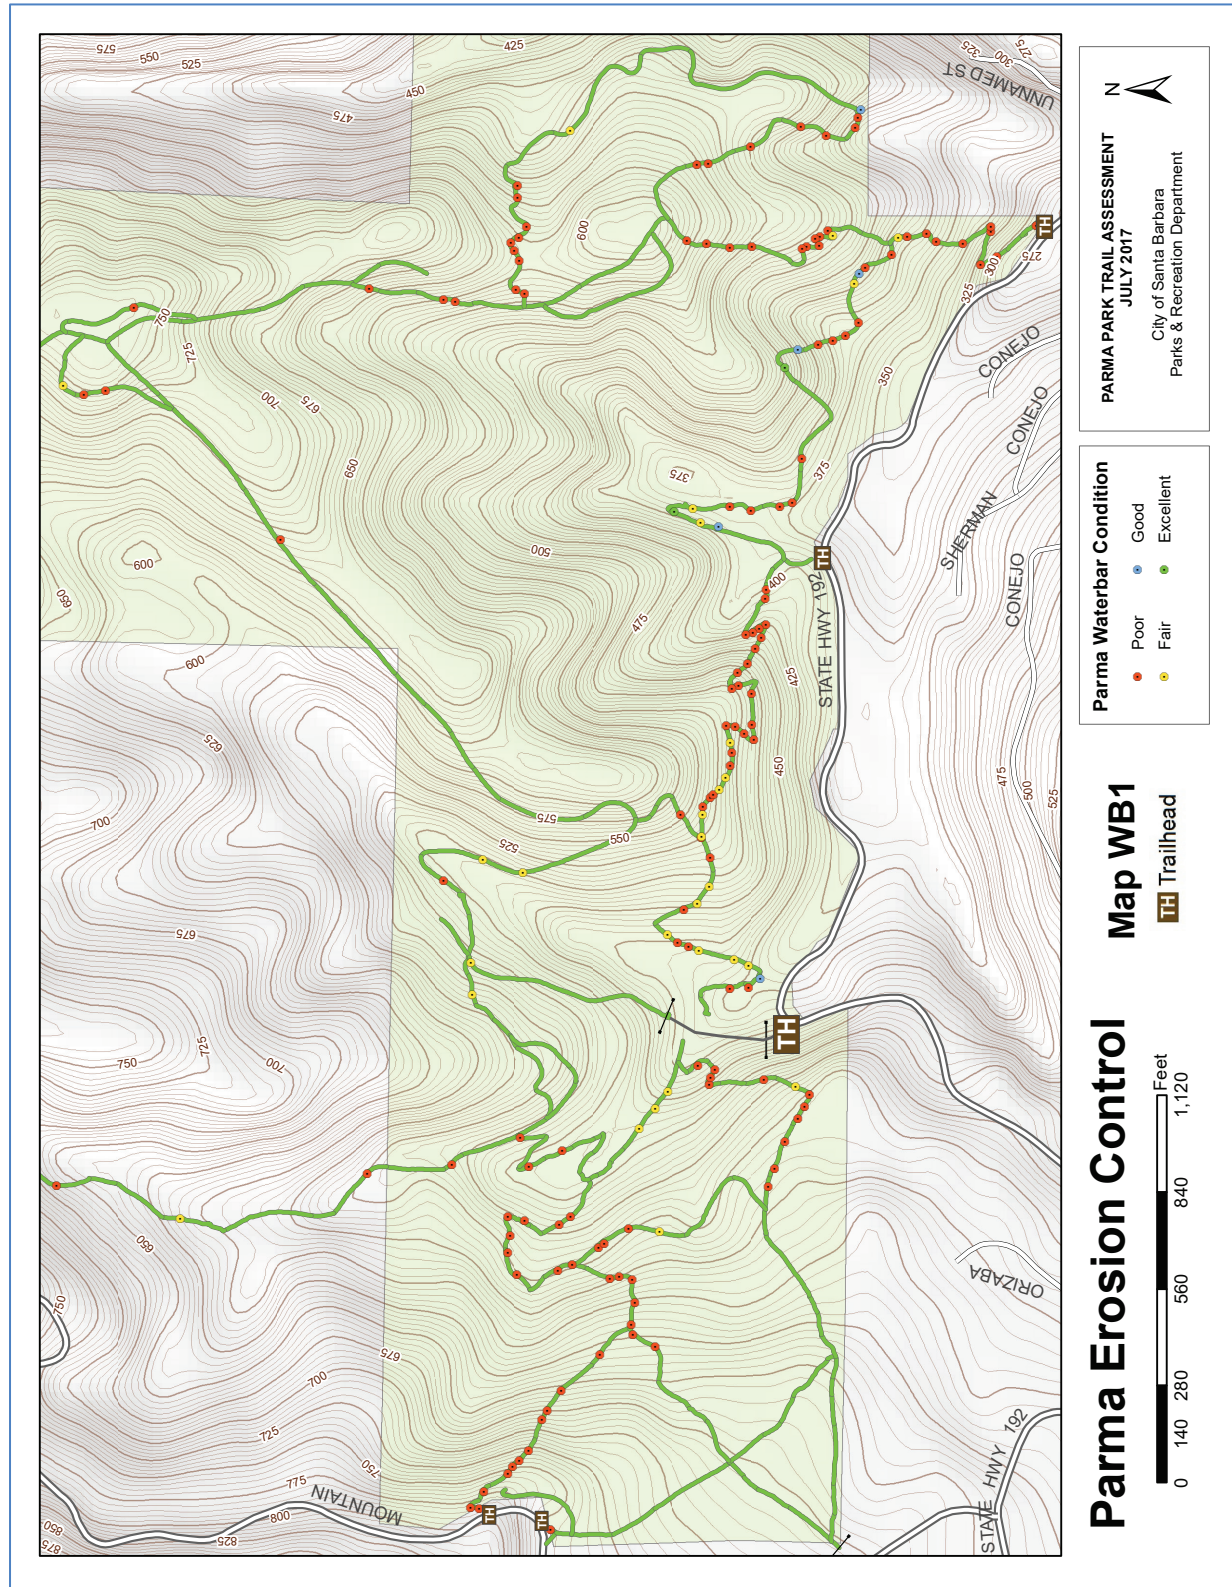
Map WB1. Parma Erosion Control

- Most of the features are waterbars, which are ineffective, require yearly maintenance and should be replaced with knicks or dips where appropriate.
- Almost no erosion control features were added in locations where equestrian traffic has created depressions within the main tread. Knicks or dips should be added in these locations as well, even though the grade may not be that steep.

- A follow up survey will be done in the second phase of this project to identify the most appropriate locations for erosion control features throughout the Park and the appropriate type for each location. The information gathered during the survey will be incorporated in the final trail design and will include recommendations of locations where erosion control features should be added and where existing features should be improved or converted to rolling grade dips or knicks.

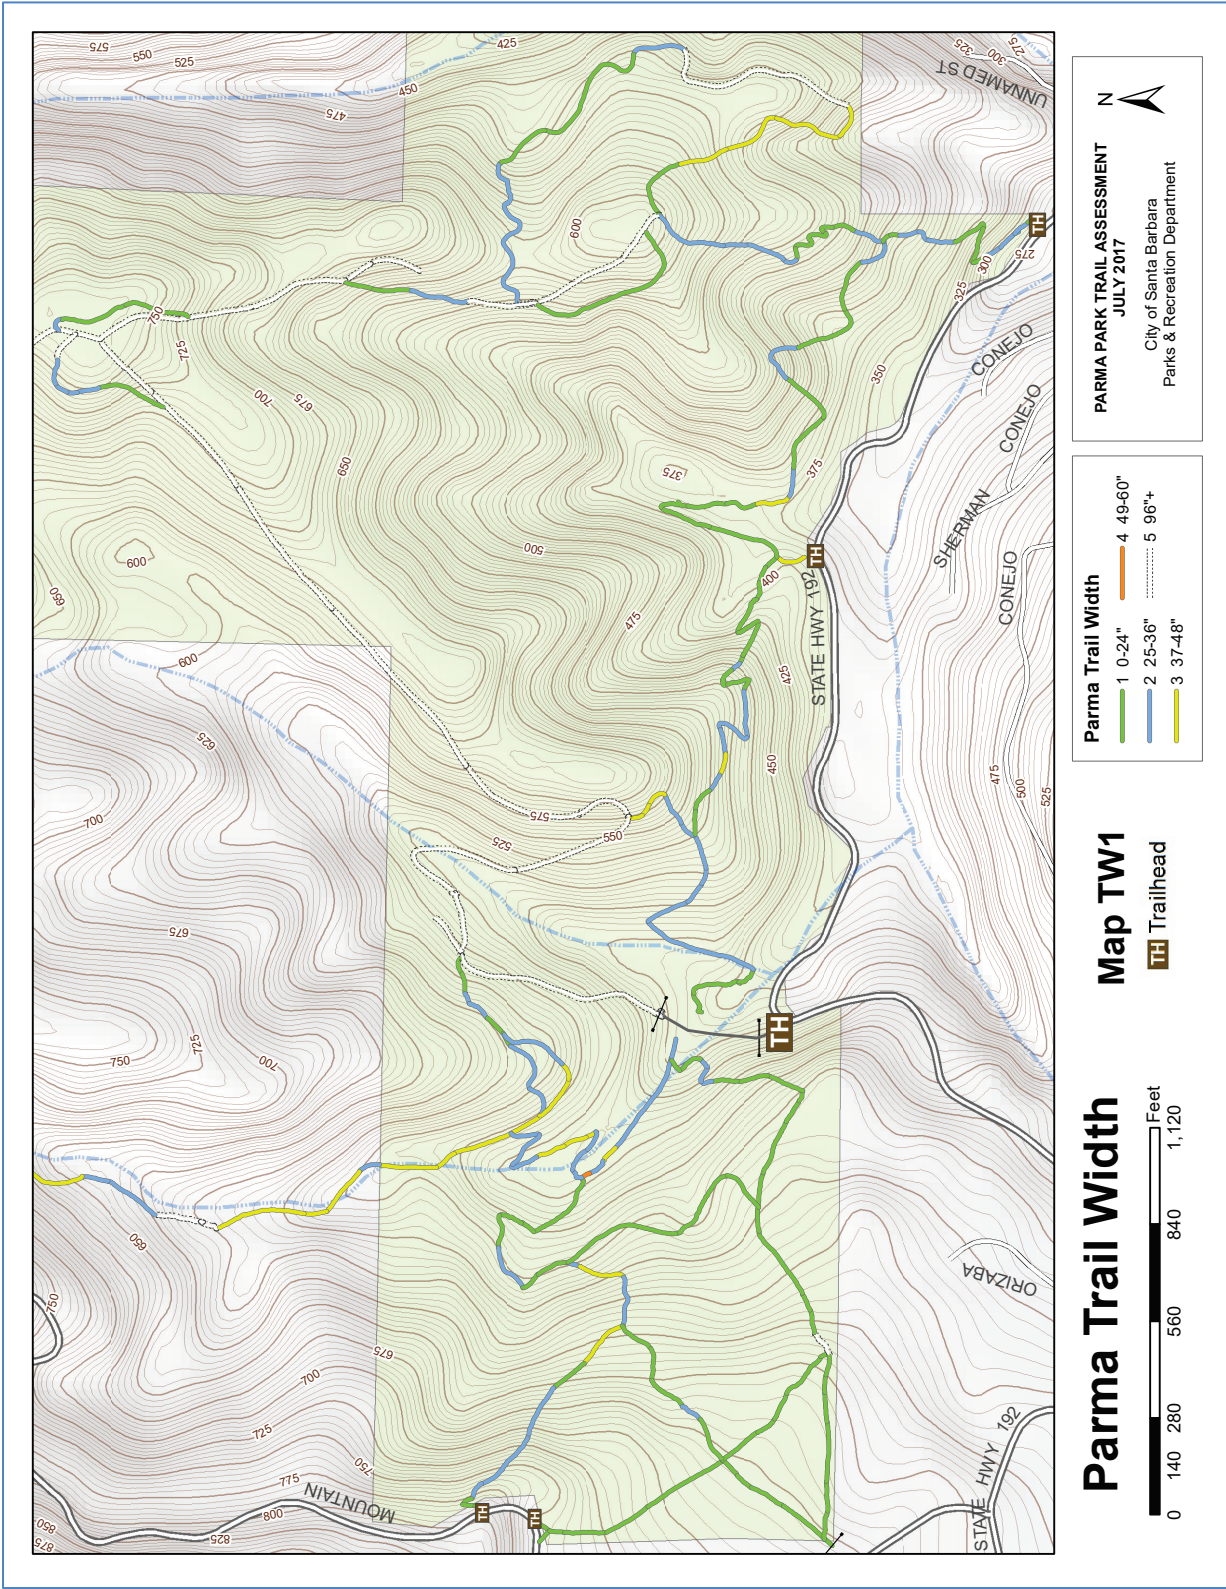
Map TW1. Parma Trail Width

<b>Table 6. Trail Width (Excludes Paved Entry Road and Fire Roads)</b>			
<b>Trail Width Range</b>	<b>No. of Segments</b>	<b>% of Total Segments</b>	<b>Notes</b>
0-24"	99	51%	Almost half of the Parma trails are less than 24" in width and many of these less than 18"-20".
25-36"	64	32%	Another ¼ of the trails are close to the Class 3 TMO width of 36", but in areas with steep sideslopes, and should probably be widened.
37-48"	30	16%	Only 16% of the trails either meet TMOs or may be wider than needed.
49-60"	2	1%	Just 1% of the trails exceed standards for width.

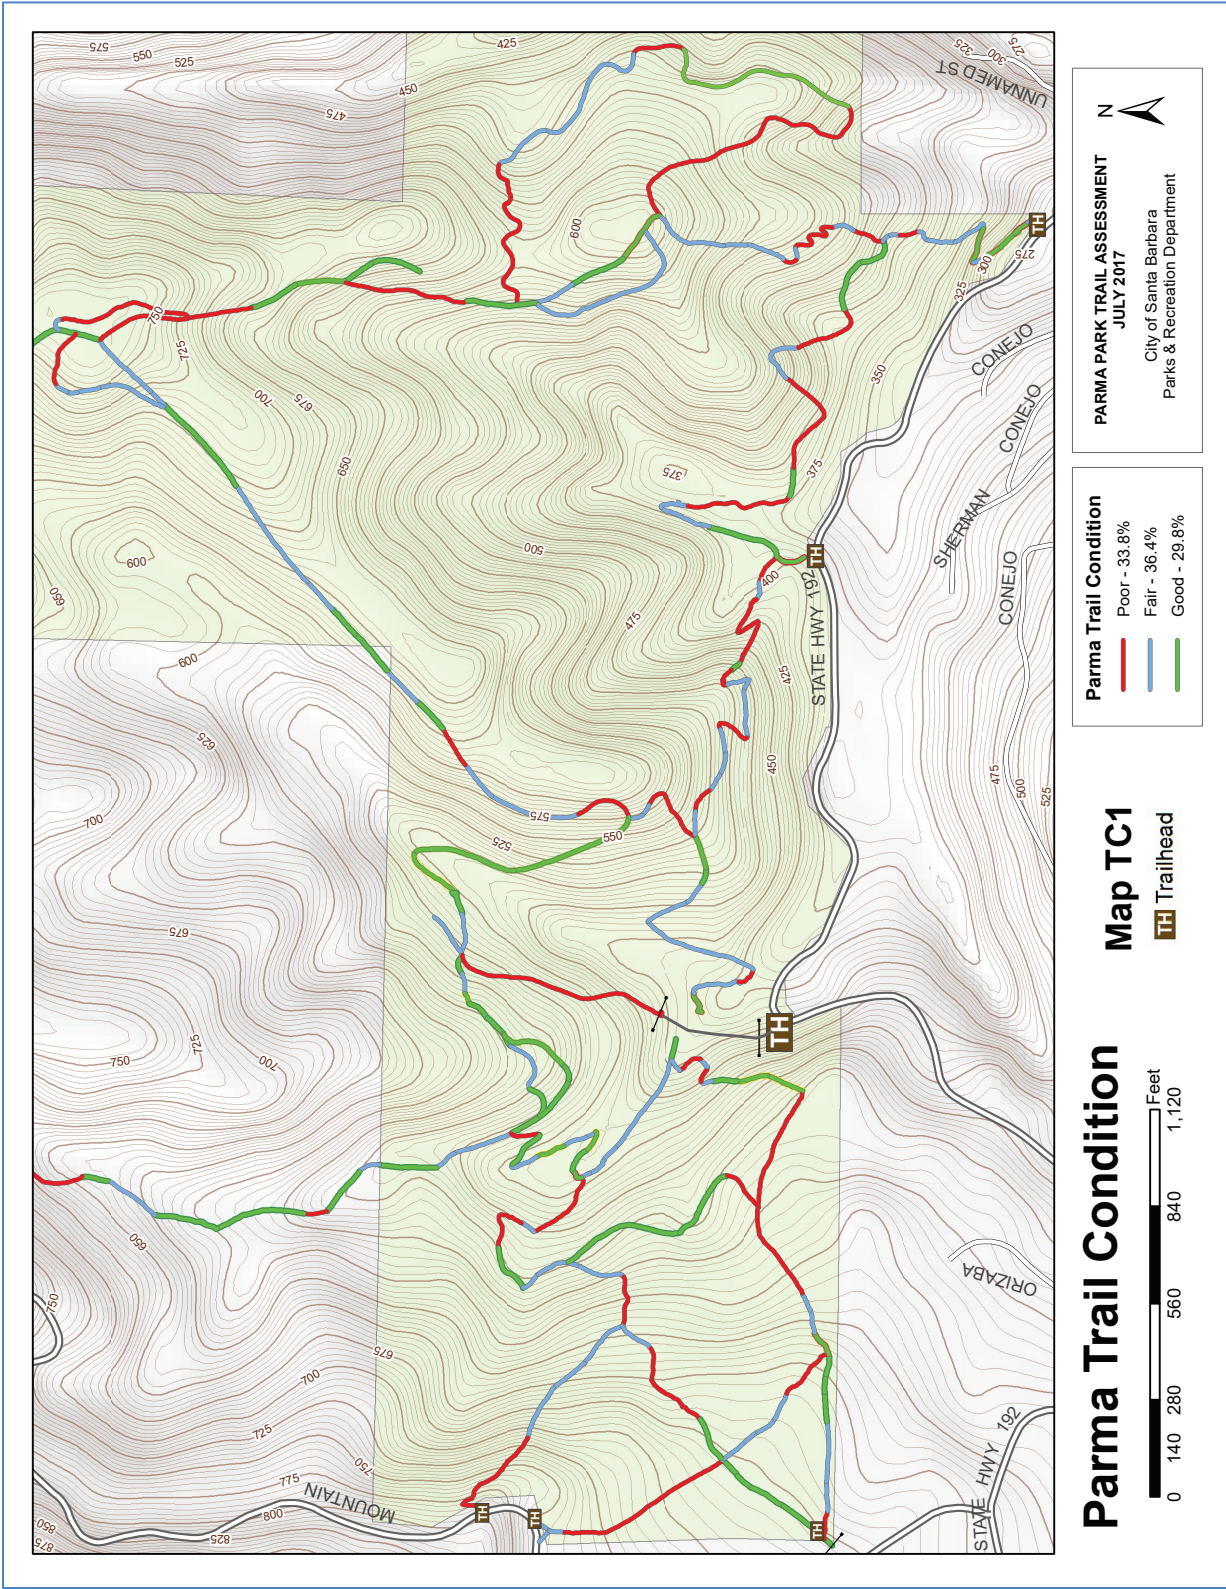
Map TC1. Parma Trail Condition Ratings

- Excessive grade in association with entrenchment or trail damage.
- Steep side slopes in conjunction the above and trails that are too narrow, creating a user safety concern.
- Poorly designed or maintained erosion control features.
- Poorly designed switchbacks.
- Brushing issues.
- Hillside slumping that has narrowed the segment.

It should be noted that even trail segments rated as “Fair” or “Good” still require some level of restoration to meet all or most of the Park’s TMOs; however, the better the rating the more easily they can be upgraded and the lower the rating the more challenging to do so, especially when it comes to meeting the Parks sustainability guidelines.

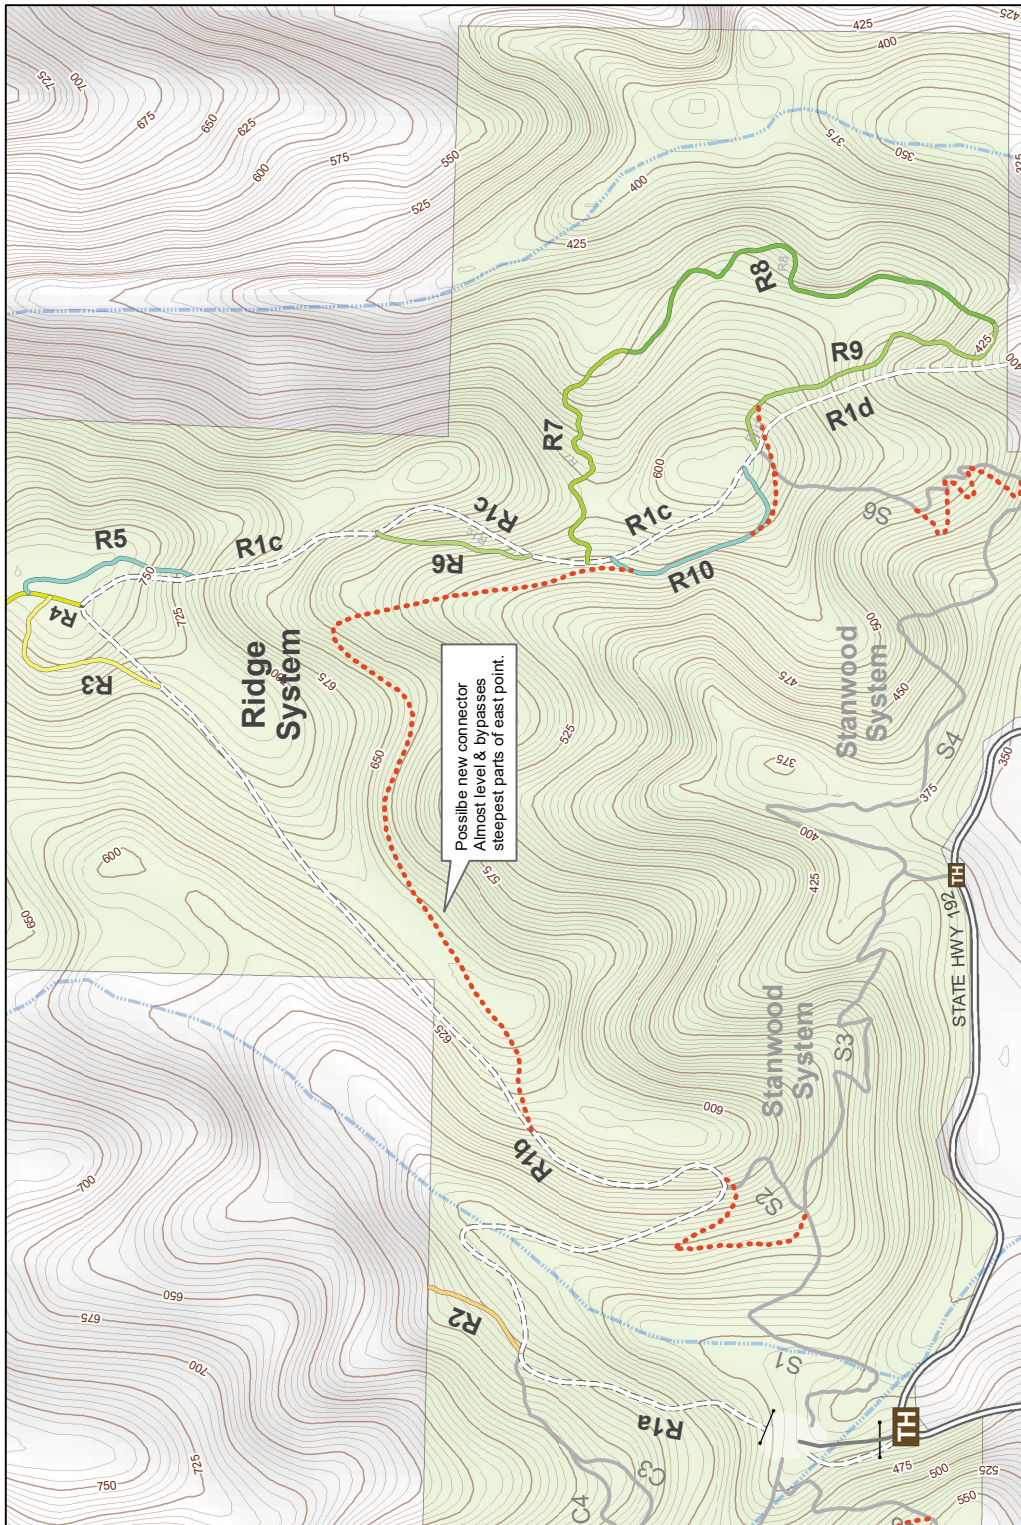
Map R1  
TH Trailhead

- Main Fire Access Road — While easy to walk, and requiring little maintenance, or at least maintenance that would be done with a road grader or bull dozer and not the typical tools used for trail maintenance. Some of the largest amounts of entrenchment within the Park system occur along R1a and R1b and are contributing to erosion along many parts of the road. This maintenance may be beyond the scope of what might be expected for a trail crew to handle, but is needed to reduce the impact of the gullying that is occurring now.

- The eastern portion of the fire access road (R1c) that turns and drops sharply downhill to its intersection with the Stanwood System is entrenched, composed of loose soils and rock and is so steep that it is potentially dangerous for all trail users. Restoration of this part of the fire access road system is also well beyond the scope of a trail maintenance crew's ability to handle.

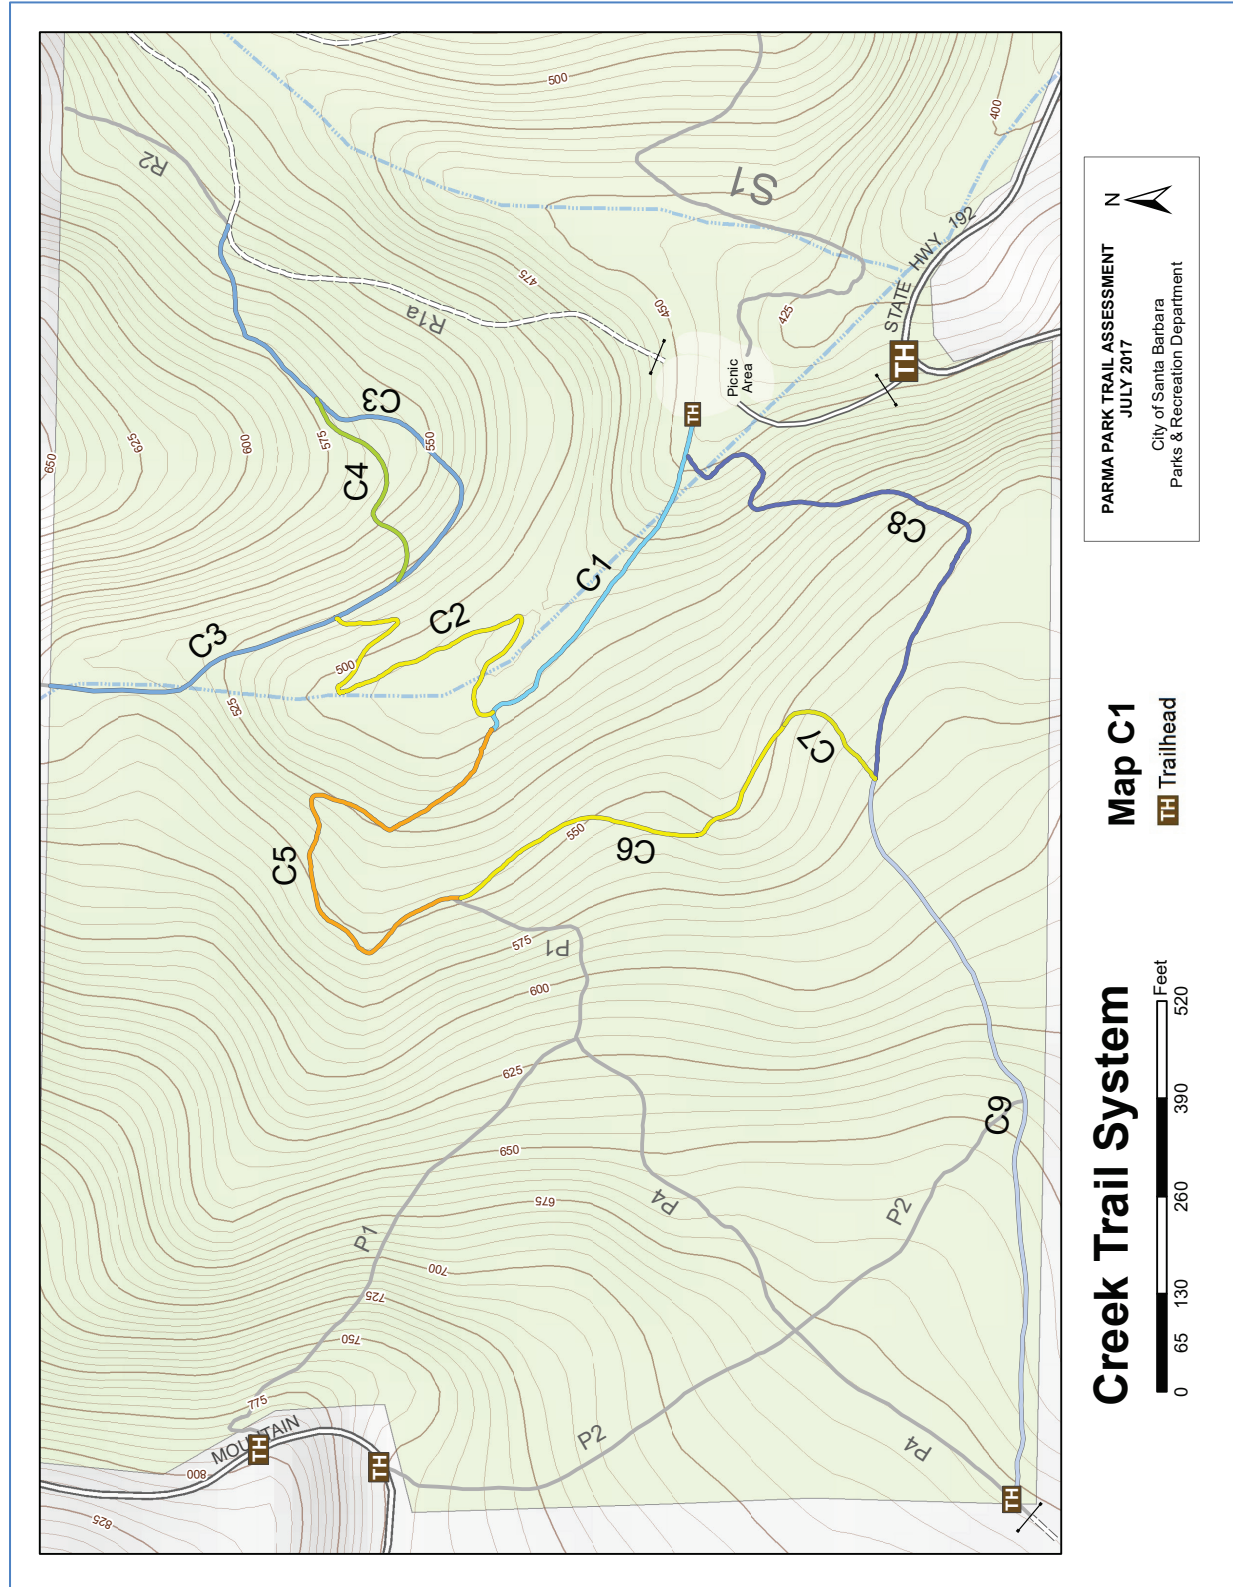
Map C1. Creek Trail System

C1 is a short beautiful section of trail that leads west along the edge of Parma Creek to a point where the canyon narrows and the segment ends. The section is entrenched from 6-8” in places and could benefit from a more curvilinear flow. At the upper end of C1, there are two short creek crossings. It might be possible to eliminate the first of these by staying on the right side rather than crossing and then almost immediately re-crossing. If possible from an environmental standpoint, armoring the creekbed with nearby rock to stabilize the crossing would be helpful.

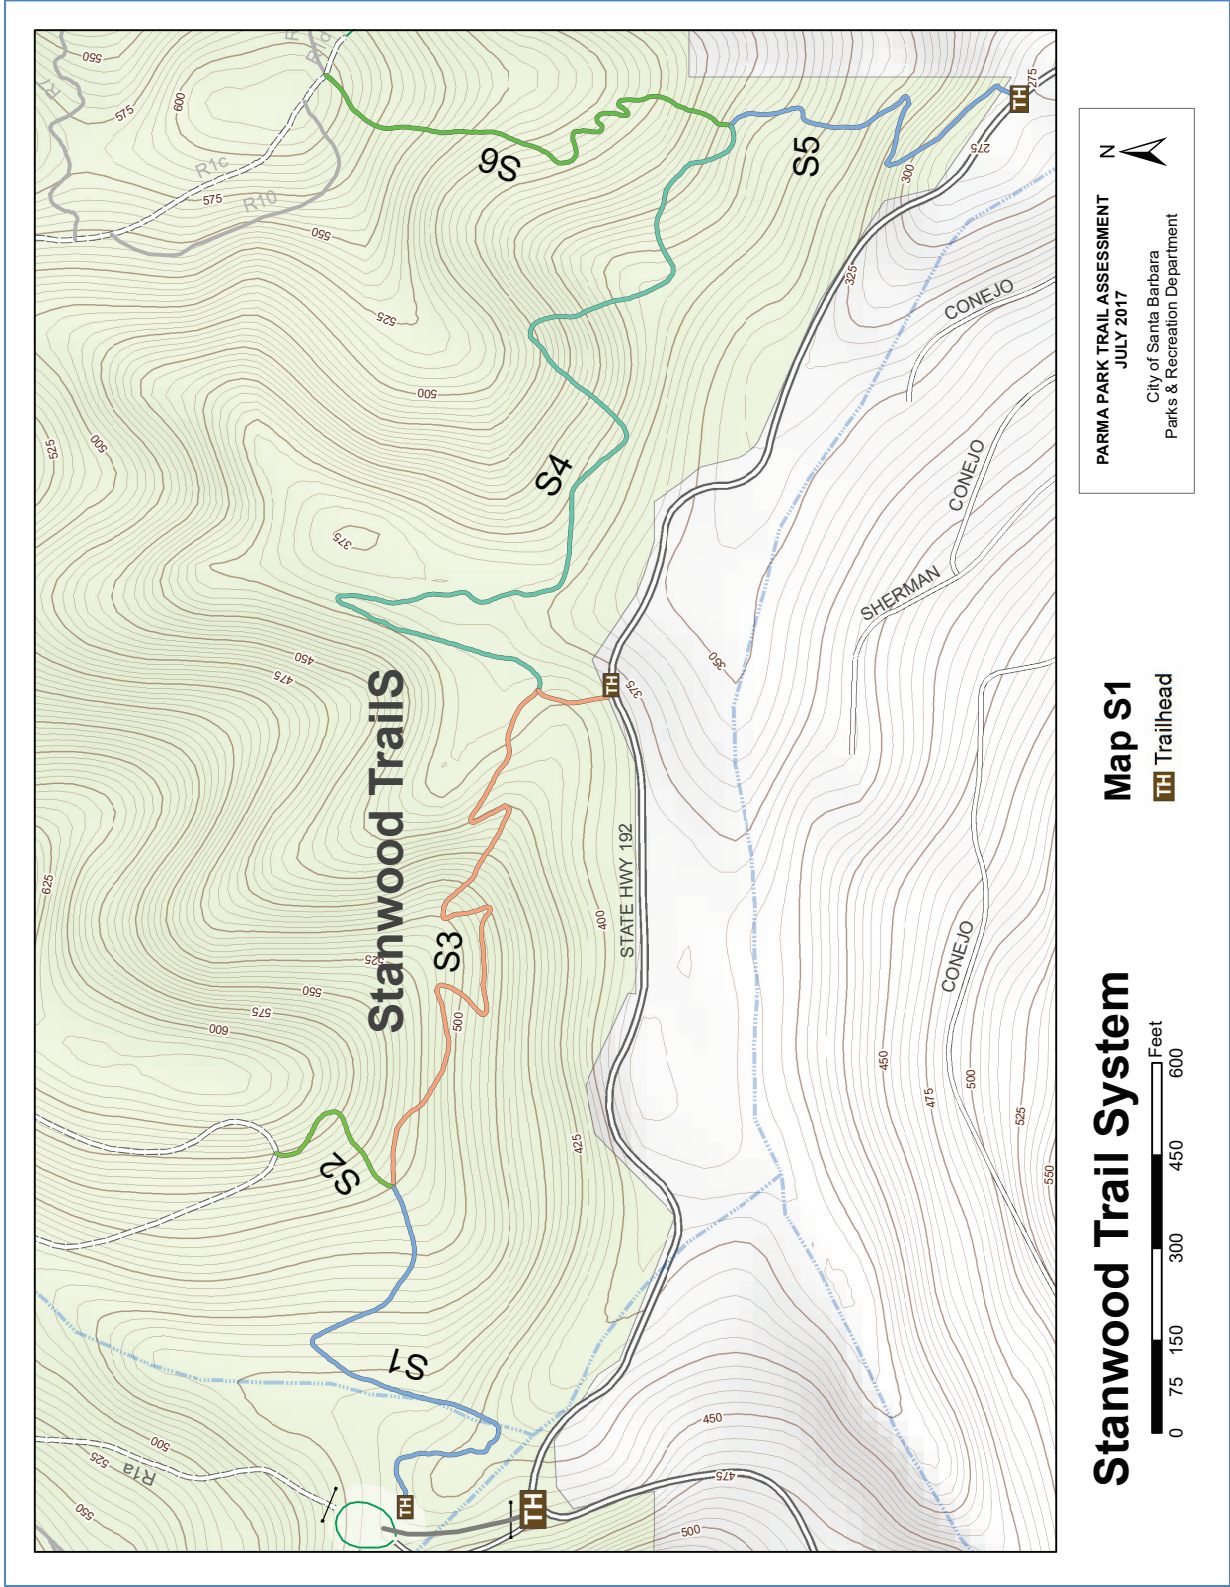
Map S1. Stanwood Trail System

S1 crosses the East Fork of Parma Creek almost immediately after leaving the picnic area. The trail diagonals gradually out of the lower canyon and around a corner (which is in extremely poor condition) that opens into a large triangular-shaped hillside covered in grass. From this point, the trail climbs around the west and north edges of the area to a point where it intersects with S2 or continues on as S3.

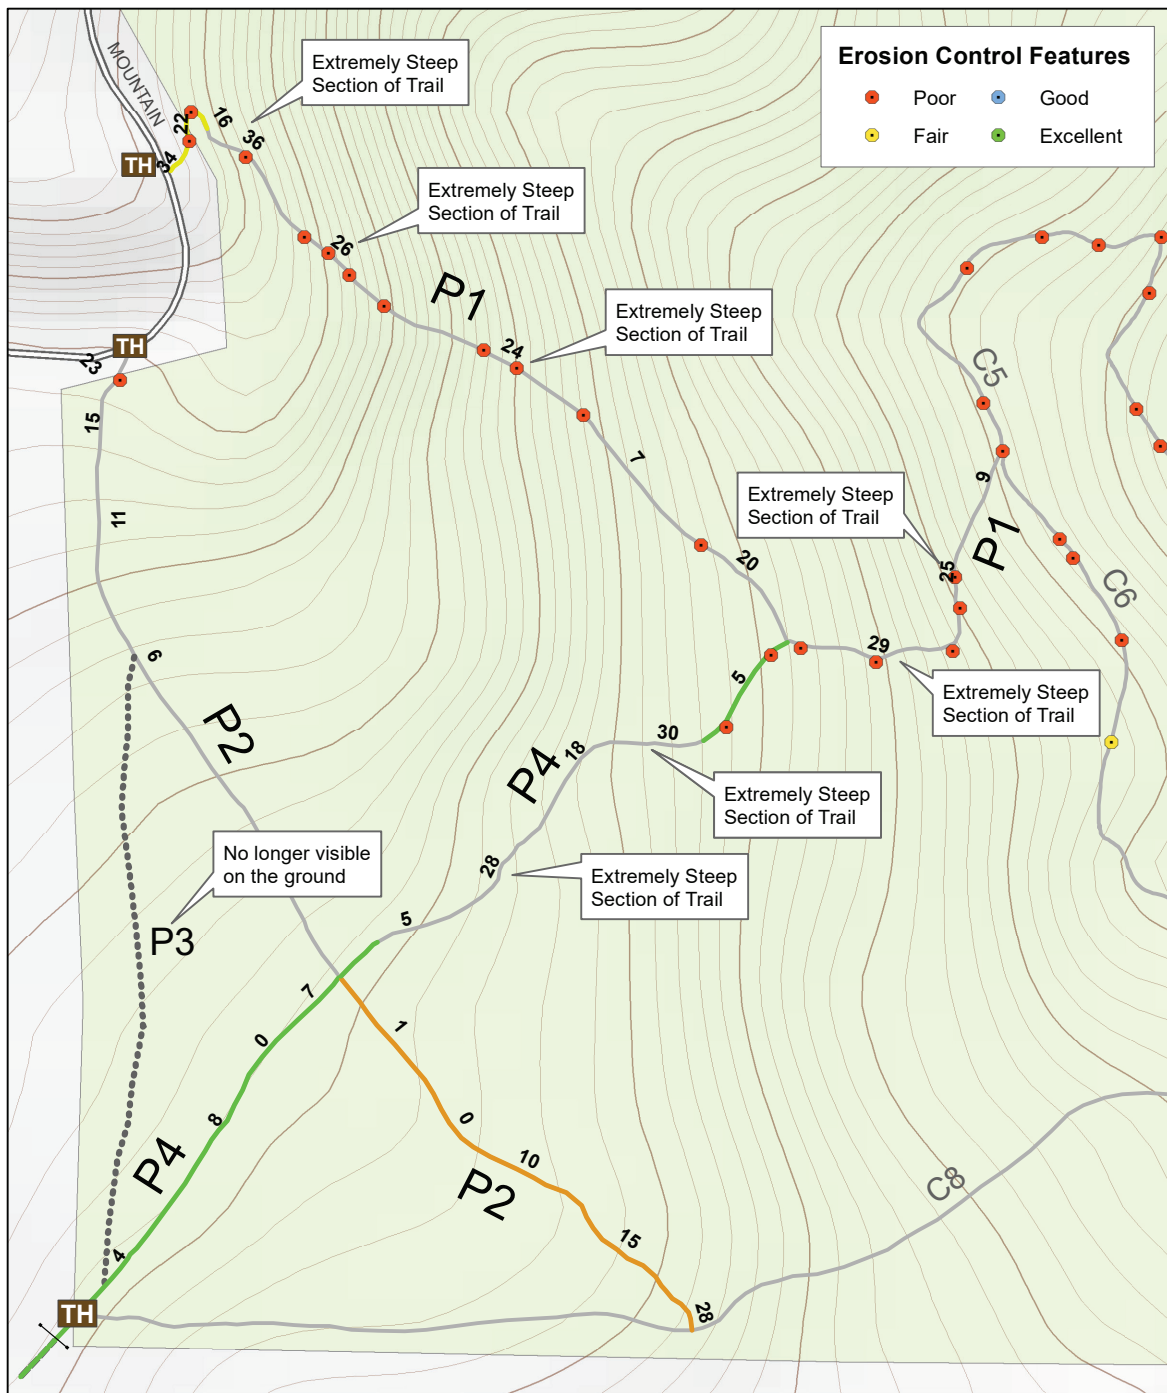
## Plateau Trail System

- **Grade.** All of P1 and the north-eastern part of P4 are in extremely poor condition due to grades that average over 20% for most of these segments. This has translated into entrenched trails with poor tread conditions and trails that are not enjoyable to use.
- **Width.** All of P2 and the southwest part of P4 average a trail width of less than 16". Though grade for both of these segments is within standards, they have become entrenched due to frequent equestrian use. Along large parts of P2 parallel social trails are developing due to the difficulty in using the main tread. This trail follows the middle of the Plateau flats more or less down the fall line and will be difficult to restore given the flat land.

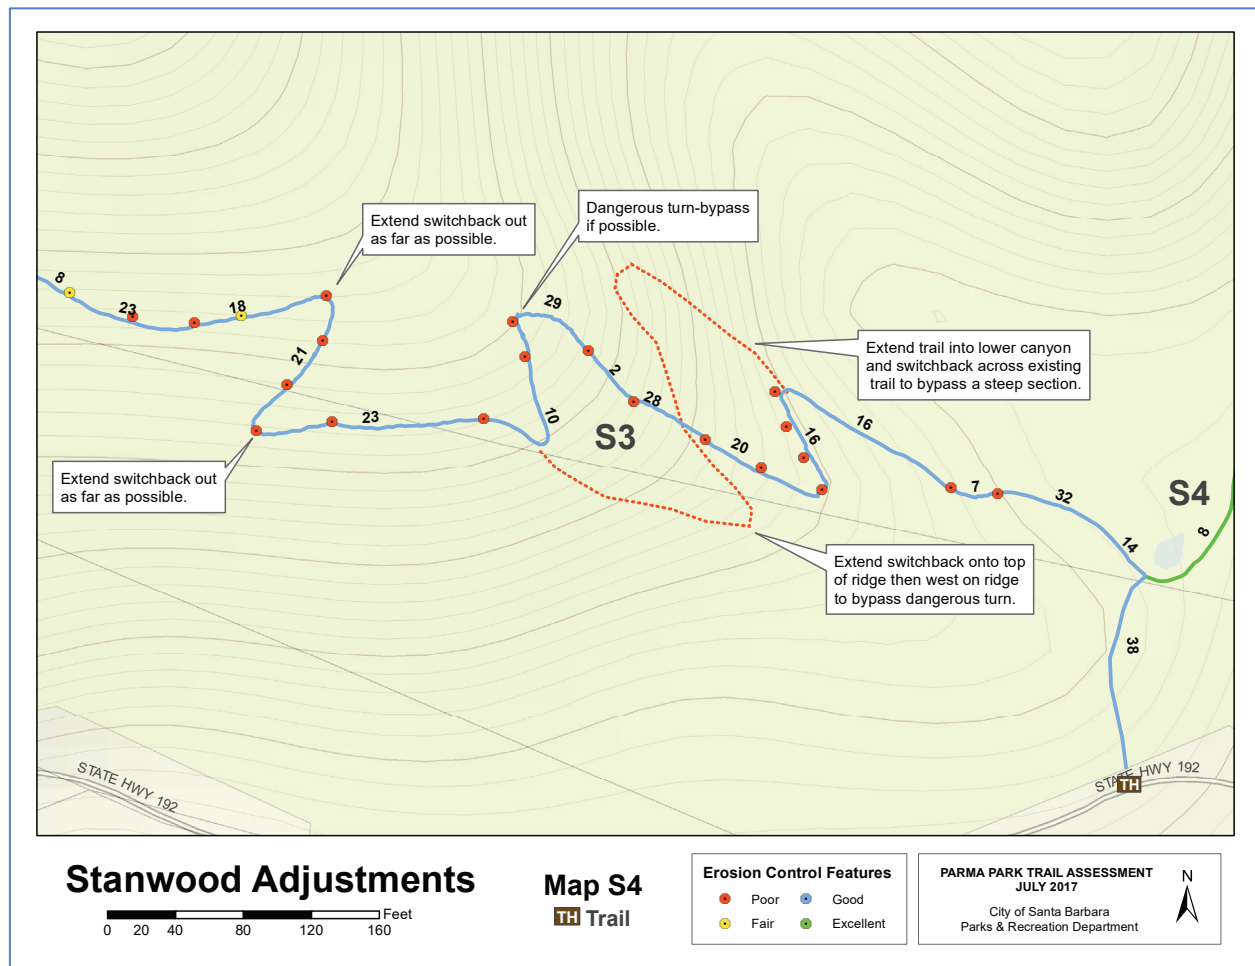
**Map S4. Potential Realignment of Trail Segment S3**

S3 drops steeply downhill to the east from S2, paralleling Stanwood Drive along a steep hillside that leads down to a small reservoir (dry much of the year) and trail access point near the road. The Stanwood trails are heavily impacted by their underlying geologic formations. Underlying S3 and areas north of the trail, the Vaqueros and Sespe Formations predominate, their more resistant sandstone and denser marine formations creating the high, narrow ridgelines while below the more erosive Rincon shales have weathered to create hillsides prone to erosion and deep canyons such as the West Fork of Sycamore Creek.

The result is a trail system (S1, S2 and S3) that contours along the junction of these more resistant and more erosive formations. As a result, the steep topography provides few options for realigning the trail in the sections that exceed sustainable grades or have switchbacks that are too steep.

Map S2 above outlines one potential spot where the it may be possible to route the trail further up a small side canyon below the trail and then back across it to avoid a part of the existing trail that is too steep. However, further exploration will be required to determine if the route is feasible or not. At this time both the thick brush and abundant poison oak makes it difficult to explore the area further.

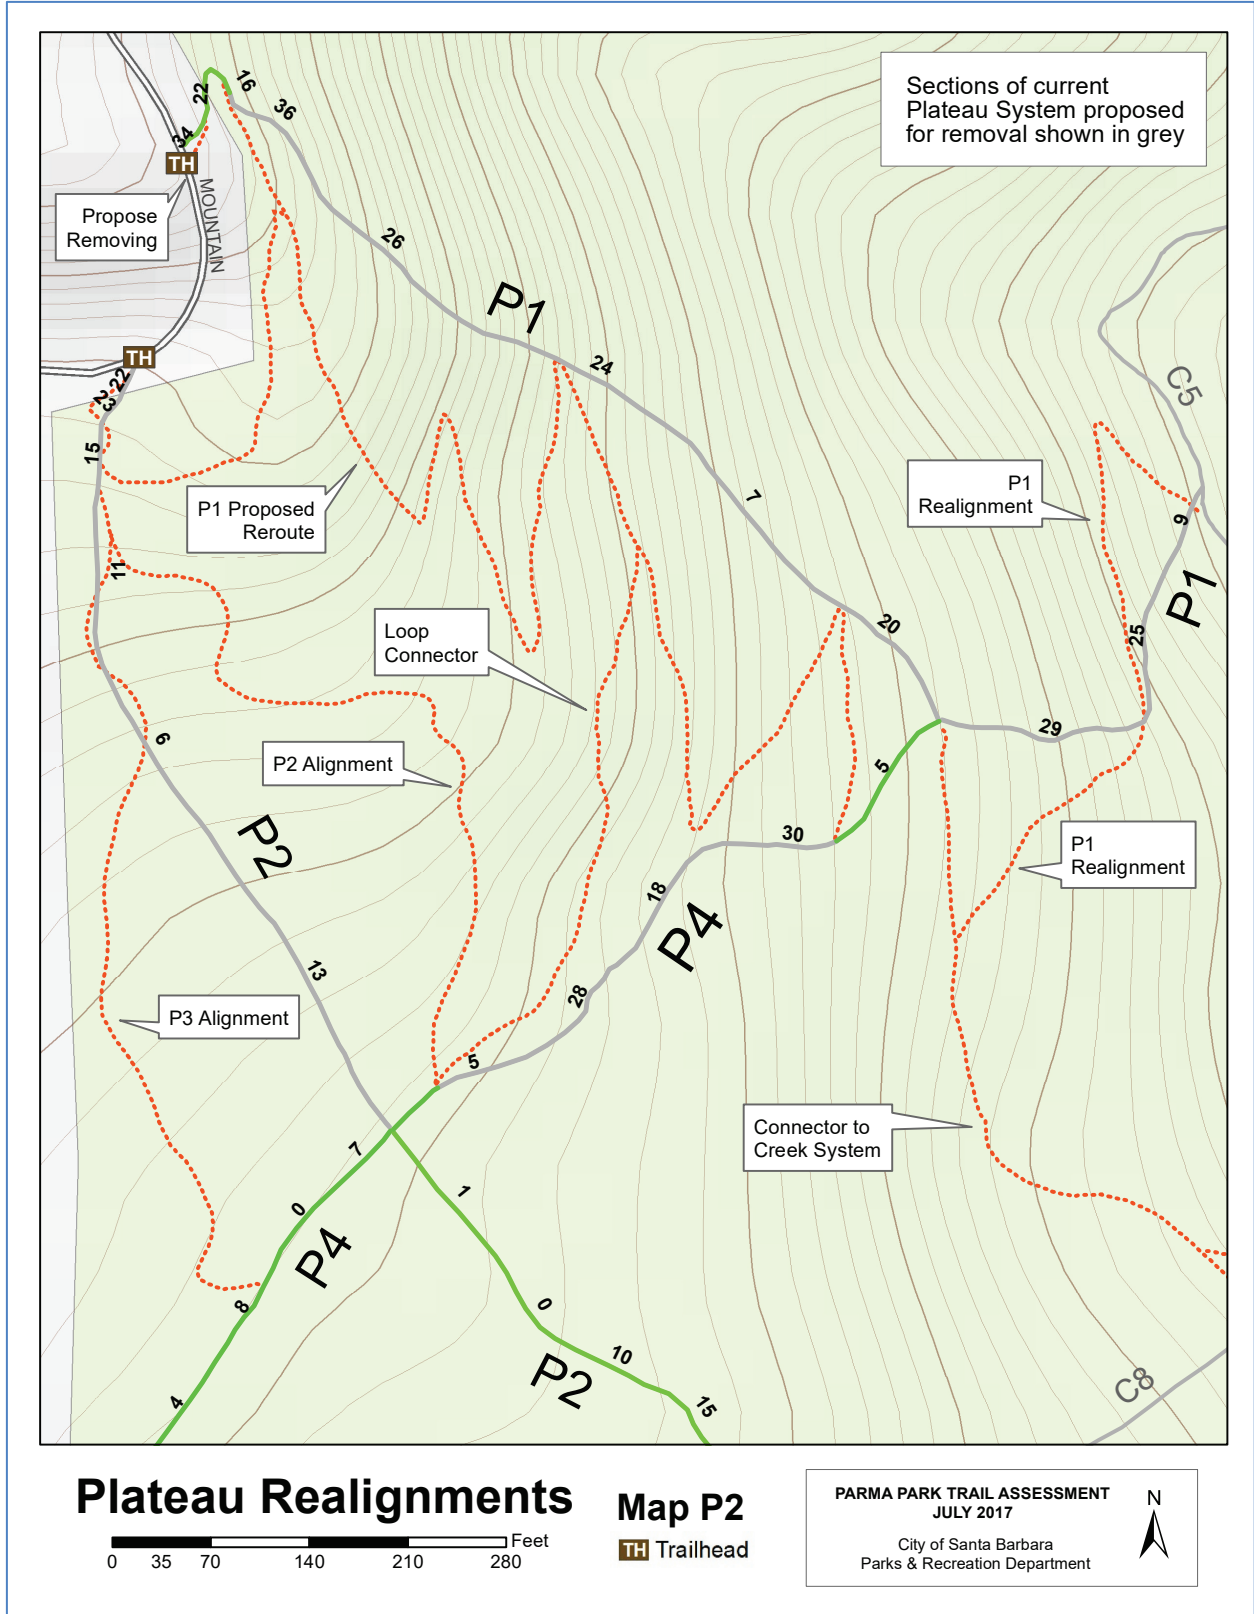
Map P2. Plateau Realignments

Currently P2 heads straight down through the Plateau Flats and intersects with the upper part of C9. The trail is narrow and entrenched and cannot be maintained over time for sustainability. A more sustainable alignment of P2 is possible by routing it slightly further to the east along the edge of the flats where there is enough sideslope to sheet water off the trail and the views overlooking the lower part of the park are dramatic.
